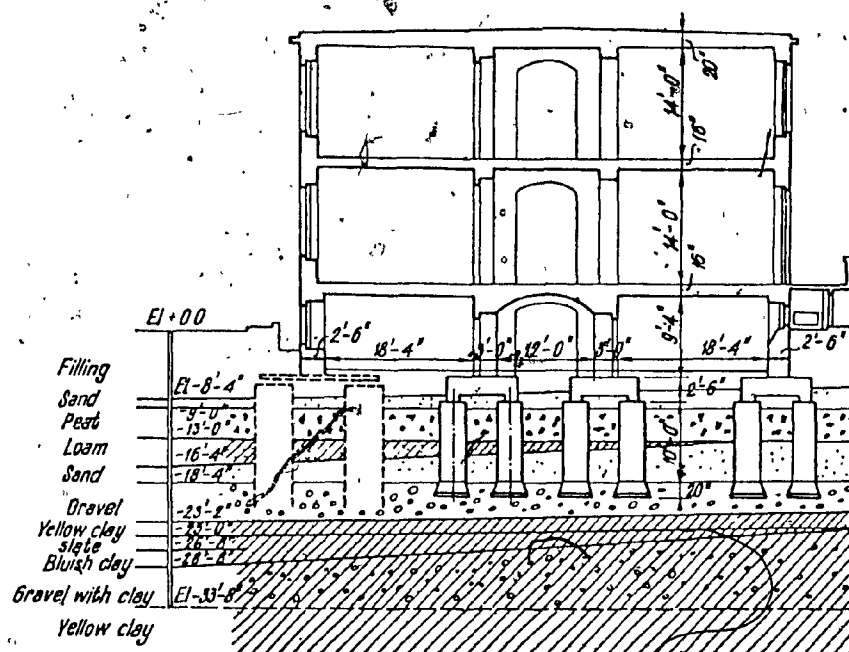
Fig. 1

The examples in fig. 1 shows a cross-section of a large hospital and its foundation where the strip footings were built at ground water level on a layer of sand, from 7 ft to 9 ft below the surface.

The building had been subjected to differential settlement ever since it was built, the rate of settlement increased when the level of the ground water was raised, and serious cracks appeared in the facades over doors, windows and in the staircase.

There were two mistakes made in the design of the foundation. The first was that the differential settlement of the layer of peat was ignored, the second was that similar foundations were used for the outer walls and the main interior walls in spite of the fact that the interior walls carried heavier loads than the outer walls. The end result of these errors was that the interior of the building settled considerably more than the exterior.

This cross section of the hospital, built in a site that was a marsh area in Budapest, during the beginning of this century, shows the layers of the underground which were investigated after the building was subjected to differential settlements. The concrete piers used to underpin the building are also indicated on the left.

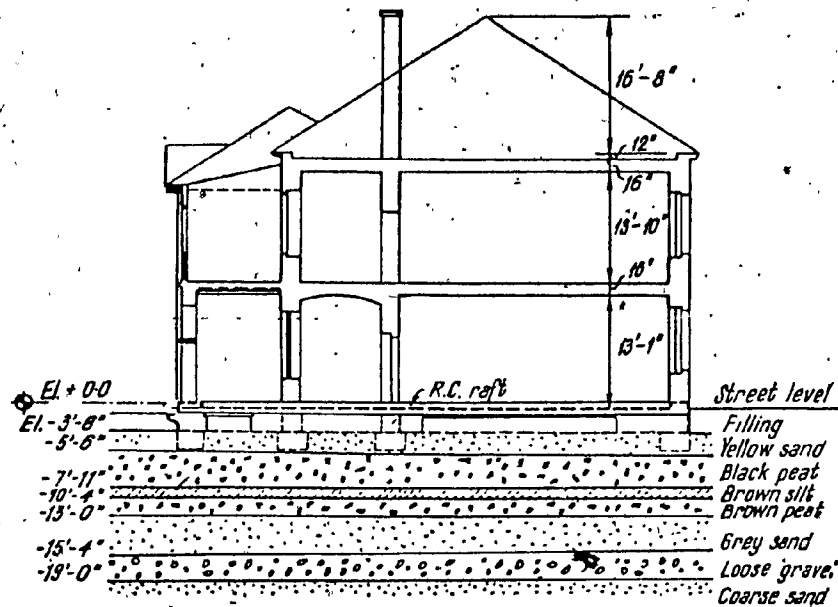
Fig. 2

without an investigation of the soil below the sand layer which extended to a depth of only 5 ft from ground level and under which were layers of peat and silt. Forty years after the building was built, differential settlements of up to 1 ft occurred as well as very large cracks in the structure. The settlement was greater every spring. A result of the higher water level in a nearby creek causing an increase in the water content of the soft peak underlying the sand.

This commercial building was built in 1904 in Germany. The weak subsoil layers which were investigated after serious settlements occurred are shown above. Also shown is the reinforced concrete used to underpin the building.

To prevent further differential settlement, a reinforced concrete raft was constructed at ground level under the entire building as shown in fig. 2. The reinforcement was placed in the areas between the strip foundations first, and half the bars in the transverse direction were passed through holes made at intervals in the footings. The slabs were concreted and the holes filled with concrete. When the concrete had hardened the remainder of the footing was broken through and the bars left projecting from the slabs were passed through from both sides. The bars were then wired together, and the holes filled with concrete. The result is a uniform pressure on the sole of the site covered by the building and the pressure bulb due to the load penetrates deeper than the load of the original strip foundations. By this method, the settlements were reduced because the compression of the soft upper strata was reduced by an amount that exceeded the settlement due to the extension of the stresses to the deeper but less compressible strata.

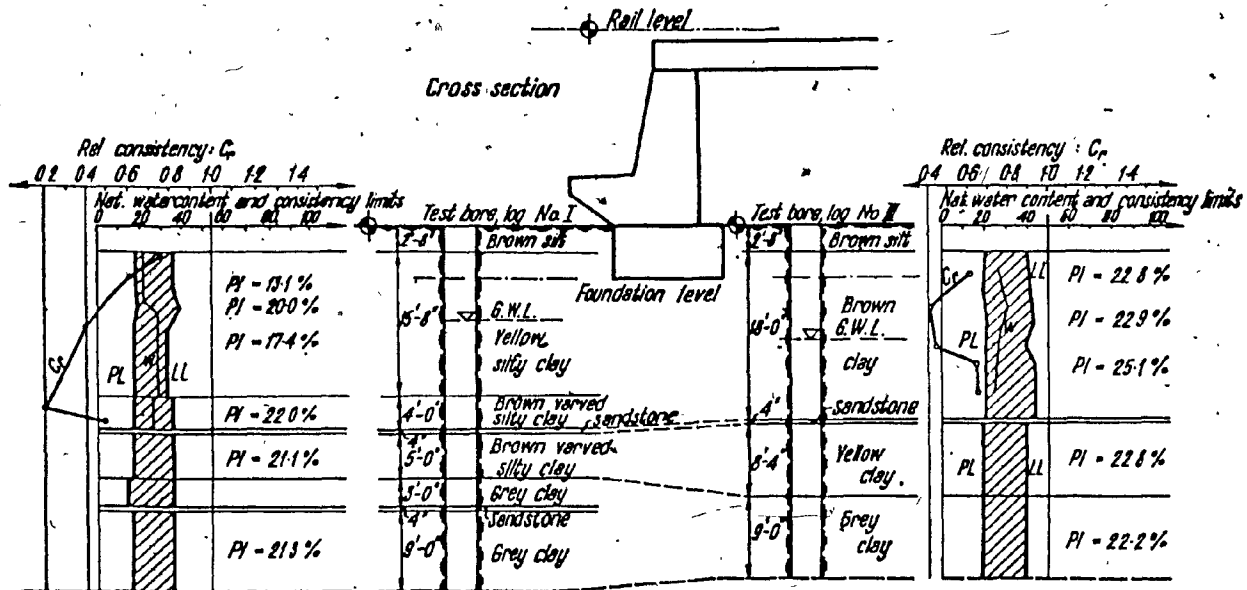
Fig. 3

This railway bridge pier was built in England in 1950. Due to a cursory investigation of the soil before construction, the pier settled considerably and was eventually abandoned. The cross section shows the results of intensive investigation afterwards.

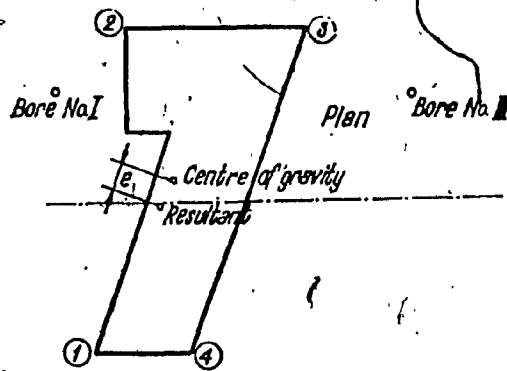
Fig. 4.

As shown in fig. 4, the plan of the foundation is irregular because the axis of the bridge is not at right angles to the railway.

This figure indicates layout of railway pier foundation from fig. 5, with bore hole locations during the intensive soil investigation.

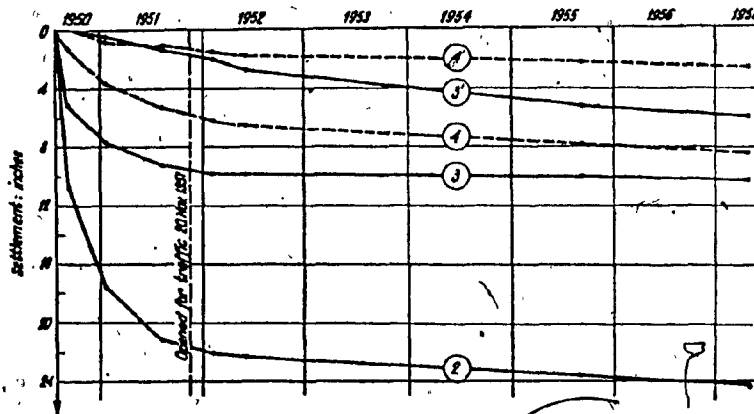
Fig. 5.

The curves in fig. 5 show the settlement during a period of years (the number in circles indicate the positions numbered on the plan in fig. 4). It can be seen that the greatest settlement that occurred when the bridge was first loaded, was at (2) where the subsoil was saturated, and was much less at (3) and (4). The settlement at (3) is greater than would be expected by comparing the pressures on

This figure indicates the results of the soil investigation of the railway pier. The numbers indicate the position numbered on the plan in fig. 4.

the ground and taking into account the unsymmetrical shape in plan of the foundation and the eccentricity of the load. It may be that the lack of symmetry of the foundation and the non-homogeneity of the soil caused the foundation to tend to rotate about an axis other than that indicated by theory.

The subsoil under the other abutment (3') and (4') was drier, and the settlement was consequently less. The settlement at these places has since however, increased, probably as a result of a transfer of load or of later increase of moisture content. At (2) the settlement has exceeded 2 ft by 1958, as shown in fig. 5, and was increasing at a rate of $3/8$ in a year. However, at the other places the magnitude of settlement was less than 1 ft and was increasing at the rate of $1/4$ in per year. The other abutment had settled twice as much as is shown. Due to the high settlements, the bridge was abandoned, and obviously a complete loss.

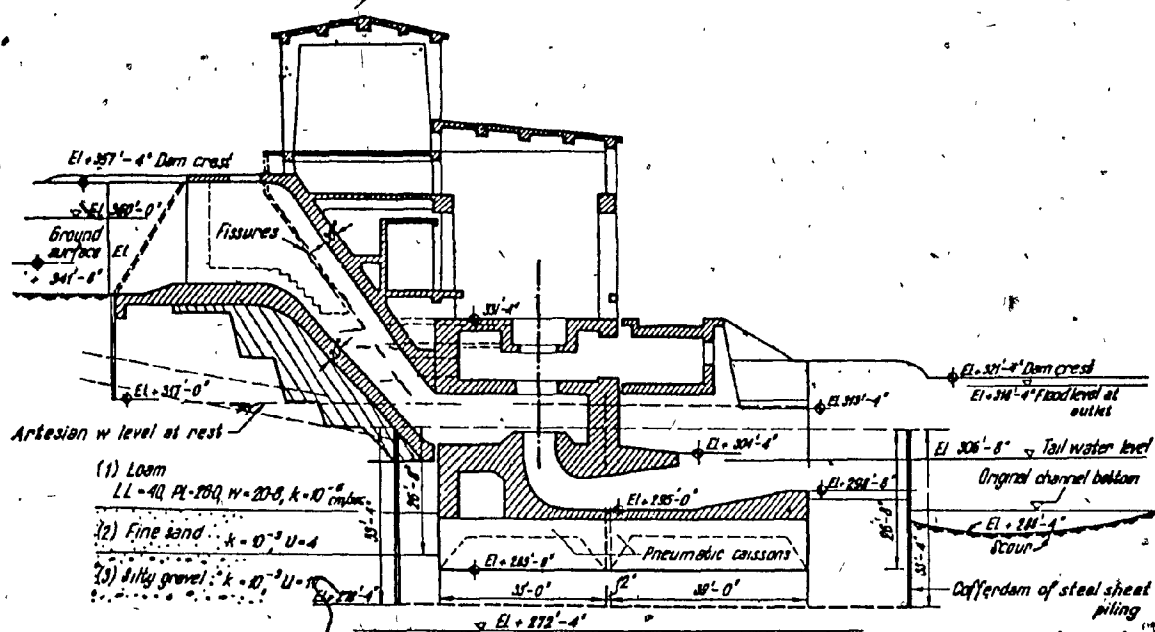
Fig. 6

Figs. 6 and 7 illustrate works comprising of three main parts each differing greatly in weight and purpose. Preliminary bores indicated sufficiently well the physical characteristics of the subsoil; but no examination was made of the ground water conditions. When the excavation reached a depth of 5 ft, ground water surged up around one of the wooden piles and the inflow increased to such an extent that the work was stopped and a different method of construction adopted.

Cross section of turbine-house of a hydro-electric plan, Sweden, where wooden piles were used and failed.

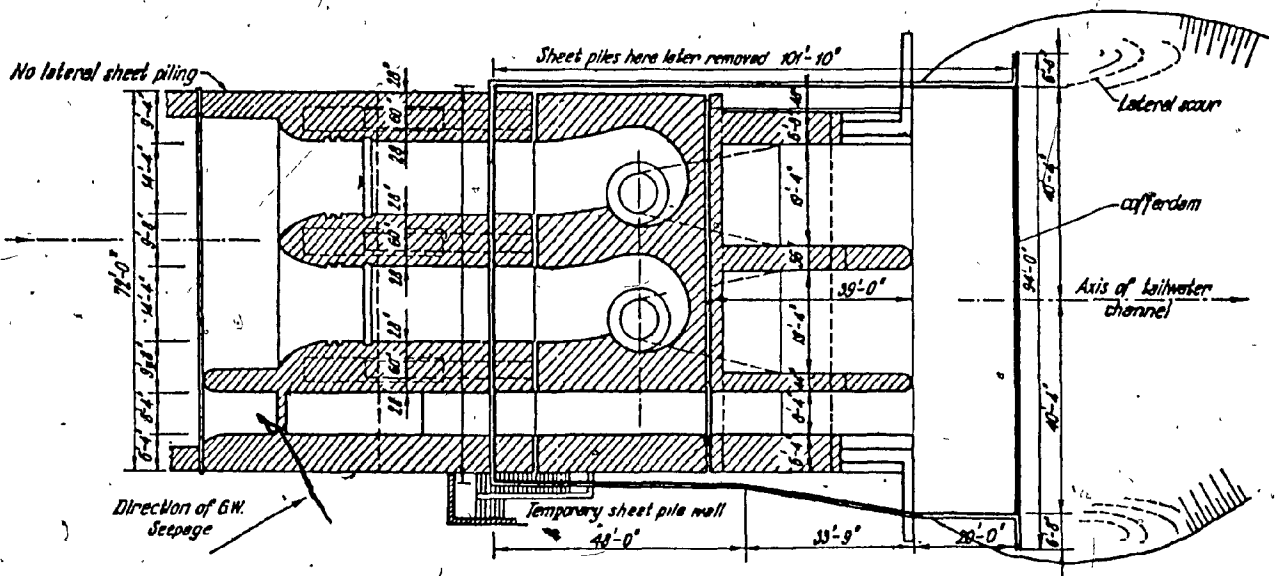
Fig. 7

Partial Layout plan of Fig. 6

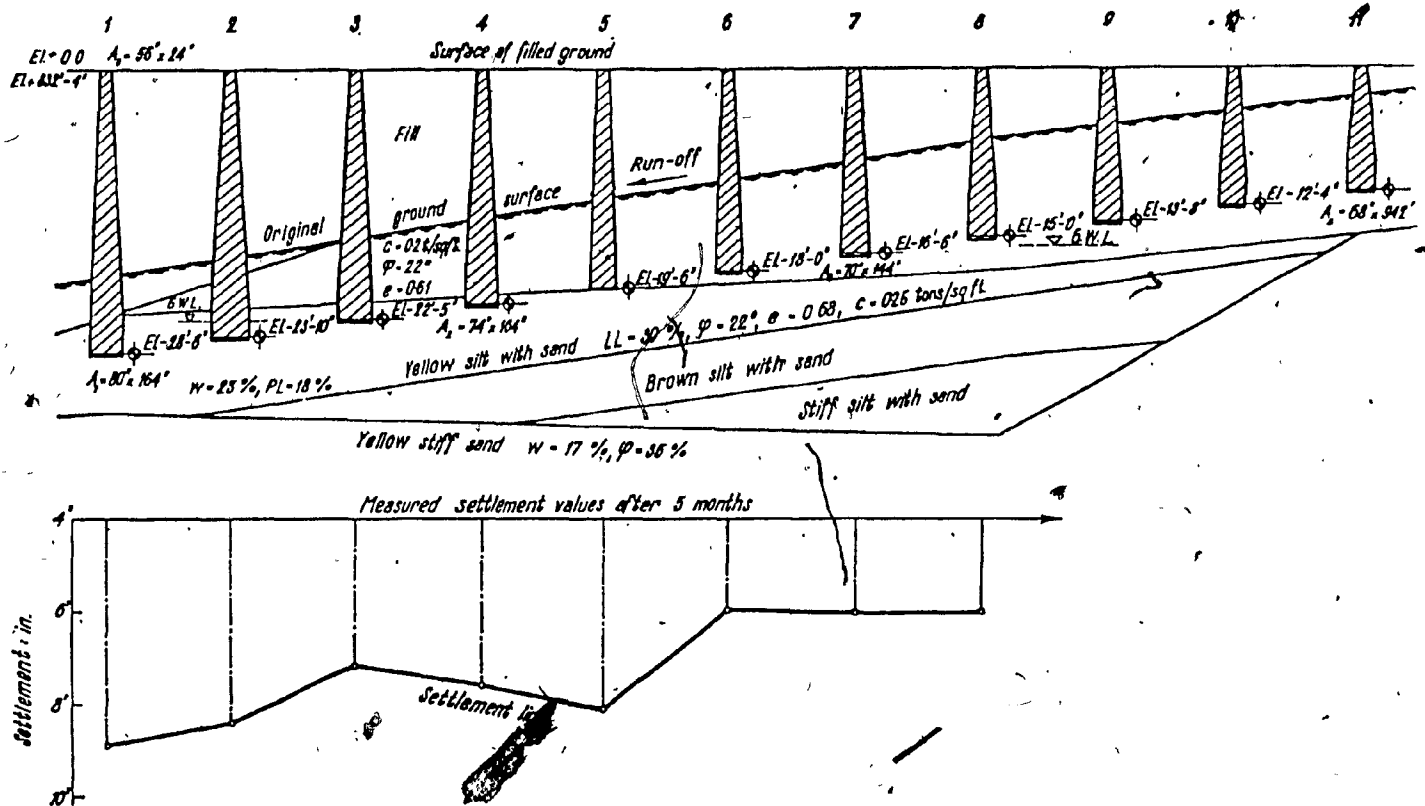
Fig. 8

is another example of failure which shows that the examination of the site is of no avail unless the results are used carefully by the designer. The soil report described the soil properties and also advised the designers on the best type of foundation suitable in the area. The bearing capacities were accurately given, together with suitable depths and dimensions for the foundations under each masonry pier, see fig. 8. The need for making exact calculations of the settlements in relation to the sensitivity of the structure were mentioned in the report as well as the need to provide drainage to divert the surface water, but there was no mention of how to deal with the problem. The foundations as shown in fig. 8 are in silty sand with an angle of internal friction of 22 degrees to 32 degrees, and a void ratio of 0.61 to 0.68 and the water content exceeds the plastic limit. These properties are related to the surface water moving down the slope, which would not only cause scour but would also vary the bearing properties of the soil as the water content was reduced. The recommendations to make exact calculations of settlements and to provide drainage channels were ignored.

Cross section of crane foundation in Germany where incomplete co-operation between design and soil report resulted in uneven settlements as shown.

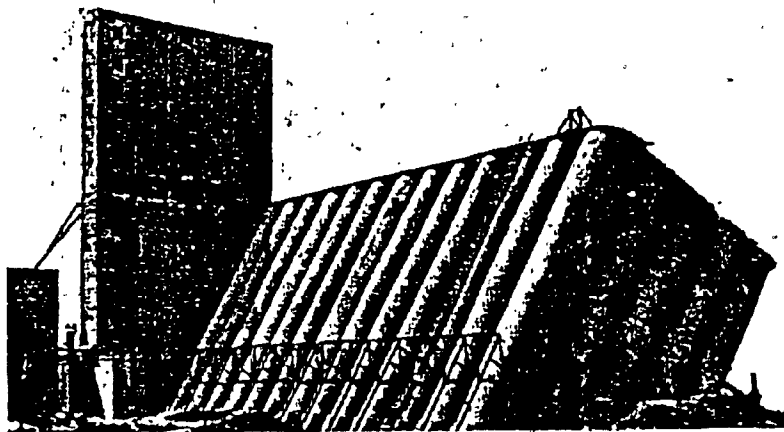
Fig. 11

A well-known failure of a foundation is that of the grain silo at Transcona, Canada. It has been ascertained recently that failure occurred when the pressure on the ground was about equal to the calculated ultimate bearing resistance of an underlying layer of plastic clay, and was essentially a general shearing failure. The silo is 70 ft by 195 ft in plan and has a capacity of 1,000,000 bushels. It comprises 65 circular bins and 48 inter-bins. The foundation was a reinforced concrete raft 2 ft thick, the underside being 12 ft below the surface of the ground. The calculated bearing pressure of 3.27 tons per square foot was based on tests on the ground at the bottom of the excavation, and the fact that this pressure had been used in the calculations for neighbouring structures. No preliminary investigation of the subsoil was made. The site is in the basin of a glacial lake and there are glacial deposits of clay about 40 ft thick under a 10 ft layer of deposits of more recent origin. Below the clay there is a well-consolidated layer of sub-glacial drift about 10 ft thick on which many of the heavier structures in the district are supported.

Construction started in 1911 and was completed in the autumn of 1913. The first sign that trouble might occur was that in the spring of 1913, after a thaw set in after heavy winter snow, the clay under an adjacent railway embankment, 30 ft high and composed of ballast,

Photographs showing the silos at Transcona,
after they have failed.

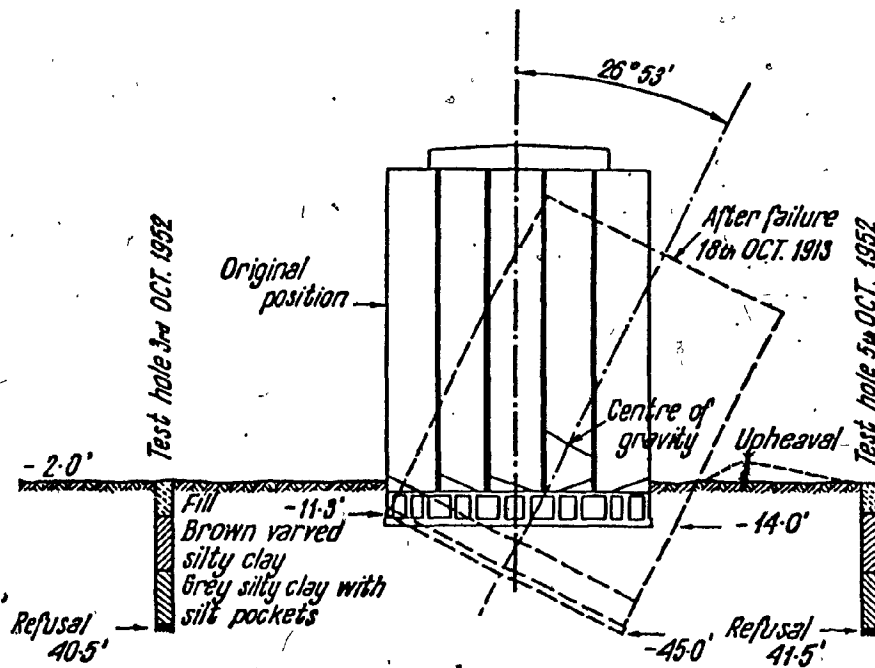
Fig. 12

Schematic diagram showing the silos before, and after tilt occurred.

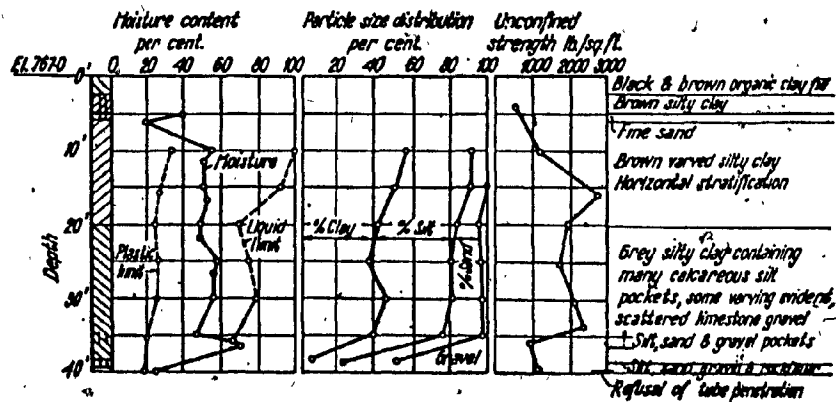
Fig. 13

From examination of undisturbed samples of the clay 60 ft away, it was determined that the average water content of successive layers of varved clay increased with their depth from 40 per cent to about 60 per cent and the compressive strength q_u of unconfined specimens decreased from 1.1 tons to 0.65 tons per square foot, the average being 0.93 ton per square foot. The average liquid limit was found to be 105 per cent, and the plastic limit 35 per cent, therefore, the plasticity index was 70 per cent, which indicates that the clay was highly colloidal and plastic (fig. 13). This condition is demonstrated by the fact that the ratio of compressive strength in natural and in remoulded states is two. The bearing capacity q_n can be determined from the formula, $q_n = cN_c = 1/2 q_u N_c$, in which N_c is $5(1 + \frac{B}{5L})(1 + \frac{D}{5B})$, in which B and L are the breadth and length of the foundation and D is the depth. Substituting the data in the foregoing,

and, with the average value of q_u , the theoretical ultimate capacity could be $1/2 (0.93 \times 5.56) = 2.57$ tons per square foot, which is slightly greater than the pressure at which failure occurred. If the least value of q_u , that is 0.65 ton per square foot for the lowest layer, is taken into account, q_u is 1.80 tons per square foot. It is not good practice to base a design on average values, for a weak layer will produce concentrations of stress in a stronger layer above it. Recently, Dr. A. Hanna (1978) has developed a theory for footing on a strong layer overlying a weak layer. This theory may be used for such soil conditions, it will predict less bearing capacity, and failure may be avoided.

Results from soil tests after the collapse occurred.

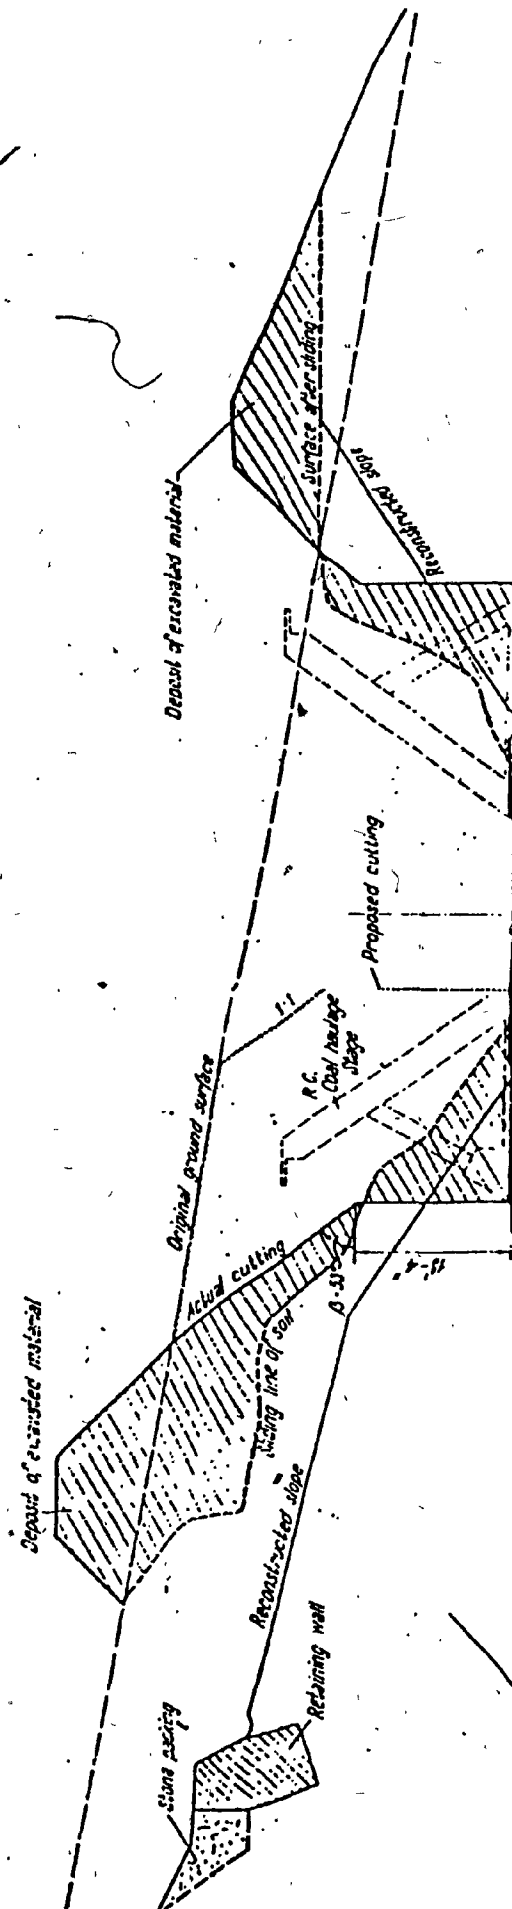
Fig. 10

The results of disregarding the possibility of the sliding of the soil as a result of excavation is shown in fig. 9. This is a coal store in soil which, due to its geological formation, was susceptible to sliding. The sides of the excavation remained stable during a dry summer, but the autumn rains caused them to slide before the staging for unloading the coal was built. The drawing shows the original design and the results of the sliding of the saturated soil.

Cross section of coal store area England, where sliding occurred after construction due to neglect in design.

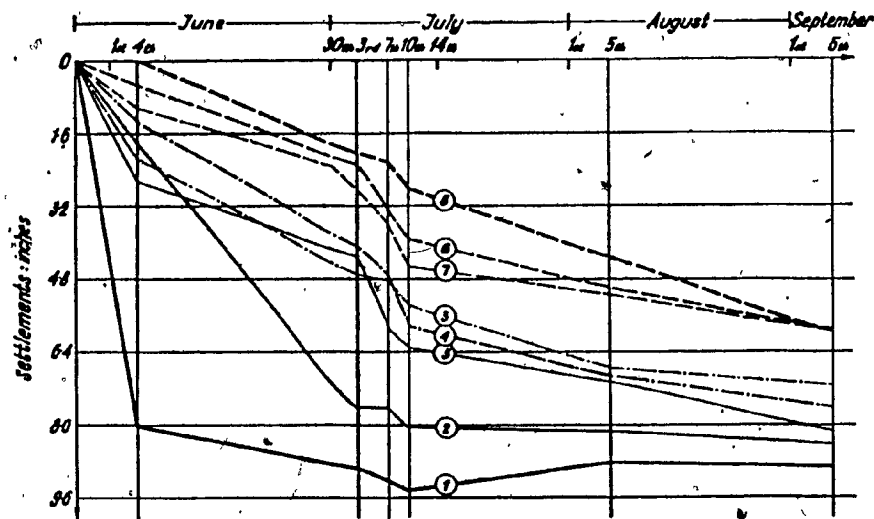
Fig. 9

Differential settlement occurred during the construction of the superstructure was suspended. The settlement record is given in fig. 9, which continues after a year of completion of construction. Under pier 1 and 2, the layer of silty sand is thinner and the settlement was sudden due to the underlying cohesionless soil. As can be seen from the record of the other piers, the greater the thickness of the intermediate layer of silty sand the lower the rate of settlement. Both the parties involved in this case are at fault, the soil

Results of settlements from fig. 8.

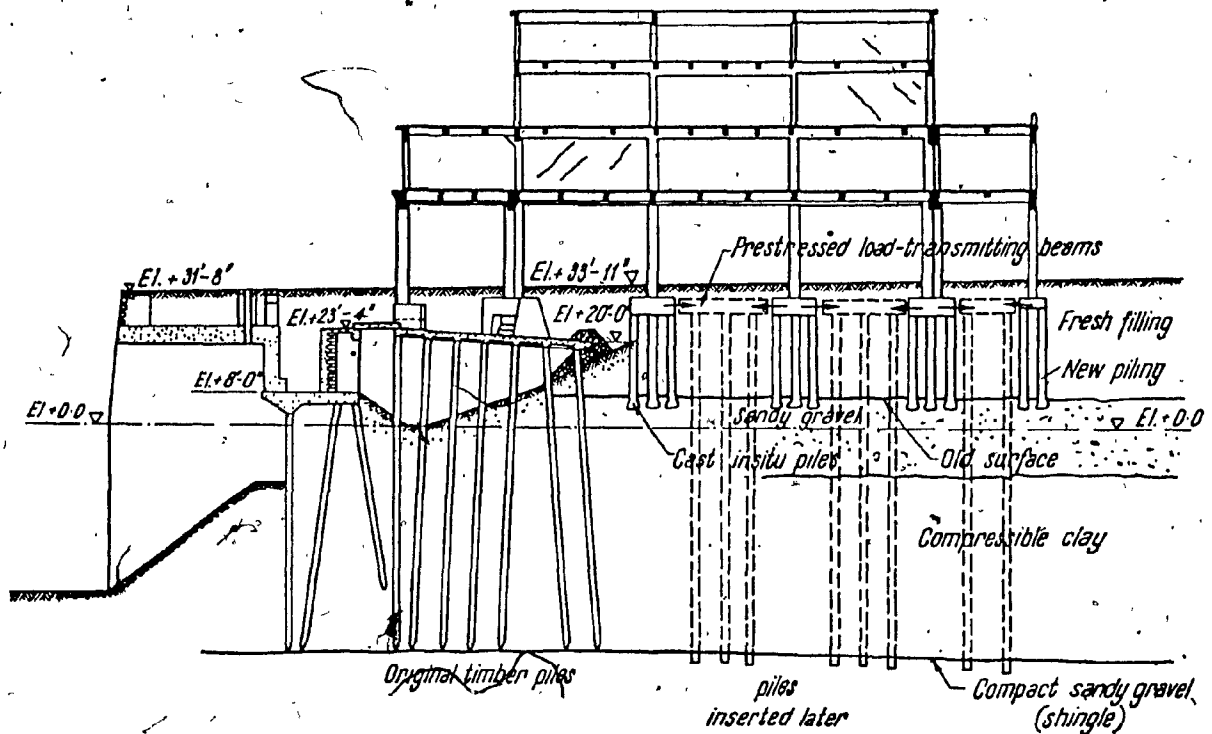
Fig. 14

The reinforced concrete frame of the building in the present example was supported on one side on an existing raft carried on timber piles 100 ft long, bearing on a layer of compact gravel, where as the other side of the frame was supported on a new piled foundation. The new foundation comprised reinforced concrete piles 33 ft long in groups of eight to thirteen, which were driven into a layer of sand and gravel 8 ft thick overlying clay 60 ft thick (Fig. 1A), beneath which compact sandy gravel extends to a great depth. The new piles settled only 1/4 inch to 1/2 inch under loads of 60 to 100 tons, from which it was concluded that the bearing capacity of the upper layer of sand gravel was sufficient to provide a satisfactory foundation, and the cost of providing piles of the same length as the timber piles (100 ft) was unnecessary. Piles 33 ft long and each designed to have a working load of 42 tons were therefore provided.

which was almost uniformly distributed over a large area of the gravel and thence to the clay. The dispersion of the pressure through the relatively thin layer of gravel was limited, and considerable pressures were transmitted to the compressible clay. Compression tests on undisturbed samples of the clay demonstrated its great compressibility as well as its fairly high water content.

Pile foundation industrial building at Le Havre France, 1932. Showing are the old and new piles with pre-stressed concrete beams used for remedy.

The remedial measures incorporated one of the first applications of prestressing and curing concrete. The columns of the original building were supported on reinforced concrete caps 15 ft by 11 ft in plan and 4 ft 8 in. thick on the groups of piles. Piles 100 ft long were inserted between the pile-caps and extended down to the compact gravel below the clay. Because of the limited headroom, and to avoid vibration, cast-in-place, piles of the pressure type were used. It was necessary to provide a support sufficiently resistant to transmit the loads on the columns to the longer piles, and also to provide a reaction to the thrust necessary to press the piles into the ground. This problem was solved by placing lightly-reinforced concrete beams between the pile-caps (Fig. 14) before inserting the new piles. The beams were then prestressed by steel bars anchored in the pile-caps, thus producing a highly-resistant horizontal beam without disturbing the existing structure. The piles were inserted through holes formed in the beams, which provided also the resistance to the jacks by means of which the piles were forced into the ground. The new cylindrical reinforced concrete piles are 2 ft external diameter and 15 in. internal diameter. The concrete was placed continuously in sliding shuttering. Each 20 ft section was cured under moist conditions and allowed to harden before

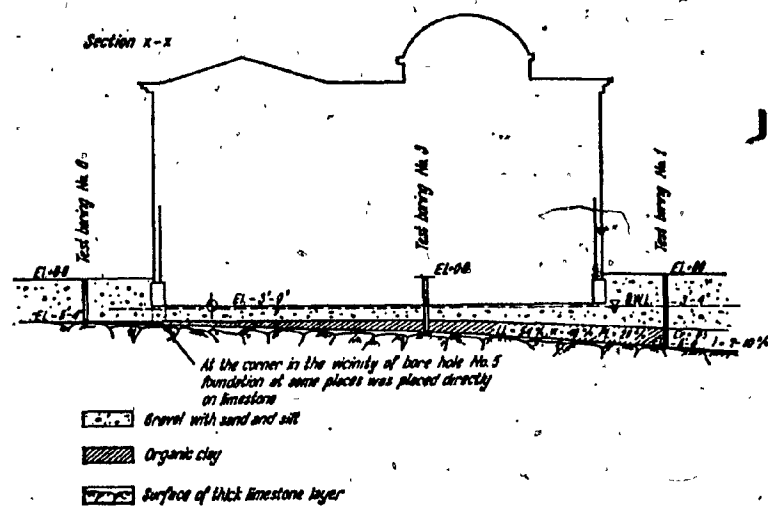
Fig. 15

Another case occurred in connection with the foundation of the main building of a public bath. The building, the plan of which is a tee, is founded on shallow strip footing extending to just below the frost-line, where the ground is uniform sandy and silty gravel. The original design provided for a deeper foundation extending to the underlying limestone, but in order to avoid the need to de-water the deeper excavations, this design was not adopted but it was decided that the foundation plane be above the level of the ground water. The good quality of the upper layer of sandy gravel was misleading, and the footings were designed for a permissible pressure of 2.2 tons per square foot at a depth not exceeding 3 ft. After two to three years, serious cracks had occurred throughout the building.

An investigation showed that the thickness of the layer of sandy gravel did not exceed 4 ft to 6 ft and below it there was a layer of very compressible organic clay and silt varying in thickness from 4 in. to 3 ft. The limestone was at a depth of 5 ft at one side of the building and 8 ft 4 in. at the other (Fig. 15). It was evident that the cracks were caused by differential settlement due to the compression of the layer of clay, which had a water content and a ratio of voids exceeding unity. The plasticity index of the clay was not great, being between 20 and 30 per cent, which is explained by the relatively low organic content; the loss on ignition was up to 10 per cent. The high water content was accounted

— Cross section of public baths building in
Budapest Rumania.

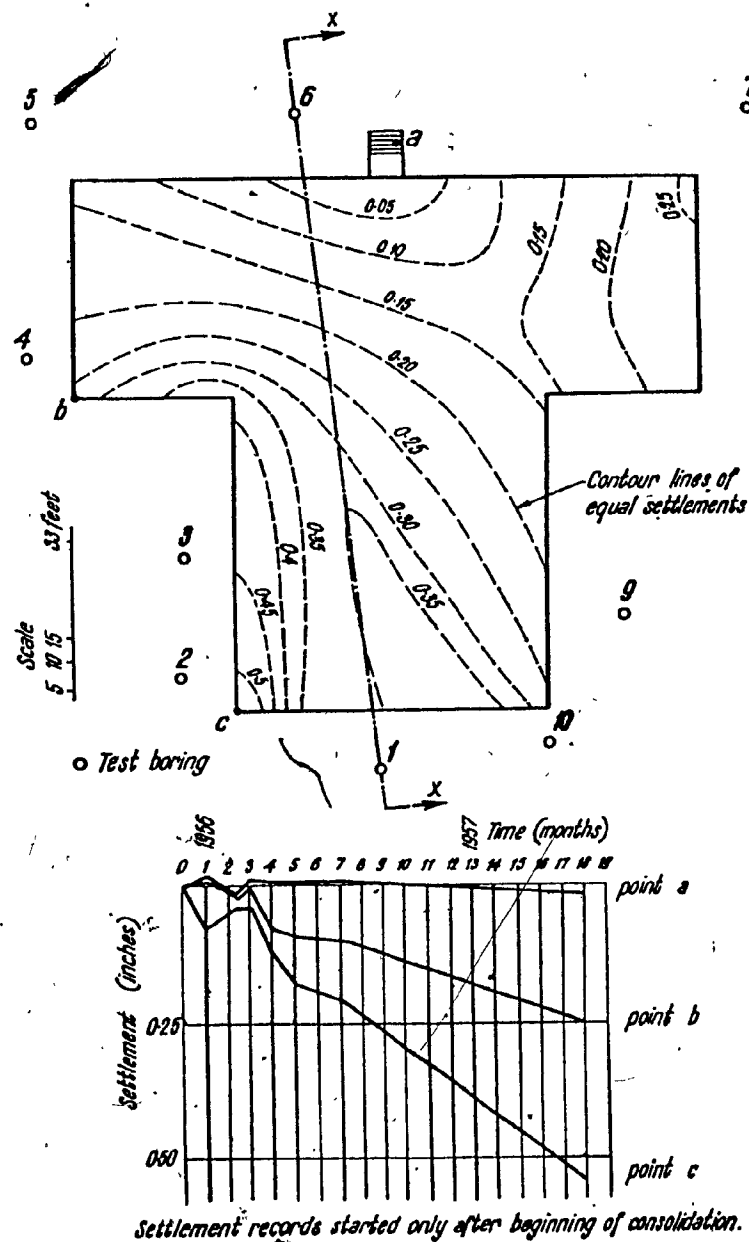
Fig. 16

Layout of Public Baths Building of fig. 15, and results of a differential settlement due to compression of the layer of clay.

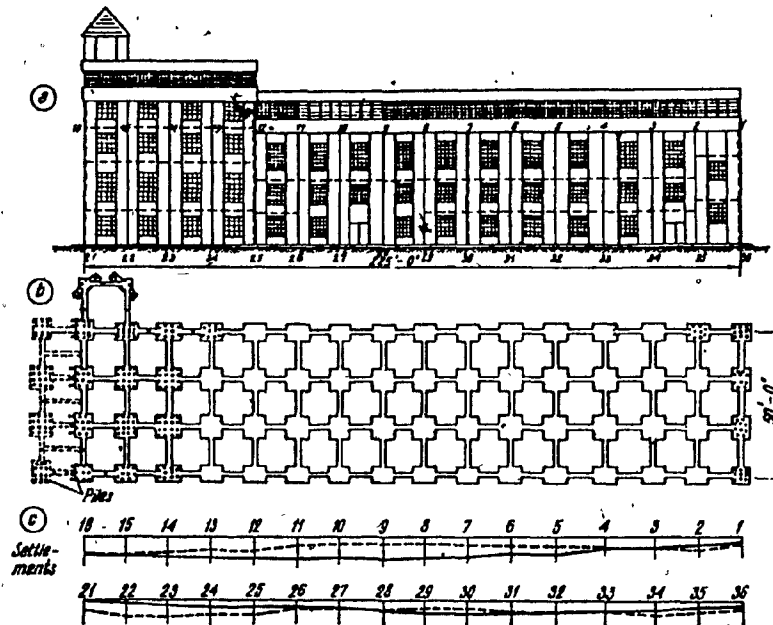
Fig. 17

Subsequent borings showed that there was a top layer 15 ft thick of sand filling, below which was a layer about 43 ft thick of peat mixed with some clay overlying a layer of fine sand 17 ft thick, and below this was compact sand and gravel. The resistance of the piles was considered to be due to the frictional resistances of the sand filling, the peaty clay, and the lower fine sand. This, however, was incorrect, as the great compressibility of the peat material offered little resistance to the settlement of the pile and annulled entirely the resistance of the overlying sand filling. The only soil that offered resistance was therefore the underlying fine sand, which had not only to provide the resistances assumed to be offered by the overlying compressible layers, but also to resist the pressures due to the consolidation of the upper layers, which resulted, through negative friction, in an additional load on the piles. In fact, the upper layers tended to sink even when they were not subjected to load. This was actually observed in the case of some groups of piles which were intended to support an extension of the building and for the time being had to carry only the concrete floor shown by the broken lines on the left-hand side of Fig. 17b, these lightly-loaded piles sank by the same amount as those under the main building.

The records of the settlements (Fig. 17c) indicate that there was considerable differential settlement between the long longitudinal sides of the building. The largest settlements, up to 2 ft 2 in. occurred under the tower in which there was a water tank, and where the load was up to 18 tons on each pile, whereas at most other parts of the building the load did

- a) Factory in Holland supported on piles
- b) Layout of foundation and extension of the main building
- c) Records of differential settlements which occurred between the two longitudinal sides of the building.

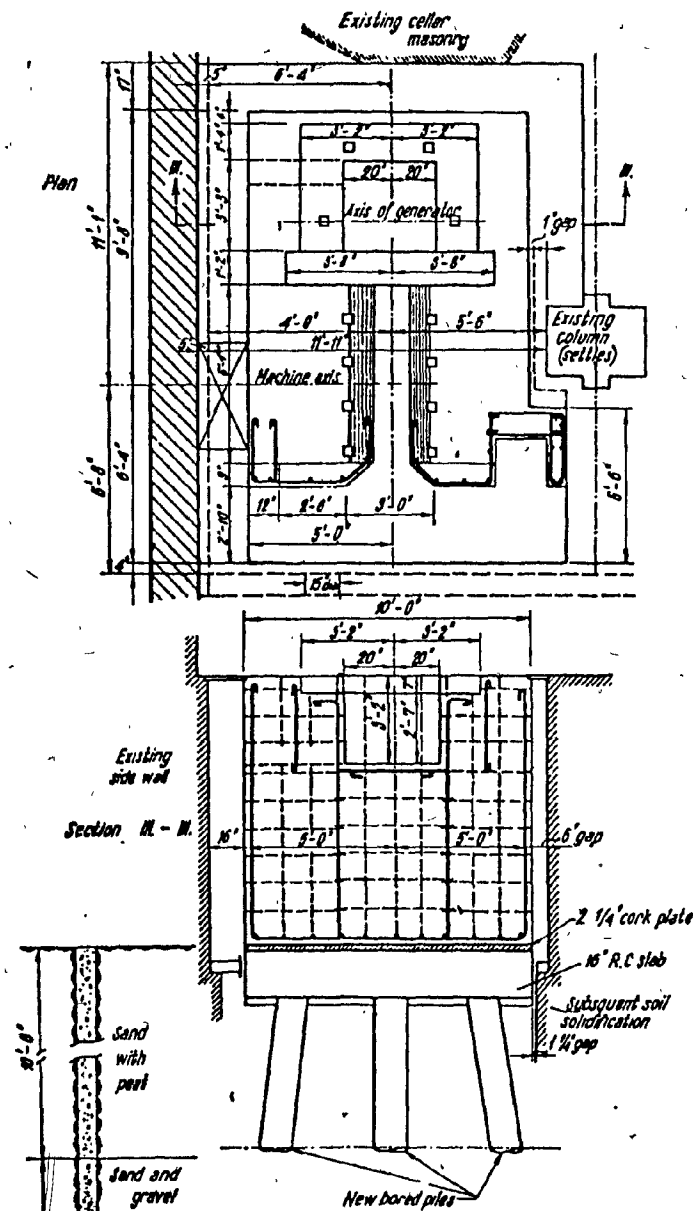
Fig. 18

In order to exemplify the effects of vibration on foundations, we will examine a case in which a diesel engine was placed on a block of reinforced concrete in the basement of an existing building (Fig. 18). The reinforced concrete mounting block was kept entirely separate from the foundations of the walls and columns of the structure to minimize vibration

Foundation layout of diesel engine, and cross section of underpin column with bored piles.

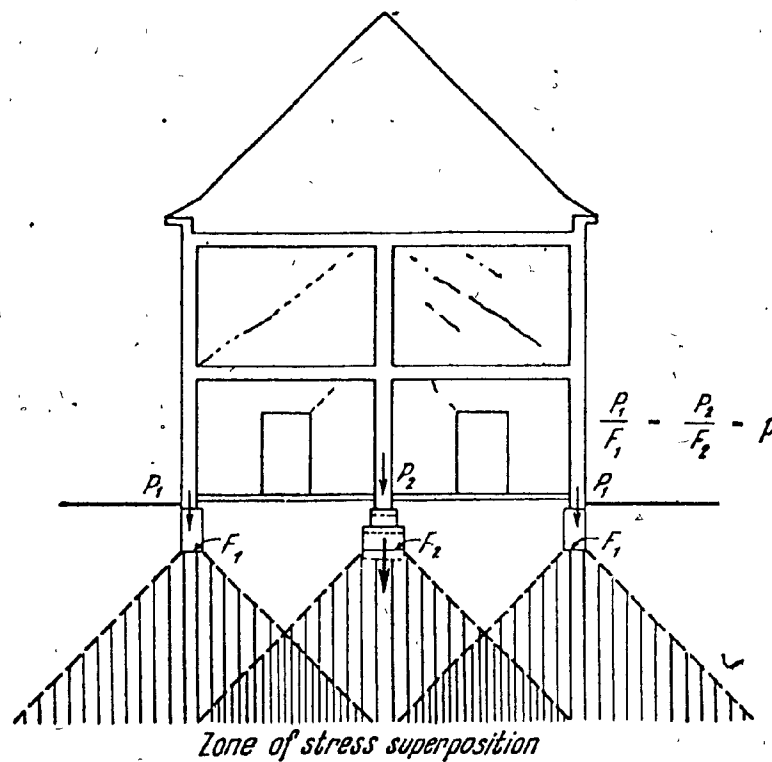
Fig. 19

In this cross section the overlapping zones of stress are demonstrated graphically. Obviously the middle column transmits more load and therefore that area is more susceptible to failure. The cracks that appeared on the building as shown are due to the overlapping stress.

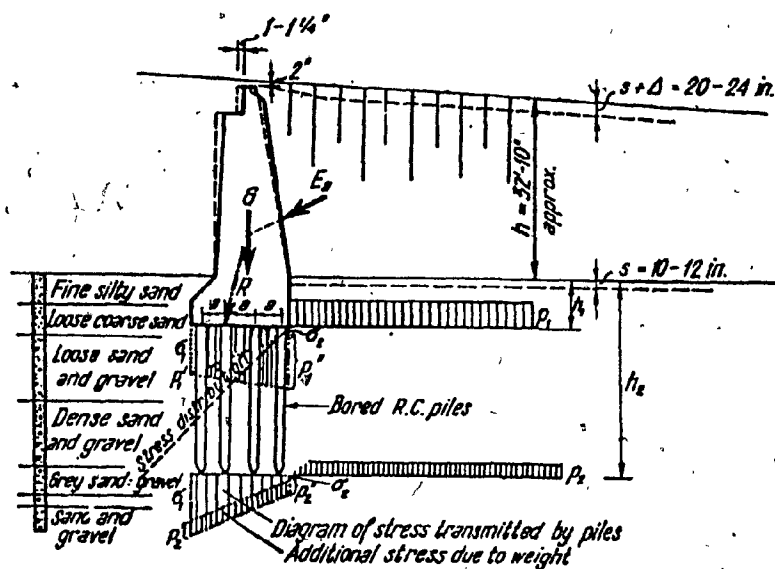
An example of the tilting of an abutment of a bridge is shown in Fig. 20. The abutments are supported on reinforced concrete bored piles extending 27 ft below the foundation. The fill for the approaches, which are about 35 ft high, was placed after the abutments were built, and caused a settlement of the ground below of 10 in. to 12 in. The load from a filling was about 2 tons per square foot, and this compressed the layers of softer soil which extended to a depth of 20 ft to 23 ft below ground level. The filling also settled a further 10 in. due to its own weight and to consolidation caused by traffic. The total settlement was therefore from 1 ft 8 in. to 2 ft. The stresses in the ground due to the weight of the filling extended in the direction of the abutment, and increased both the lateral and vertical forces acting on the back of the abutment and on its foundation. If there were no piles, it is seen in Fig. 20 that the additional load due to the filling is so much greater under the back of the abutment than under the front that the abutment would tilt in the direction of the filling instead of in a forward direction. The drawing shows the plane of stress-distribution due to the filling, the stress-distribution diagram due to the original pressures σ_1 and σ_2 , and the stress-distribution diagram when to the original pressures are added the P'_1 and P''_1 due to the filling.

Bridge abutment supported a reinforced concrete bored piles approximately 27 ft below the foundation is shown above. Also shown are stress distribution diagram due to the original pressures and the stress-distribution diagram when the original pressures are added due to the filling, as well as settlement and tilt. This abutment was built at Medue, Danube River.

case of this bridge the result was that the abutment tilted forward, and this is the general case when an abutment is built on a deep foundation. The forward tilt was about 1 in. at the edge of the foundation block, corresponding to a differential settlement of $\frac{1}{2}$ in. to $\frac{5}{8}$ in. If the spacing of the piles had not been uniform, but arranged to conform to the trapezoidal stress-distribution diagram, the differential settlement of forward and rear edges and the tilting of the abutment could have been avoided. It should also be kept in mind that the passive resistance of earth will always serve to reduce the magnitude of forward tilting in such cases.

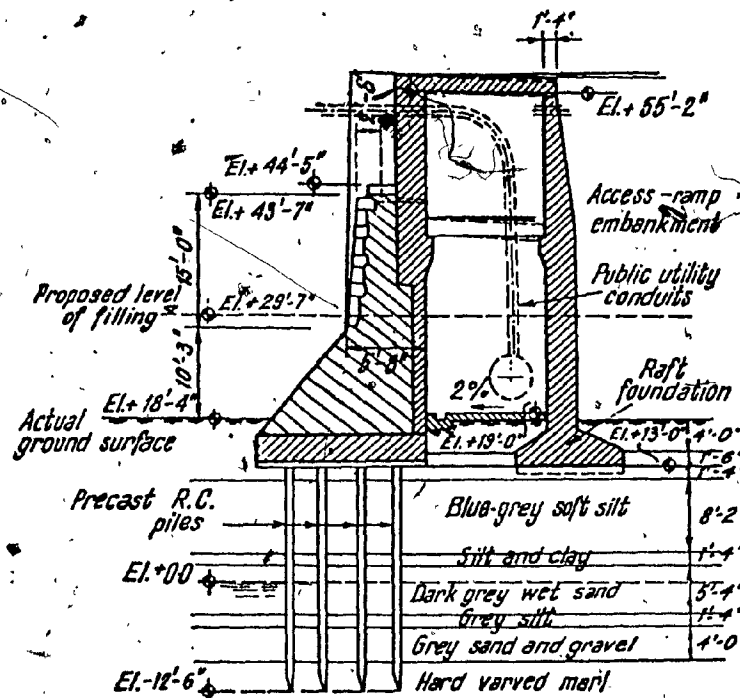
Fig. 21

Another abutment (Fig. 21), is an example of the backward tilting of a tall reinforced concrete abutment on a shallow foundation. This abutment was built in two parts, one on the river face which supports the bridge and transmits the vertical forces directly to piles driven down to a stiff marl, the second, a wall to resist the horizontal force of an access ramp about 40 ft high. The foundation raft of this tall and slender wall is on silt at about the level of the penetration of frost, and the wall is connected to the abutment by two reinforced concrete slabs designed as strutting beams and another slab at ground level. By these means the risk of differential settlement was anticipated. Because the part of the abutment supporting the bridge was practically secure against displacement, the wall against the earth filling was flexibly supported and could follow horizontal and vertical movements, the slabs connecting the two parts acted as freely-supported beams and could resist any torsional forces. Also the wall against the filling was very rigid and

Cross section of abutment at Arpord bridge in Budapest. Backward tilting and differential settlement occurred. Shown above are the raft foundation built to prevent failure.

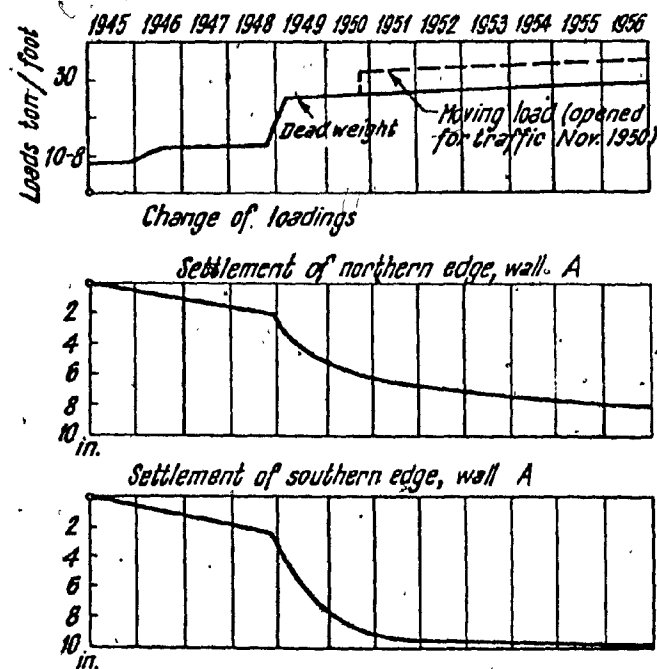
Fig. 22

These graphs describe the movements and settlements of the abutment in Fig. 21, from the beginning of the settlements until they have stopped eleven years after.

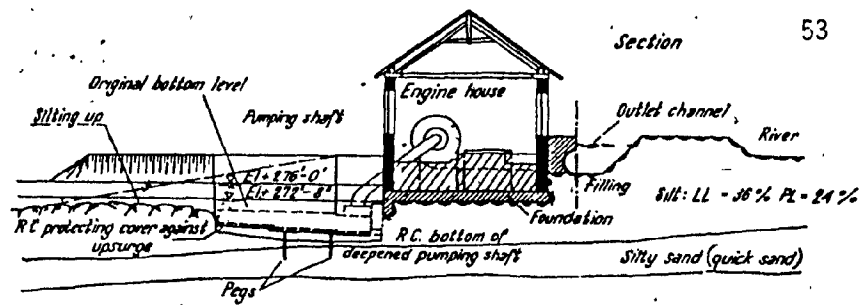
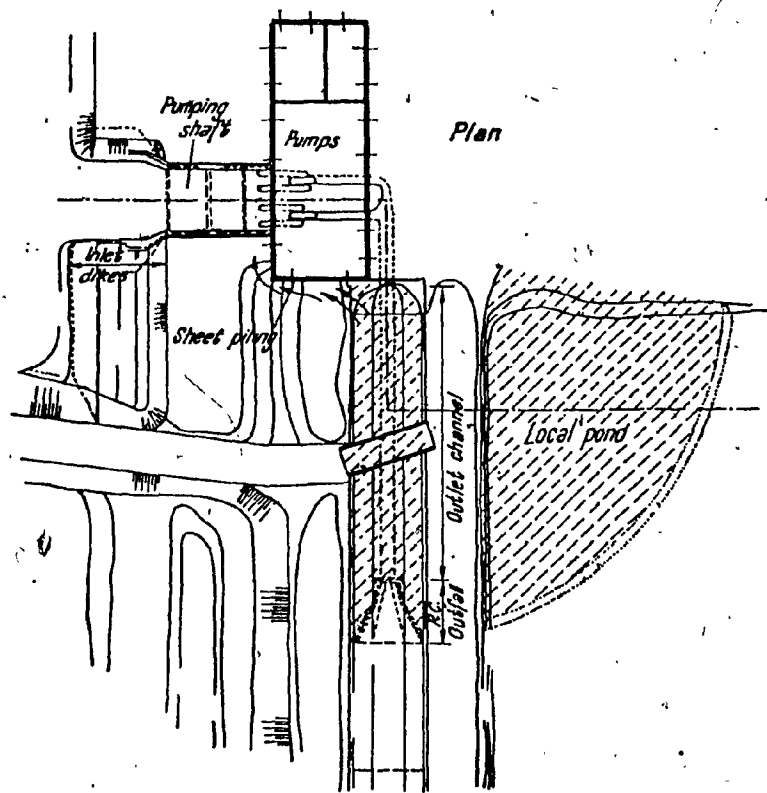
Fig. 23

Shown above are the plan and cross section of the pump house, protected with sheet piling from seepage. This pumping station is located at Karapanesa, Rumania.

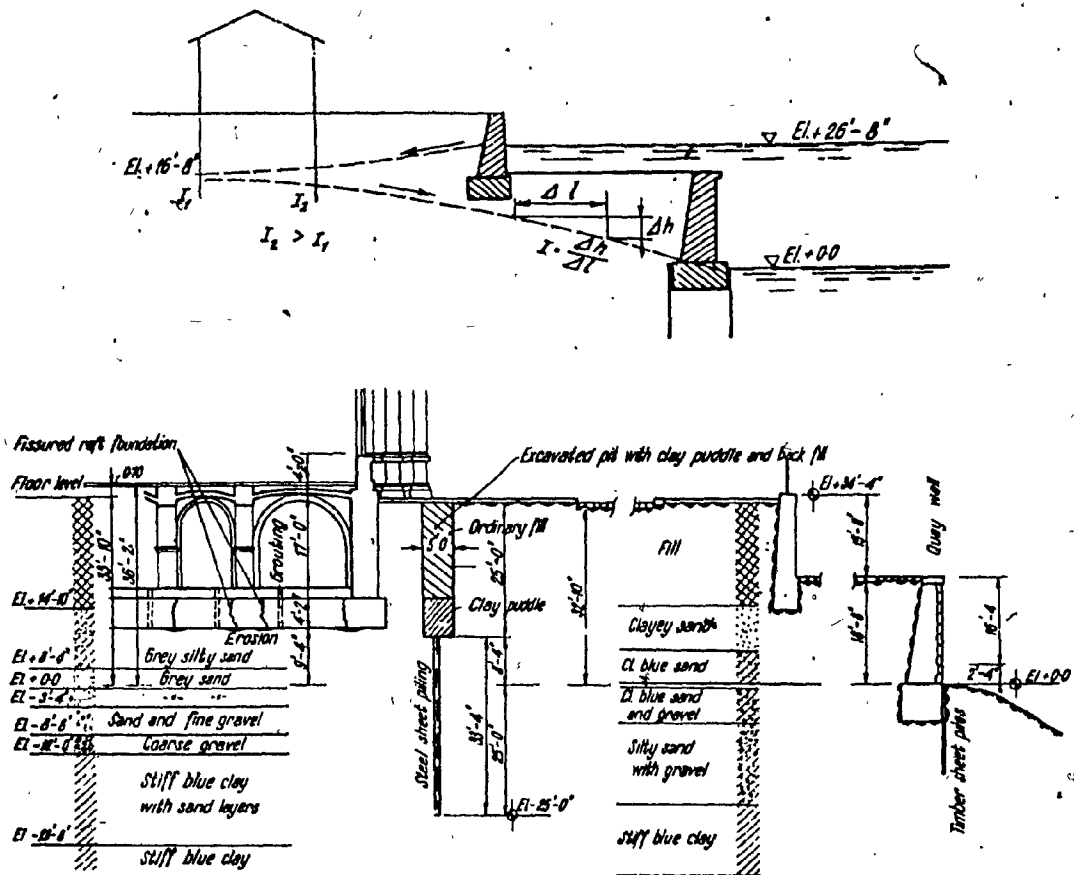
Fig. 26

Customs House at Budapest, Hungary, in which the cracks and settlements increased so that after 20 years it could not be used. Scouring of the soil due to seepage of the ground-water was the cause.
