**REHABILITATION OF RC INVERTED-T BENTCAP GIRDERS
USING ANCHORED CFRP SHEETS**

A Thesis

Building, Civil and Environmental Engineering

CONCORDIA UNIVERSITY

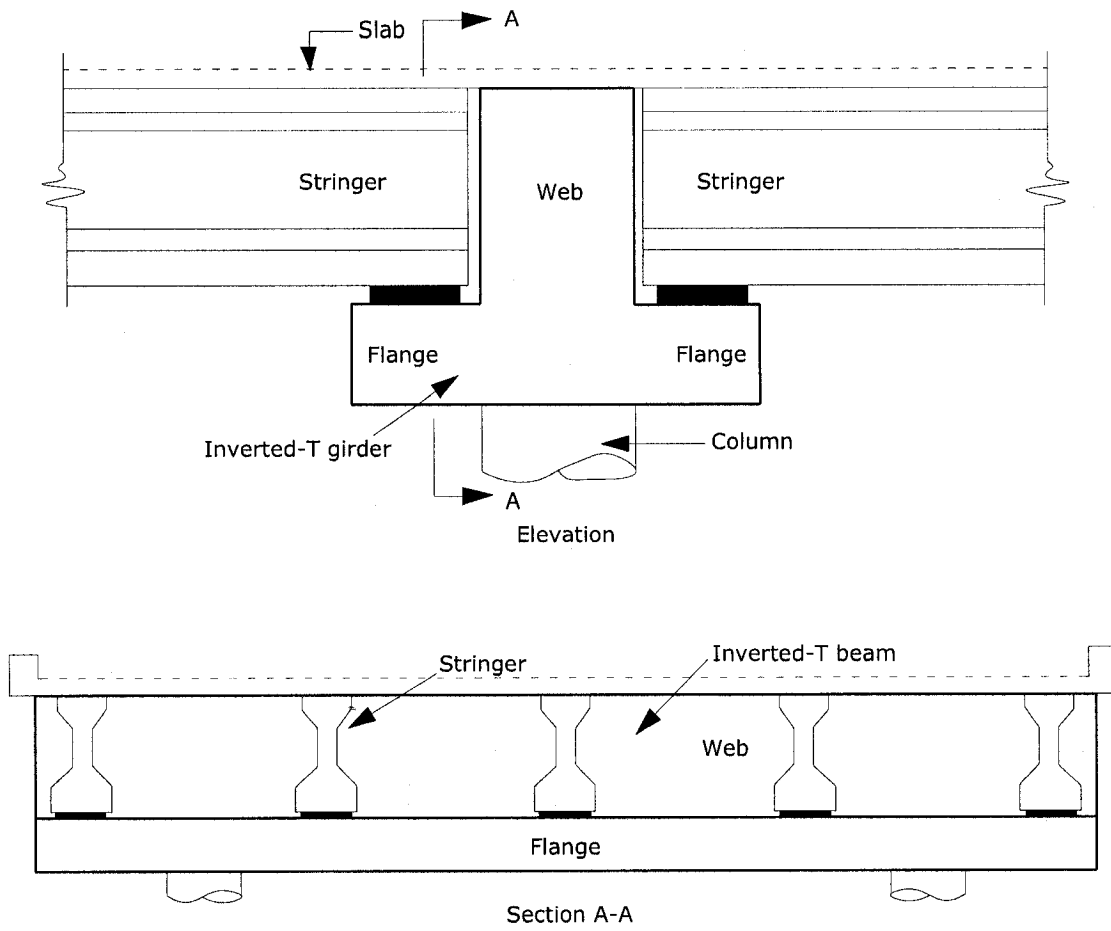
Figure 2.2 Inverted-T girder bentcap

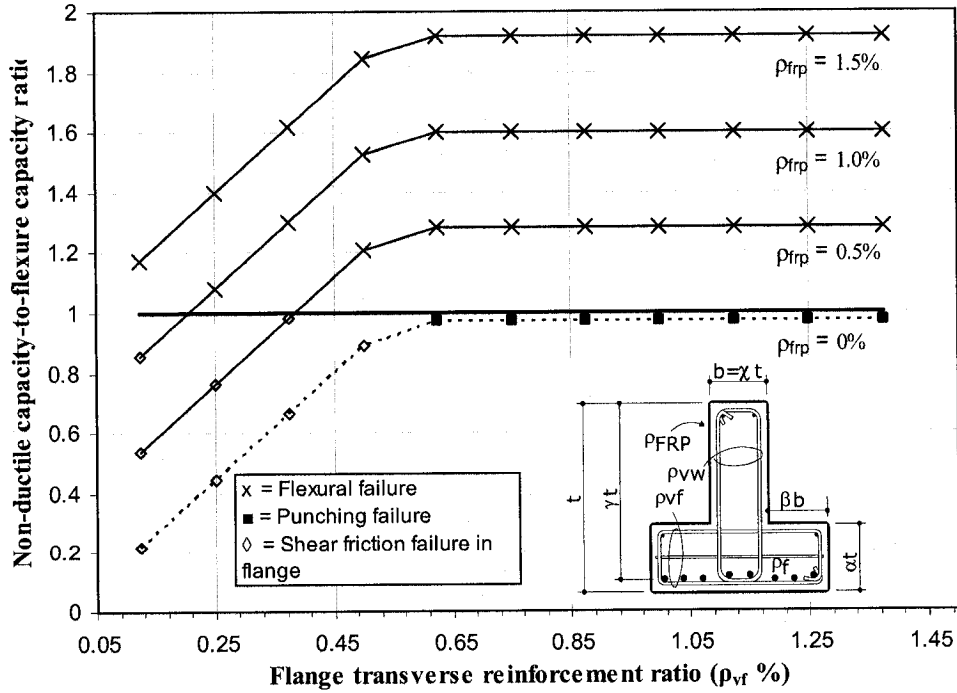
Figure 3.6 Influence of ρ_{vf} on the non ductile capacity-to-flexure capacity ratio

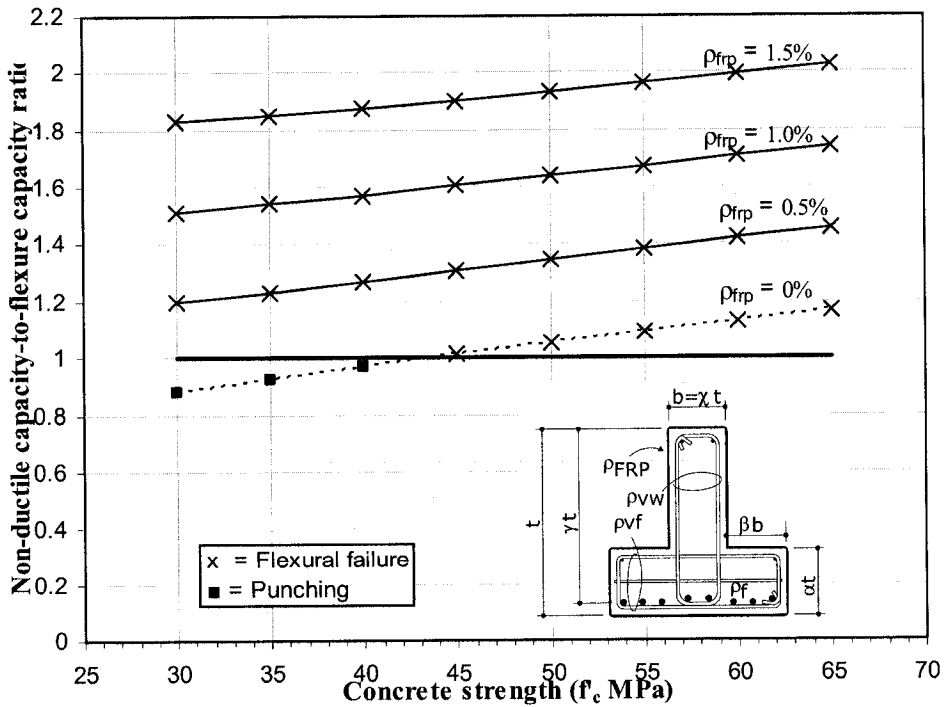
Figure 3.8 Influence of f'_c on the non ductile capacity-to-flexure capacity ratio

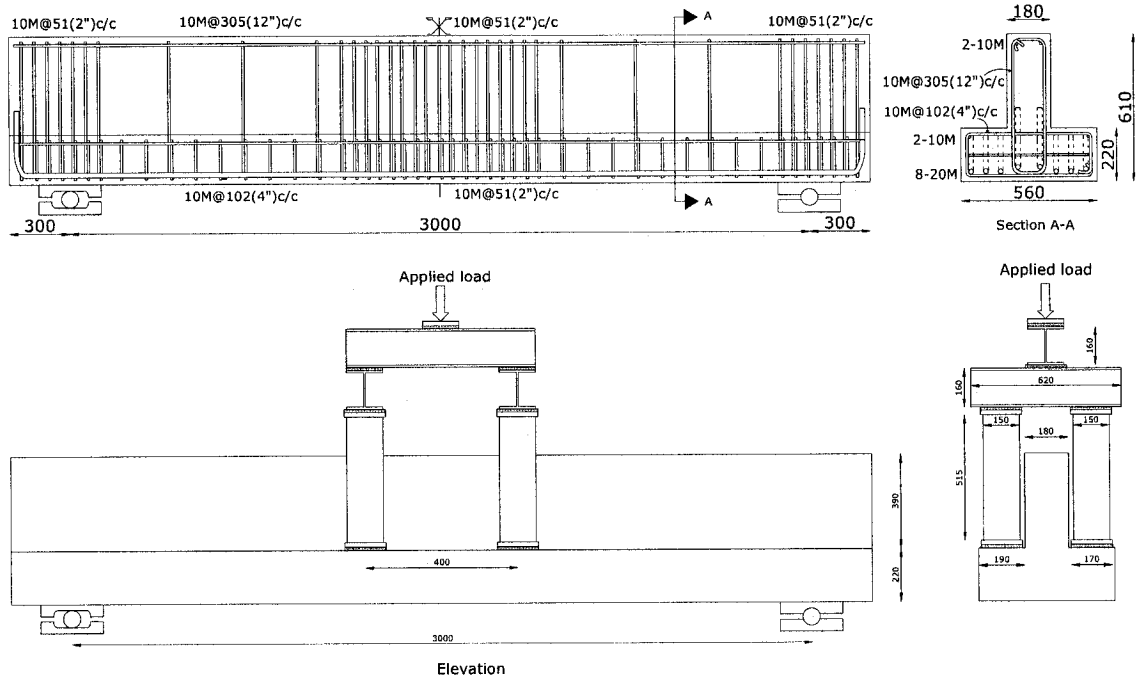
Figure 4.3 Dimensions, details of reinforcement and test profile for girder IT-G3

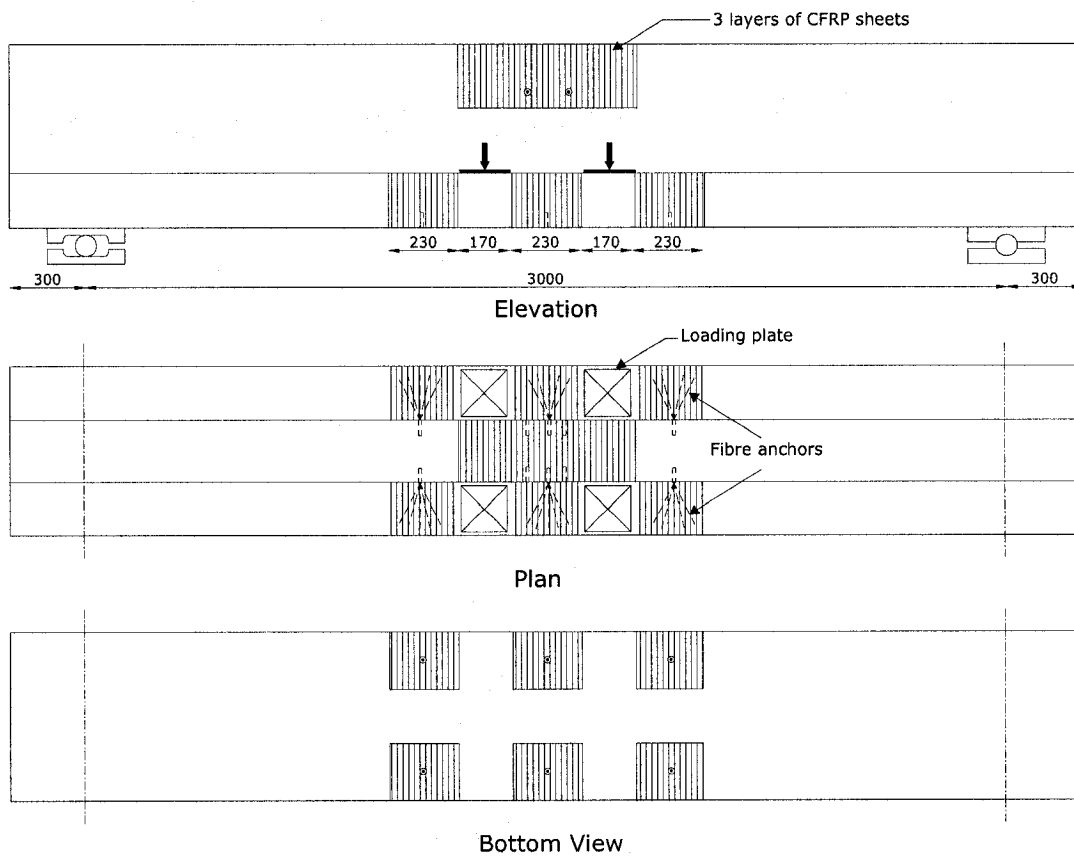
Figure 4.10 Rehabilitation scheme of girder IT-G4R

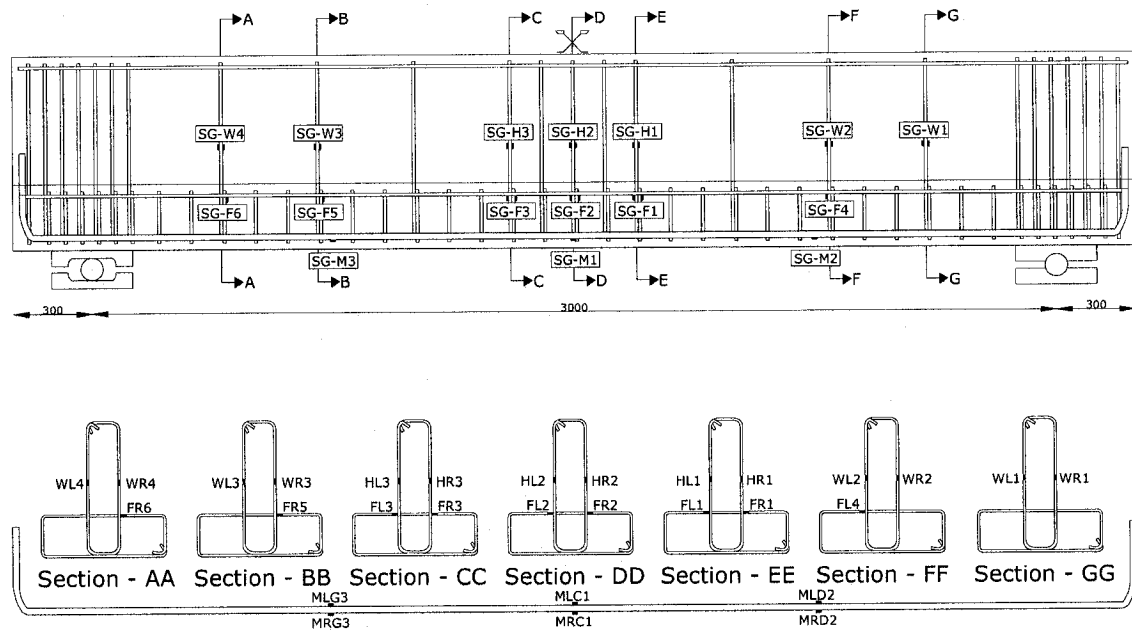
Figure 4.13 Typical locations of strain gauges in the tested girders

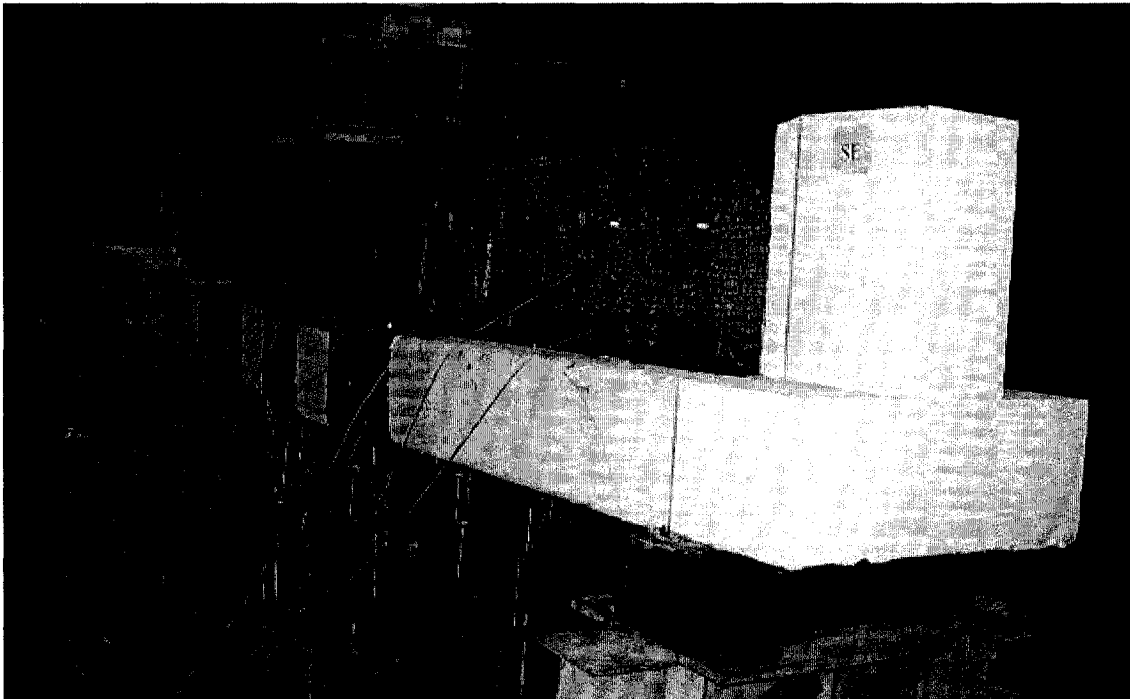
Figure 5.16 Rehabilitated girder IT-G2R at failure

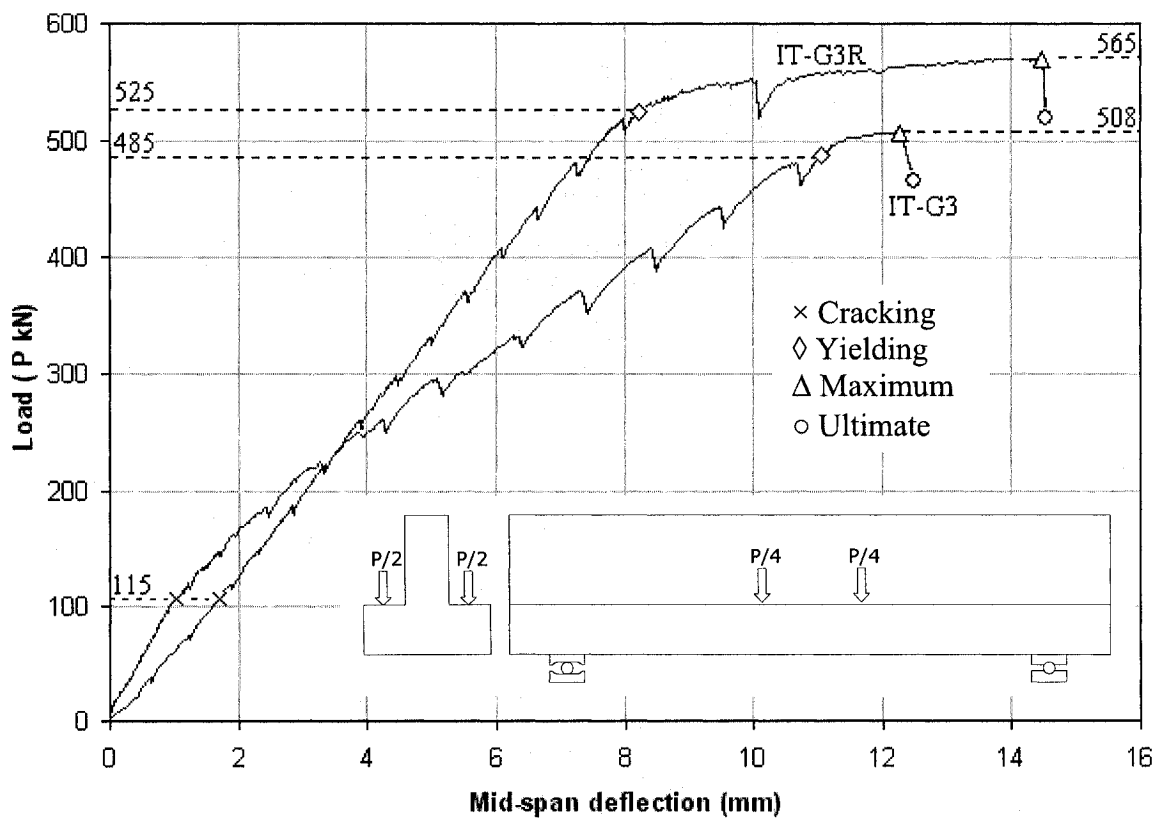
Figure 5.26 Load-deflection relationship for girders IT-G3 and IT-G3R
