# **Automated Sewer Inspection Analysis and Condition Assessment**

A Thesis

Building, Civil, and Environmental Engineering

Concordia University

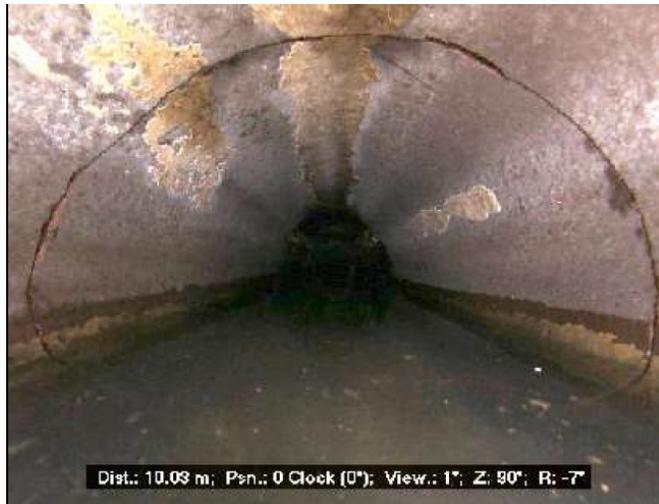
Figure 1.1 CCTV Caption of a Circumferential Crack Defect

CCTV is a method used to record videos for underground pipelines. It is used to inspect pipelines that can be too small or dangerous for humans to enter. In their early stages, CCTV cameras were winched between two manholes to record the condition of the pipeline. Over time, CCTV cameras were mounted on top of a crawler or a float. Operators were able to control the movement of the robot, as well as that of the camera, from far distances. The camera records the inner-surface condition of the pipeline and supplies information above the flow line. Later, experts use the recorded video to interpret, comment on, and make conclusions about the pipeline's condition. Although some sophisticated technologies have been introduced for sewer inspection, CCTV is still the most commonly utilized technique. A survey by Thomson et al. (2004) showed that 100% of the respondents used CCTV as their primary sewer inspection technique. Figure 1.1 is an example of a CCTV caption of a circumferential crack defect.

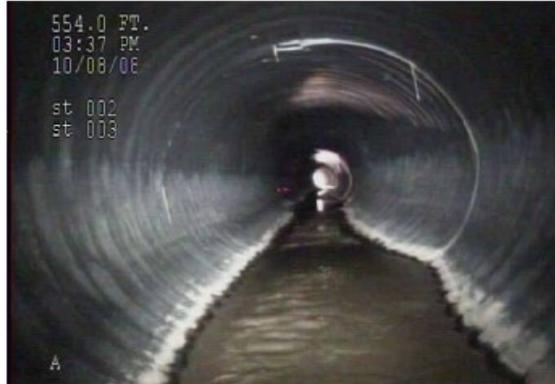
**Figure 2.2 CCTV Caption of a Sewer Pipeline, Acquired from CUES**

Laser profilers are used mostly with a CCTV camera (Tuccillo et al. 2010). Using the two technologies would provide the complete condition of a pipeline, as suggested by Redzone (2008). For instance, laser is able to capture any small changes in the geometry of the pipeline, which are difficult to detect with a CCTV camera. On the other hand, CCTV cameras can detect cracks and fractures. Using both technologies provides cost savings and better rehabilitation plans. Moreover, in some case studies, using CCTV alone resulted in misleading conclusions. Figure 2.2 is a picture from a CCTV recorded video where slight or no deflection can be detected. For the same location of the pipeline, Figure 2.3 is the 2-D laser image, showing a deformation of 12% to 13%.

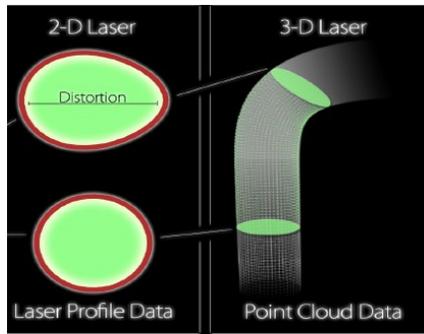
Figure 2.4 A Comparison between 2-D and 3-D Laser Images  
(Thayer et al. 2009)

In another case study, the CCTV camera analysis provided several structural defects, including multiple fractures and a hole in a pipeline (Redzone 2008). However, when the laser profiler was used, it did not detect any of the defects reported by CCTV. It was concluded that the hole presented in the CCTV camera video was a shadow and light reflection was detected as wall fractures in the CCTV video interpretation. Such a conclusion saved thousands of dollars of rehabilitation work.

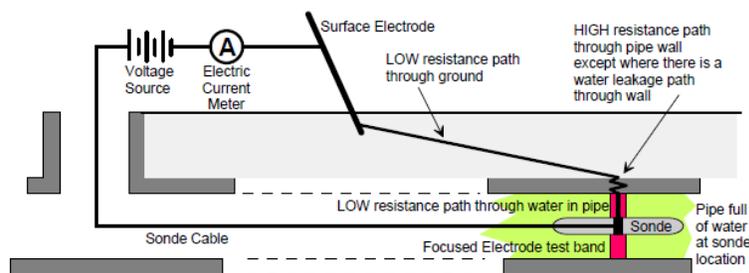
**Figure 2.5 Mechanism of Electro Scan Machine (Harris and Tasello 2004)**

As Figure 2.5 shows, the voltage is applied between the Sonde, the electrode in the pipe, and the surface electrode. The pipe should be full of water at the Sonde location. Between the two electrodes, the electrical resistance is very low; however, the pipe wall's electrical resistance is high. As a result, the high electrical resistivity will prevent any leakage of the current. Any crack or hole will indicate a current's leakage (Harris and Dobson 2006). Cracks or fractures that do not leak provide low threshold anomalies.

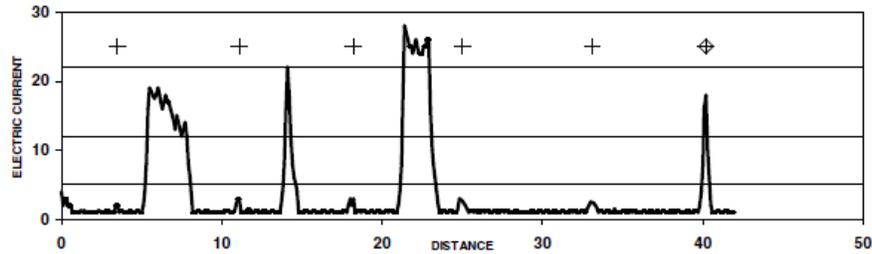
Figure 2.6 An Example of Electro Scan Current Output (Harris and Dobson 2006)

Figure 2.6 shows a sample result of an electro scan inspection of a pipeline. It shows the electrical current values along the distance traveled. With an accuracy of  $\pm 40\%$ , electro scan overcomes the drawbacks of CCTV.

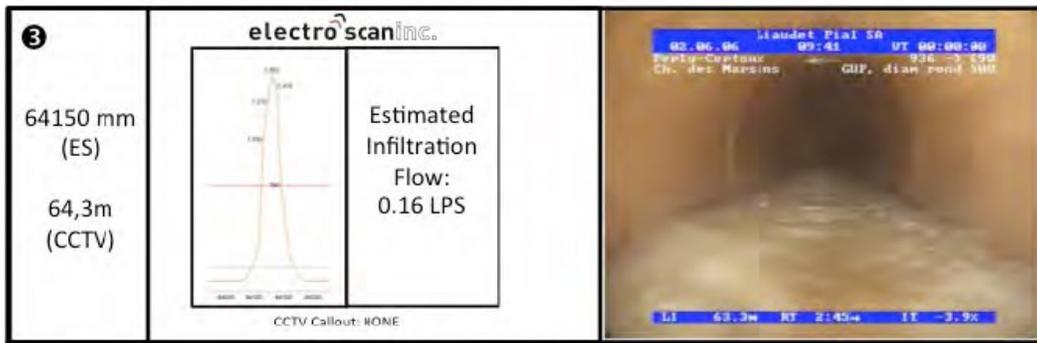
Figure 2.7 CCTV vs. Electro Scan Results, Acquired from Electro Scan Reports

whereby the CCTV inspection failed to identify infiltration defects. In Figure 2.7, the CCTV caption showed no infiltration; however, the electro scan equipment showed an infiltration of 0.16 liter per second. In another situation from the same pipeline, shown in Figure 2.8, the CCTV showed no infiltration, whereas the electro scan detected a 0.21 liter per second infiltration. Therefore, the electro scan inspection was able to overcome some of the CCTV camera limitations.

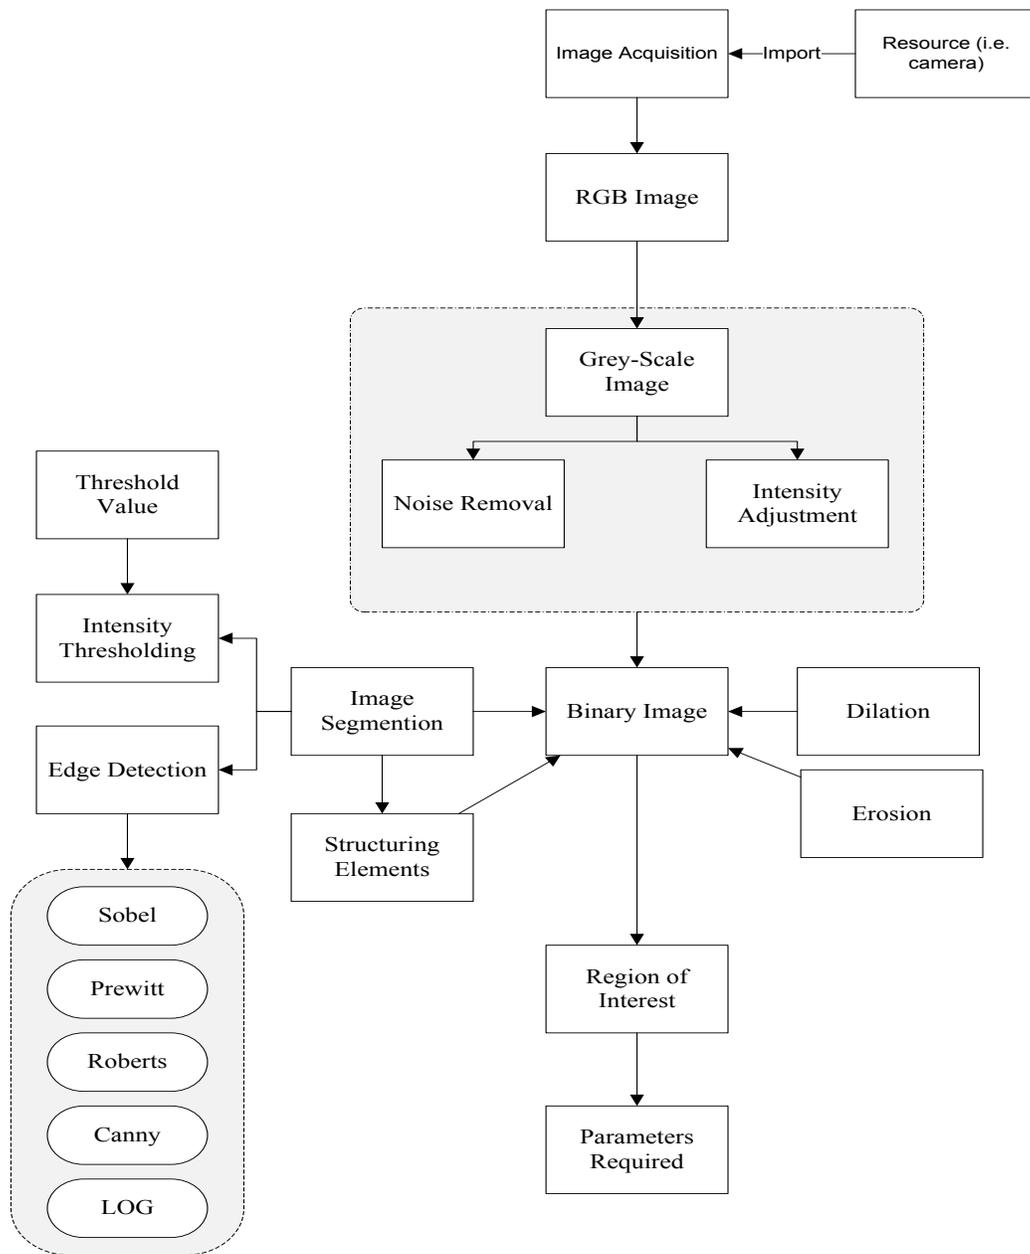
Figure 2.9 Common Image Processing Procedure

as edges may not be identified by the edge detection methods. Those problems occur because of image noise if the real edge does not make any border in the image or if a nonreal edge is identified. However, Solomon and Breckon (2011) claimed that the Canny method is the best edge detection technique.

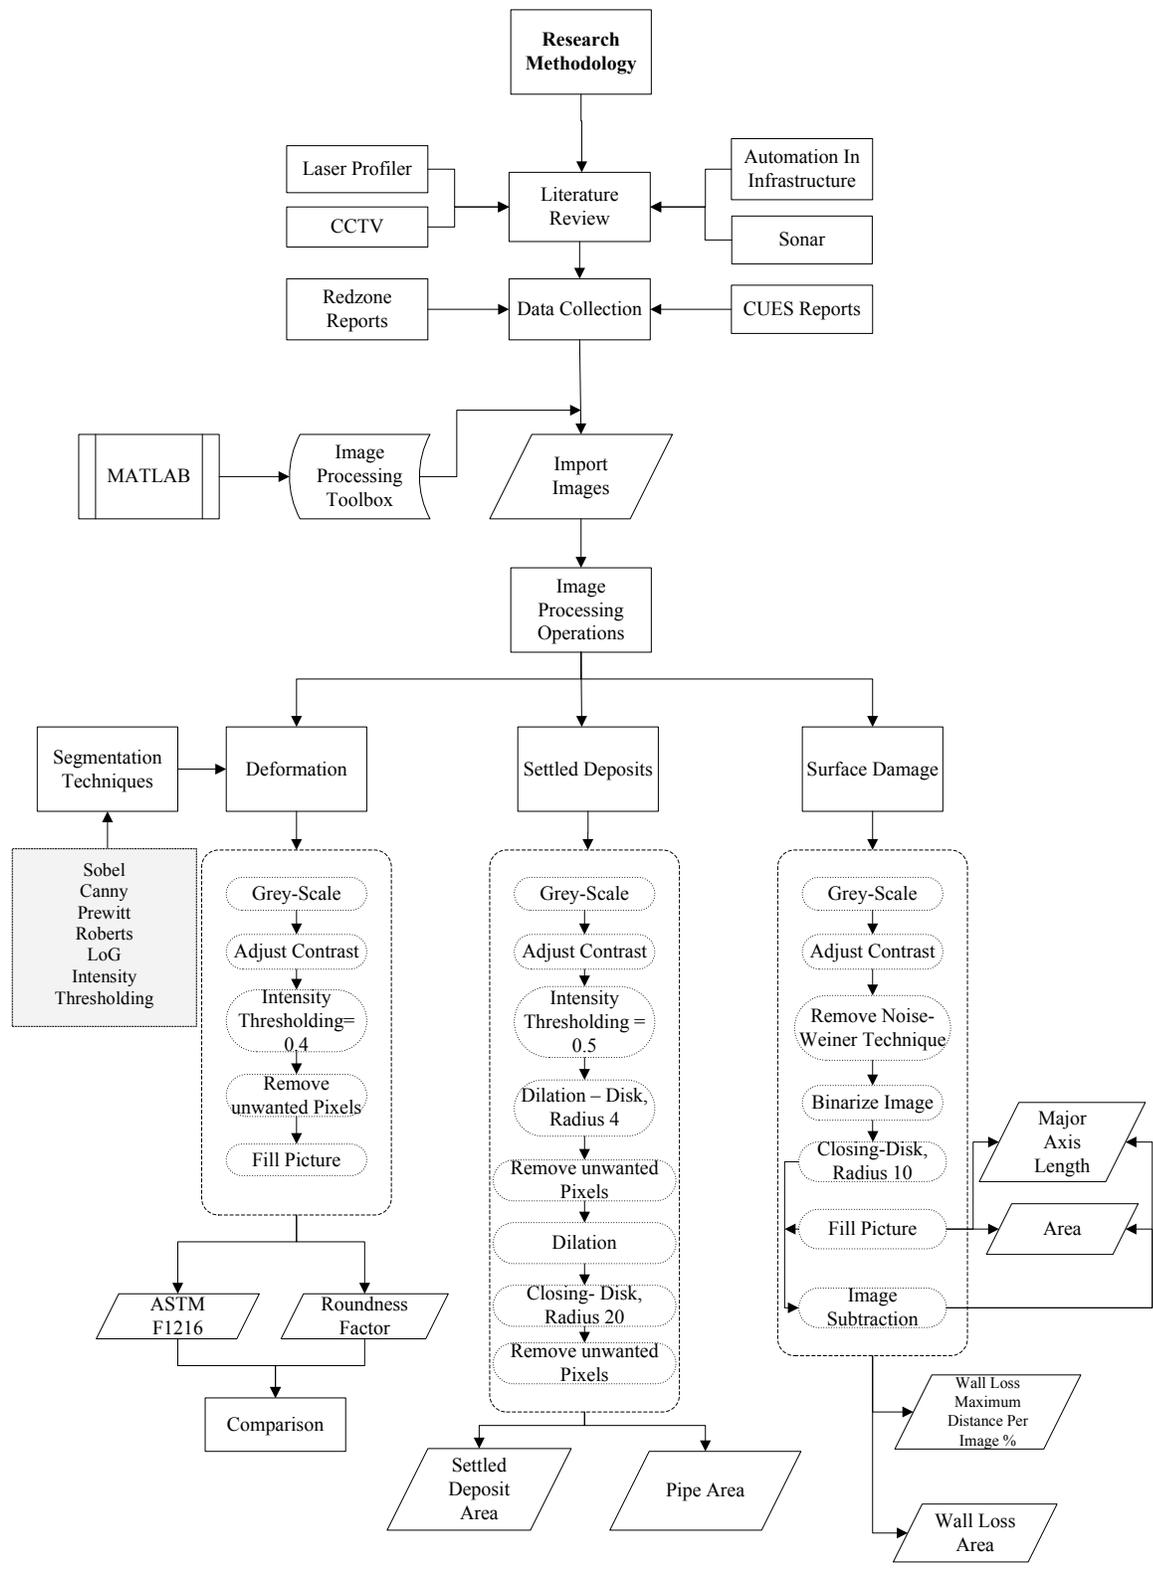
**Figure 3.2 Defects Image Processing Algorithms**

To implement image processing techniques, numerous images were required. Several companies that supply laser profilers and sonar were contacted. Unfortunately, only two companies responded and provided sample reports, namely Redzone Robotics and CUES. The reports were further analyzed and few images were found. The data considered contained four images of deformation defects, four images of settled deposits defects, and two images of surface damage defects. These images were essential to design the automated tool for quantification purposes.

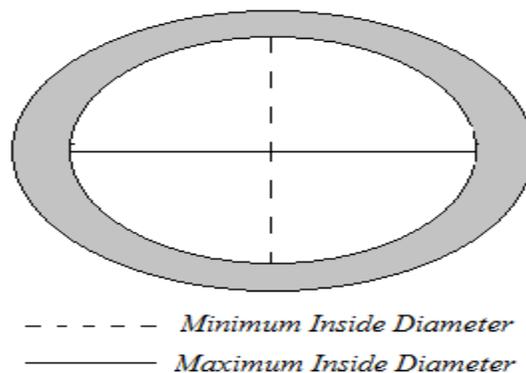
Figure 3.3 Drawing Representing an Unfilled, Deformed Sewer Pipe

Several companies utilize equation 3.4 to measure the deformation of the pipes from the laser profiler images. This section shall explain the development of equation 3.4. Figure 3.3 is a representation of an unfilled sewer pipeline. The figure illustrates a deformed pipeline that describes the minimum and maximum inside diameters. The minimum inside diameter is located at the vertical axis, while the maximum inside diameter is located at the horizontal axis.

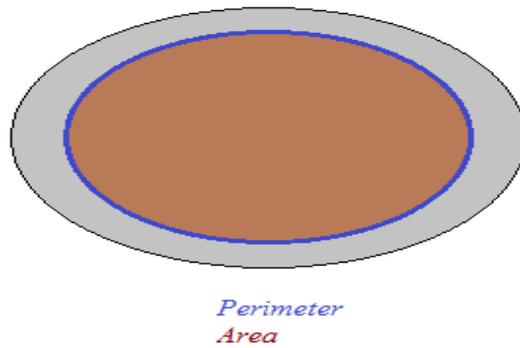
**Figure 3.5 Drawing Representing a Deformed Sewer Pipe**

Figure 3.5 explains the parameters  $A$  and  $P$ . According to the figure,  $A$  represents the existing area of the deformed pipeline, and  $P$  represents the existing perimeter of the deformed pipeline. Based on the roundness factor formula, the ratio of an exact circular object that is not deformed is 1. Therefore, it has no ovality, and in this context, deformation of the shape will be 0. Applying the same concept, if a shape has a factor less than 1, the difference between 1 and the roundness factor represents the deformation. As a result, the deformation based on the roundness factor is presented in equation 3.7.

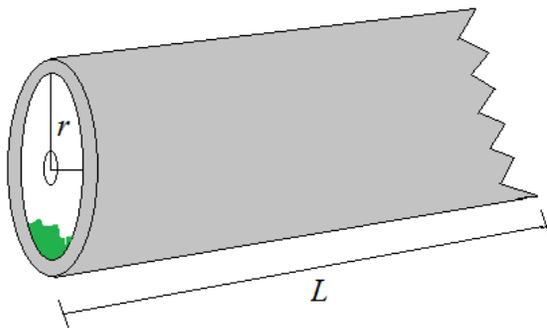
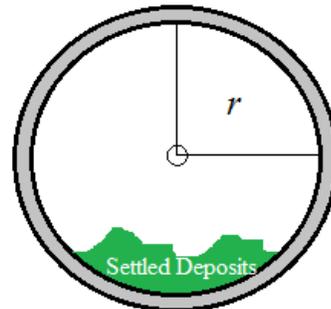
An image processing algorithm was utilized to quantify the settled deposits volume along a segment of a pipe. Images from Redzone's sonar application were used for this purpose. The images were imported to MATLAB, where several operations were done. Basic mathematical formulas were used to determine the settled deposits percentage from the pipe's diameter. Figures 3.18 and 3.19 simulate a sewer pipe of length  $L$  and radius  $r$ .

Figure 3.18 Sewer Pipeline 3-D View Representation

Figure 3.19 Cross-Sectional View of Figure 3.18

The proposed image processing methodology is dependent on reaching a binary image that isolates the settled deposits from each original image, similar to Figure 3.19. Equations 3.8, 3.9, and 3.10 are used in this regard.

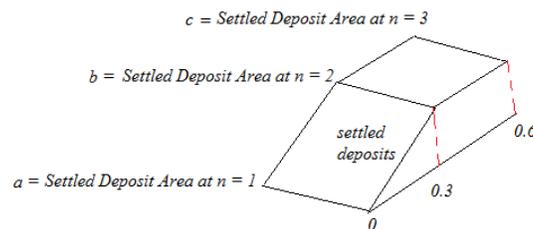
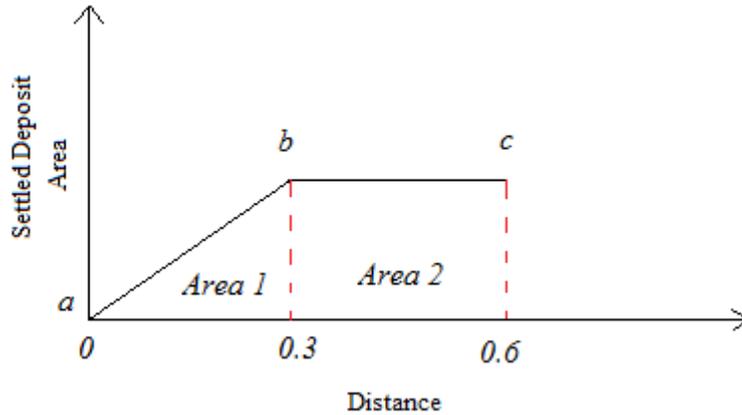
Where  $n$  refers to the number of images imported. For instance, the first image ( $n = 1$ ) will be at location 0 m. The second image ( $n = 2$ ) will be at location 0.3 m. Once the actual settled deposits area has been found at each 0.3 m, it yields the calculation of the settled deposits volume. The actual deposit areas will be scattered in a 2-D plot at each respective position. The points in the graph will be joined with a straight line, assuming that the change in the settled deposits area is linear, as demonstrated below.

**Figure 3.20 3-D View of Settled Deposits Volume Assumption**

Figure 3.21 2-D View of Figure 3.20

Therefore, the area under the curve will represent the total volume of the actual settled deposits on the bottom of the inside surface of the pipeline. For example, in Figure 3.21, the volume will equal the summation of Area 1 and Area 2 as follows:

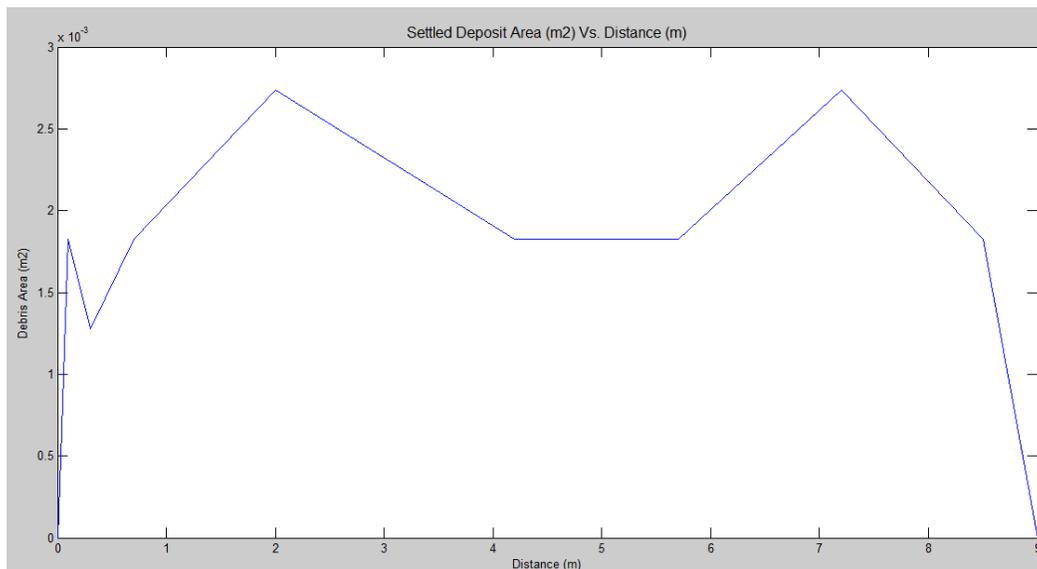
Figure 3.33 Qatar's Case Study 1: Settled Deposits Area vs. Distance

It is important to find the volume of settled deposits present in a sewer segment. It is also important to investigate the blockage percentage along the segment. Figure 3.33 plots the settled deposits area versus the distance of an actual pipeline in Qatar's case study 1. The inspected length was 9 m. The report provided the blockage percentages at different locations. Later, the settled deposits area was calculated, scattered, and joined to calculate the area under the curve. The volume of the settled deposits was calculated as per equation 3.15. The volume was found to be  $0.0186 \text{ m}^3$ . Equation 3.16 was utilized to find the segment total blockage rate, which was 11.33%.

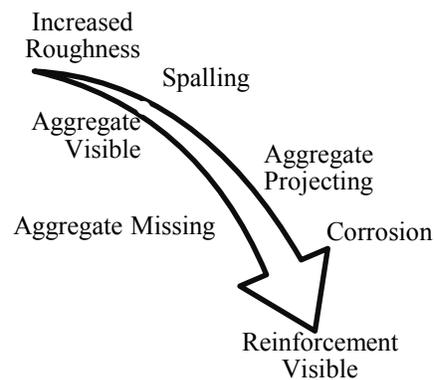
Figure 3.34 Surface Damage Subdefects

By definition, surface damage is one type of a sewer's structural defects in which the inside wall of the pipe deteriorates by abrasion, erosion, or chemical corrosion (NZWWWA 2006). Figure 3.34 lists the subdefects of the surface damage defect from the least severe to the most severe. The next subsection explains the algorithm proposed to quantify the surface damage defect.

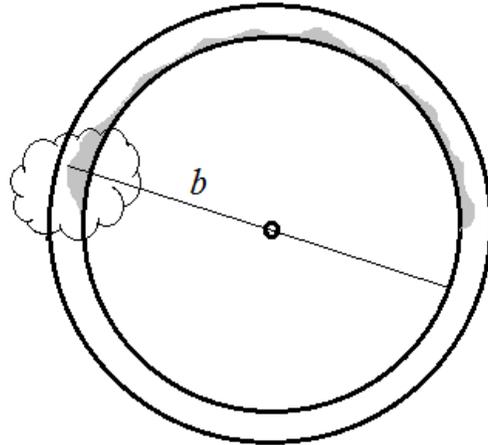
Figure 3.35 Representation of a Sewer Pipeline with Wall Loss

The quantification of the surface damage was found by applying mathematical equations. The algorithm developed in MATLAB was able to find the wall loss area percentage compared to the inside pipe area. In addition, it provided the maximum wall loss percentage compared to the pipe's diameter. Thus, the volume of the wall loss along the inspected segment was calculated as explained in the settled deposits volume calculation. Figure 3.35 represents a sewer pipeline having a surface damage with a certain pattern. Figure 3.36 magnifies the clouded part, which corresponds to the maximum wall loss in the pattern. In Figure 3.36,  $a$  refers to the maximum distance of loss in the section, and in Figure 3.35,  $b$  is equal to the inside diameter +  $a$ . Several basic mathematical equations are considered in the development of the methodology.

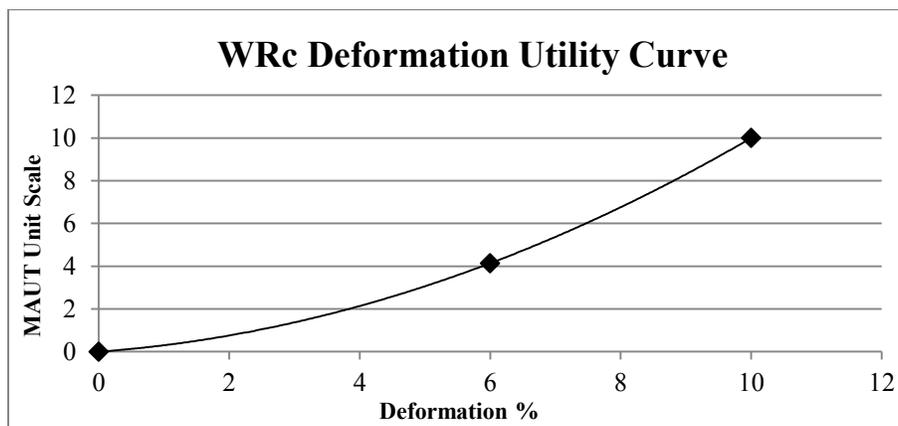
Figure 3.45 WRc Deformation Utility Curve

- Next, the x-value and y-value from Table 3.3 are plotted. As per Figure 3.45, the curve produced is a polynomial of degree 2. Based on the figure, the regression type perfectly plots the data considered, as its  $R^2$  equals 1.

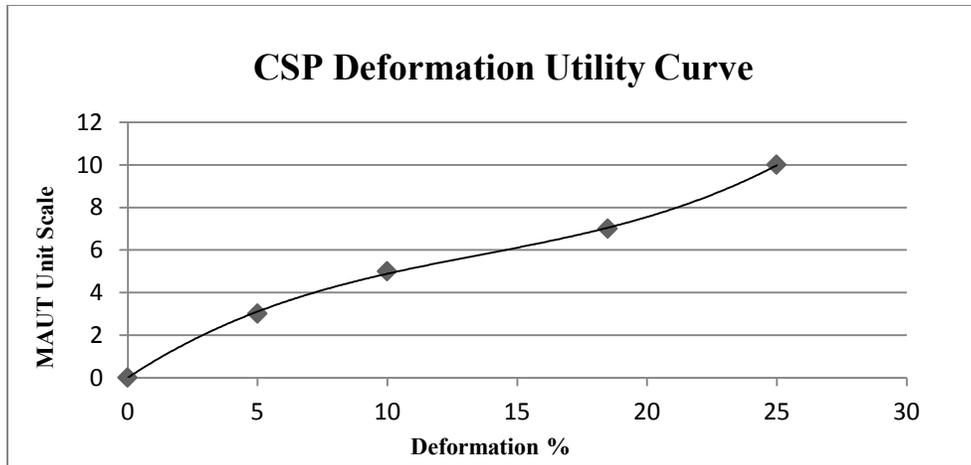
Figure 3.46 CSP Deformation Utility Curve

- Next, the x-value and y-value from Table 3.5 are plotted. As per Figure 3.46, the curve produced is a polynomial of degree 3. Based on the figure, the regression type perfectly plots the data considered, as its  $R^2$  equals 0.9995.

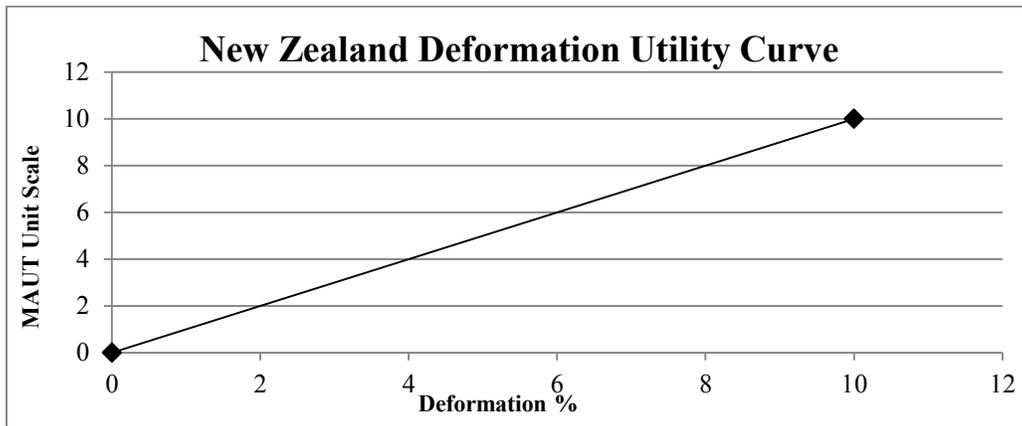
**Figure 3.47 New Zealand Deformation Utility Curve**

- Because only two points are used, the expected plot shall produce a linear equation, as per Figure 3.47.

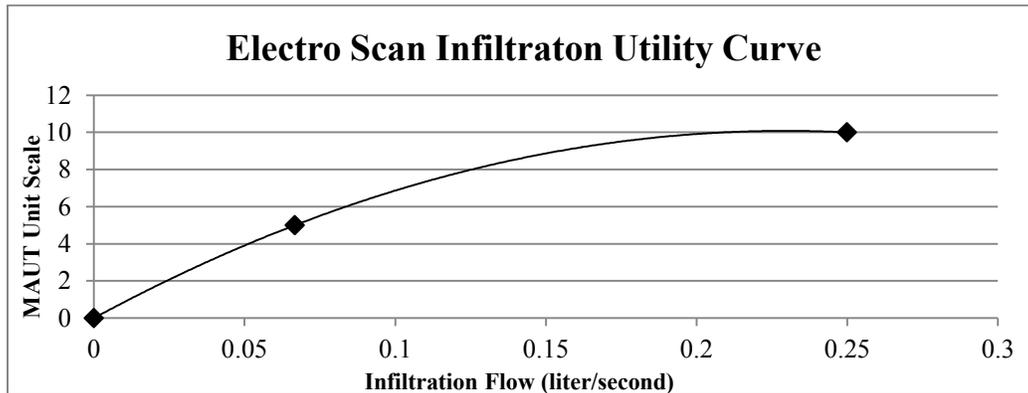
Figure 3.51 Electro Scan Infiltration Utility Curve

- These points are plotted and the best regression type, which is a polynomial of degree 2, is considered, per Figure 3.51. Based on the figure, the regression type perfectly plots the data considered, as its  $R^2$  is 1.

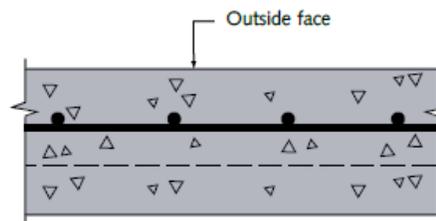
**Figure 3.52 Wall Thickness Cross-Section of a Concrete Pipeline (Humes 2009)**

C) Figure 3.52 is a cross-sectional view of the reinforced concrete pipeline wall thickness. According to the figure, the first layer of reinforcement, starting from the inside face, is the circumferential reinforcement. Therefore, for any RC pipeline size, the most severe case occurs when losing 50% or more of the wall thickness. For clarification, if the wall thickness loss reaches 50% or more, circular reinforcements will be visible. Hence, more corrosion will take place. As a result, structural strength drops and the pipeline becomes susceptible to failure.

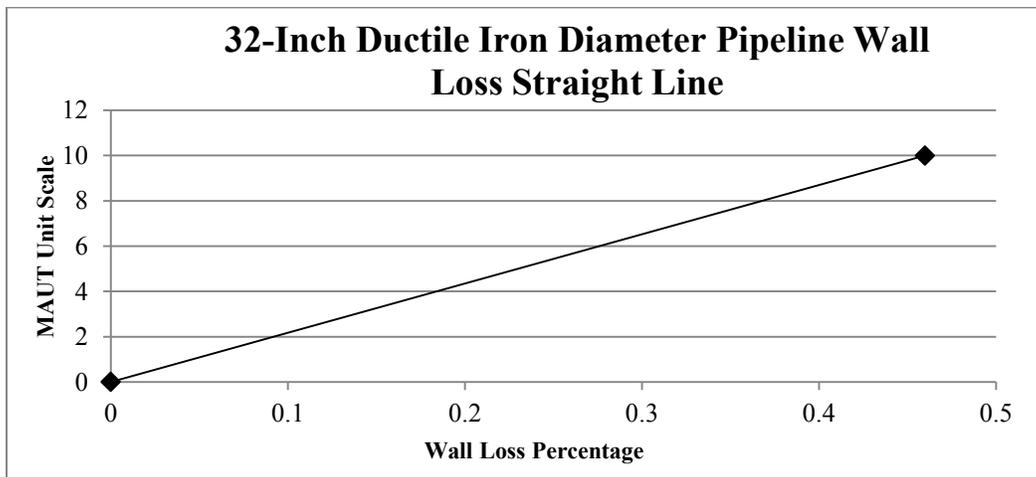
**Figure 3.54 32-Inch Diameter Ductile Iron Pipeline Wall Loss Straight Line**

As an example of the utility function development, 32-inch pipe is considered. From the table, the permissible percentage is 0.46%, which is set at a 10 MAUT unit scale. Figure 3.54 plots the straight line.

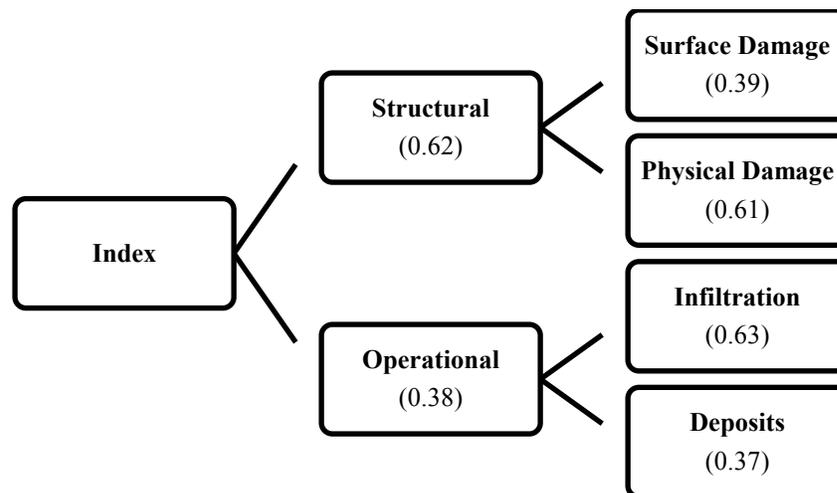
Figure 3.56 Weights of Defect and Subdefects Groups

- A) Each defect shall retain a unique weight that describes its importance to the other defects. Daher (2015) conducted a survey to find the importance weights among many of the pipeline defects. Because this research evaluates only four defects, their relative weights were found in the responses to his questionnaire. Figure 3.56 presents the relative weights calculated for each defect group and its subdefects.
- B) When building the utility functions, a 0 to 10 scale was considered, where 0 represented no severity of pipeline segment and 10 was critical. Therefore, from the utility functions, each defect will provide a specific value, between 0 and 10, pertinent to the condition of the pipeline concerning the same defect.

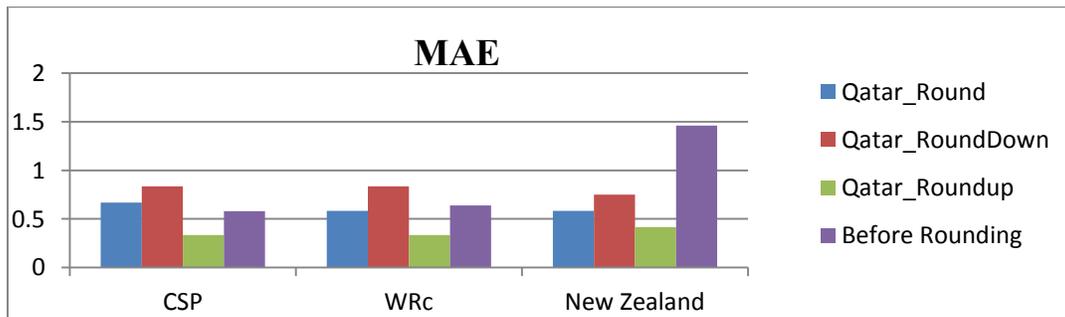
**Figure 4.2 Case Study 1, MAE**

Before testing the rounding types, the MAE values were computed for CSP, WRc and New Zealand and the values were 0.58, 0.64 and 1.46, respectively. After investigating the three types of rounding, they were compared using the MAE. Figure 4.2 is the bar chart of the MAE values for the three rounding types. When rounding the computed grade to the nearest number, the MAEs for CSP, WRc, and New Zealand were 0.67, 0.58, and 0.58, respectively. However, when rounding down the computed index, the MAEs for CSP, WRc, and New Zealand were 0.83, 0.83, and 0.75, respectively. Finally, when rounding up the computed index, the MAEs for CSP, WRc, and New Zealand were 0.33, 0.33, and 0.42, respectively. Comparing the MAE values, rounding up produced the least MAE values; hence, it is more reliable than the other types.

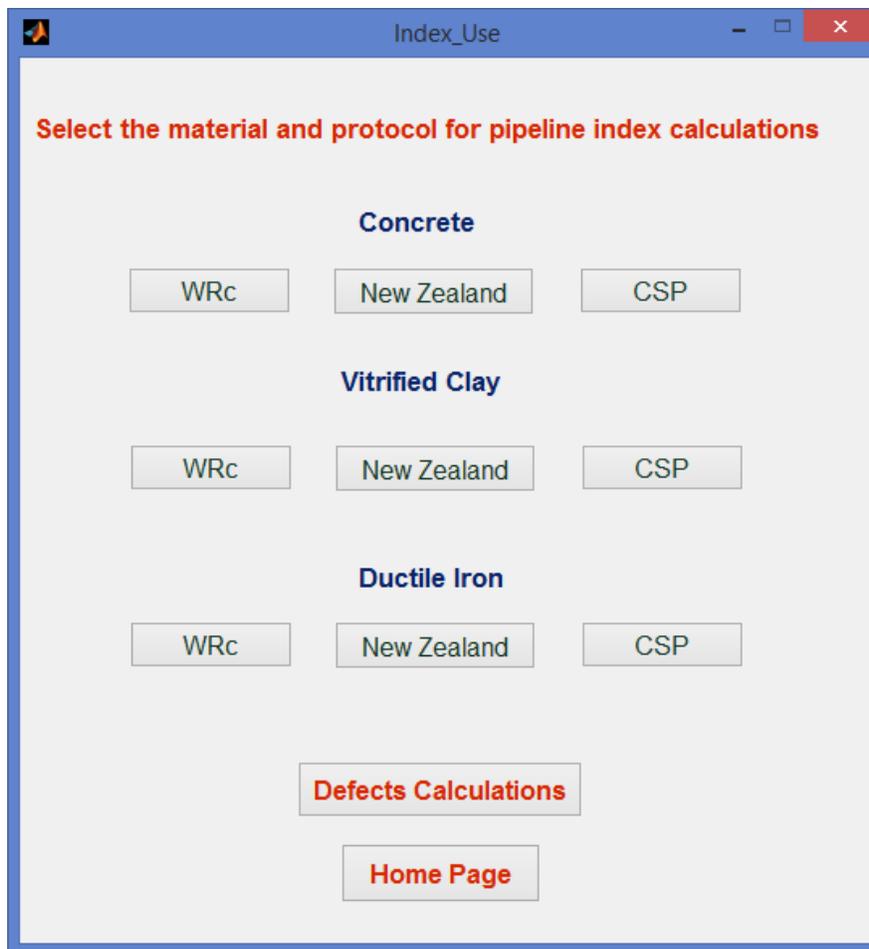
Figure 5.8 Grade Calculation Window Page

Figure 5.8 is a window that is concerned with the index calculation. The user can select the material of the sewer pipeline as well as the sewer protocol. The calculation method is based on the utility functions. The three protocols were used in the development of deformation and settled deposits utility functions. Therefore, the buttons refer to their names. For example, the “WRc” button under “Concrete” will calculate the grade based on the WRc utility deformation equation, WRc utility settled deposits equation, electro scan utility infiltration equation, and concrete utility equation based on the pipeline size.
