Surface damage evaluation of honeycomb sandwich aircraft panels using 3D scanning technology

T. Reyno, C. Marsden, D. Wowk

To appear in: *NDT and E International*

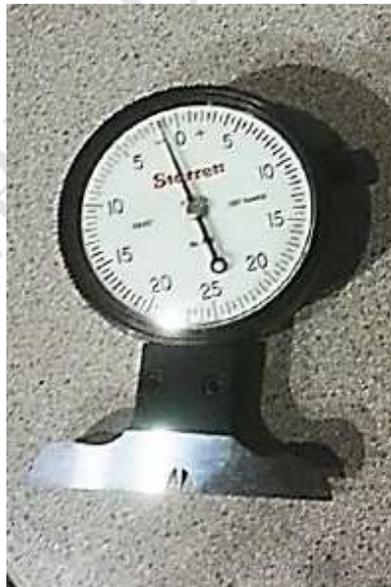
Figure 1: Starrett 643J dial depth gauge

OEM damage limits are typically defined in terms of the structural criticality of the affected panel; dent depth and length; total dent area; and the proximity of dents to specific features. Dent depth is usually measured using a dial or digital depth gauge [2-9], a ruler, or, in some cases, a high resolution electronic indicator [10, 11]. For the dial depth gauge, the gauge is positioned with the needle pointing normal to the inspection surface, and the dent is probed by taking multiple manual readings within the dent impression to find a maximum value. This can be time-consuming for the manual inspection of surfaces with many dents, such as aircraft panels exposed to hail damage or tool drop. This process is further prolonged by the manual recording of each measurement when using a dial depth gauge, like the one shown in Figure 1 used within this study.

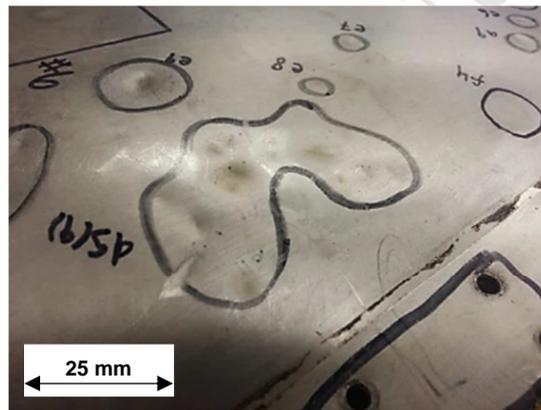
Figure 2: Dent cluster on a retired aircraft panel with dents circled using black marker by inspection personnel

Honeycomb sandwich panels are used extensively in both commercial and military aircraft due to their high stiffness- and strength-to-weight ratios. Honeycomb panels are constructed using thin face sheets bonded to a low-density hexagonal core. For aluminum-faced panels, impact due to hail or tool drop can result in both surface denting, as shown in Figure 2,

The 3D scanning method demonstrates a smaller range of measurement variability compared to conventional depth gauge measurements. This was evaluated for the dents on the curved panel surface shown in Figure 2. It was found that manually rotating the position of the depth gauge about the center of the four dent impressions and taking depth measurements at five different angles with respect to the longitudinal axis of the panel yielded variability up to 0.102 mm. The depth values obtained for these dents after five repetitions of the 3D scanning method only varied by a maximum of 0.028 mm. This indicates that the variation in dent depth measurements between different inspection personnel using manual methods is likely to be larger than when using the 3D scanning method.

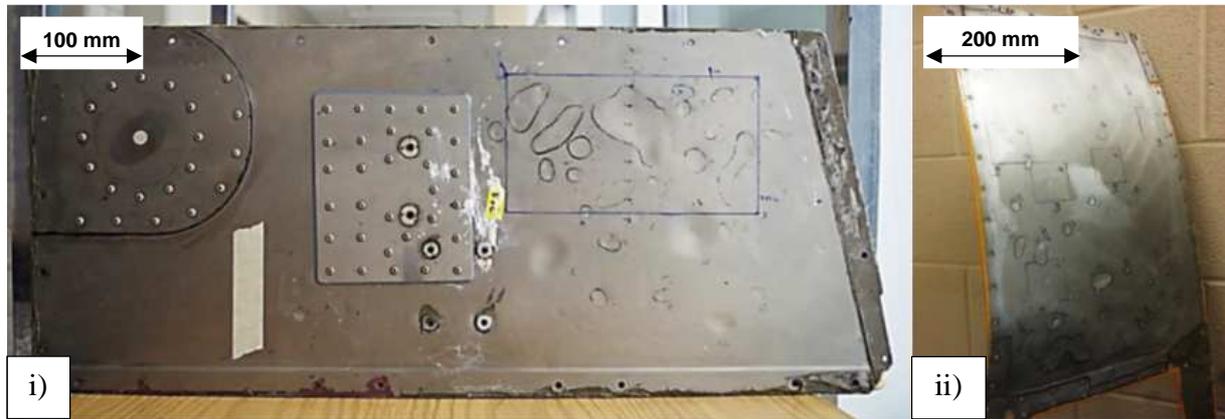
Figure 3: Honeycomb sandwich aircraft panel inspection specimens. i) flat panel, ii) curved panel

The proposed 3D scanning-based inspection method was developed and validated using three honeycomb sandwich aircraft panels that had been retired based on collective surface damage due to low-velocity impact that exceeded the allowable damage limits defined in the aircraft SRMs. The three specimens included two approximately flat panels with specifications as listed in Table 1, and a curved panel with specifications as listed in Table 2. Photographs of one of the flat panels and the curved panel are shown in Figure 3.

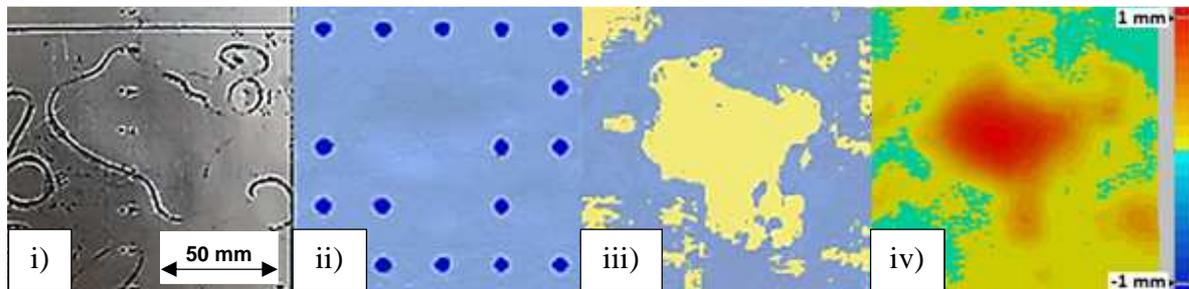
Figure 4: 3D scanning methodology; i) damaged aircraft panel surface; ii) point cloud data for the damaged surface (light blue) with grid of selected undamaged regions (dark blue); iii) 3D CAD surface (yellow) fit based on grid of undamaged regions; iv) deviation analysis color map showing dent depth (mm)

An outline of the methodology is given below, and is illustrated in Figure 4:

1. The panel is scanned to produce a point cloud rendering of the damaged surface.
2. A grid of circular point cloud regions corresponding to the undamaged surface of the panel is selected as shown in Figure 4 ii), whereas any region identified as being within a dent is manually omitted.

3. A 3D CAD surface is fit to the grid of undamaged regions to recreate the geometry of the undamaged panel, as shown by the yellow surface fit through the point cloud data in Figure 4 iii). The accuracy of the surface fit is evaluated using a convergence study as discussed in Sections 2.2.1-2.2.2.

4. A deviation analysis is performed between the point cloud data from the damaged panel and the 3D CAD surface representing the undamaged panel, producing a color map that identifies the dents as shown in Figure 4 iv).

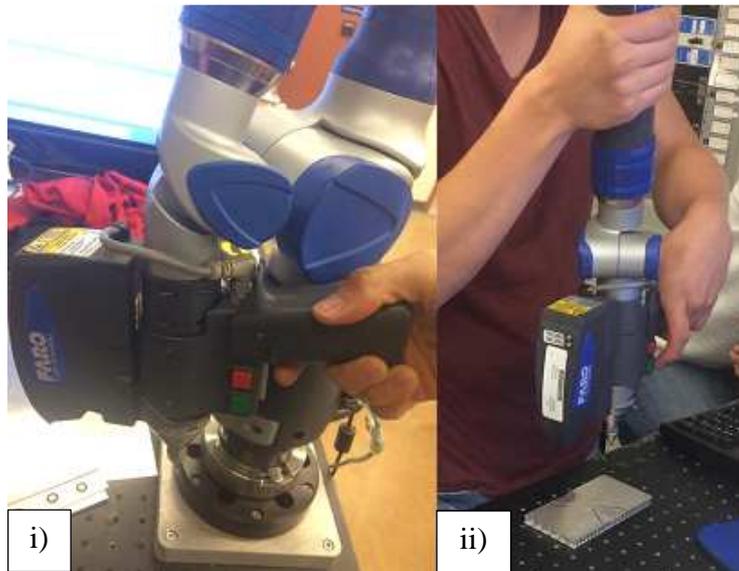
Figure 5: FARO® Edge 3D scanning apparatus. i) scanning pistol and base of scanning apparatus, ii) scanning pistol orientation during scan of aluminum honeycomb coupon

Point cloud data for the damaged aircraft panels was gathered using a FARO[®] Edge 3D scanning apparatus (Figure 5) comprised of a FARO[®] Laser Line Probe and SmartArm technology with single point repeatability from 0.024-0.064 mm, which indicates that the position of a point measured multiple times using the probe is expected to vary by less than 0.064 mm. The point cloud data for one of the two flat aircraft panels is illustrated in Figure 6. The data acquisition process was performed using Geomagic Design X software.

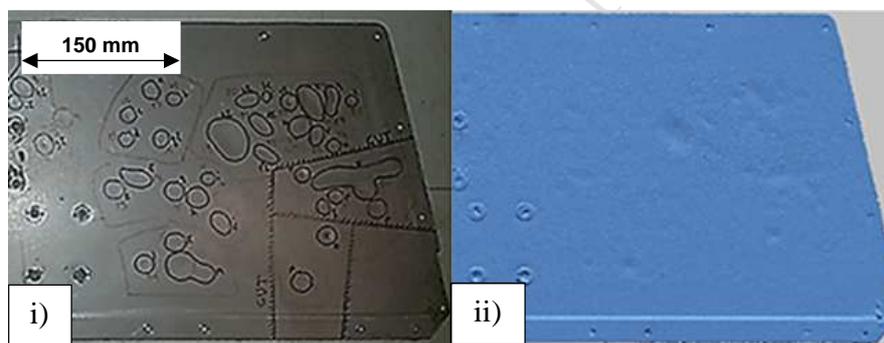
Figure 6: Flat, dented aircraft panel. i) photograph, ii) corresponding 3D point cloud rendering

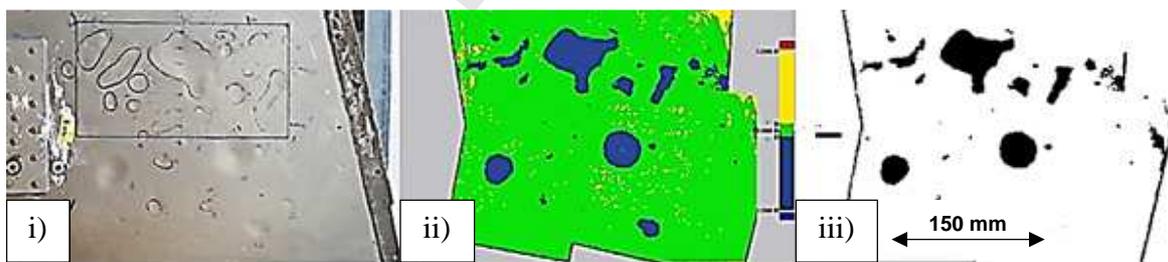
Figure 7: Dent length and area assessment; i) damaged panel; ii) color map identifying dents; iii) measurement of selected shapes in greyscale image

measurement represents planar area, making it independent of dent depth. The procedure for measuring dent length and area is described below, and is illustrated in Figure 7.

1. A second deviation analysis is performed on the existing point cloud data within Design X with the *color bar* setting set to *solid color*. This procedure yields a color map that clearly outlines the perimeter of each dent, as shown in Figure 7 ii), where any deviation beyond the defined tolerance is presented as a single color (dark blue).

2. The color map is converted to an 8-bit greyscale image using ImageJ, as shown in Figure 7 iii). Although not used in this study, the image may also be processed using sharpening or despeckling, which reduces noise and may enhance the analysis of more complex damage regions. For the analysis of curved geometries, the Design X *Normal To* function is used on the 3D CAD surface to rotate the color map such that it is perpendicular to the viewer and normal to the panel surface.

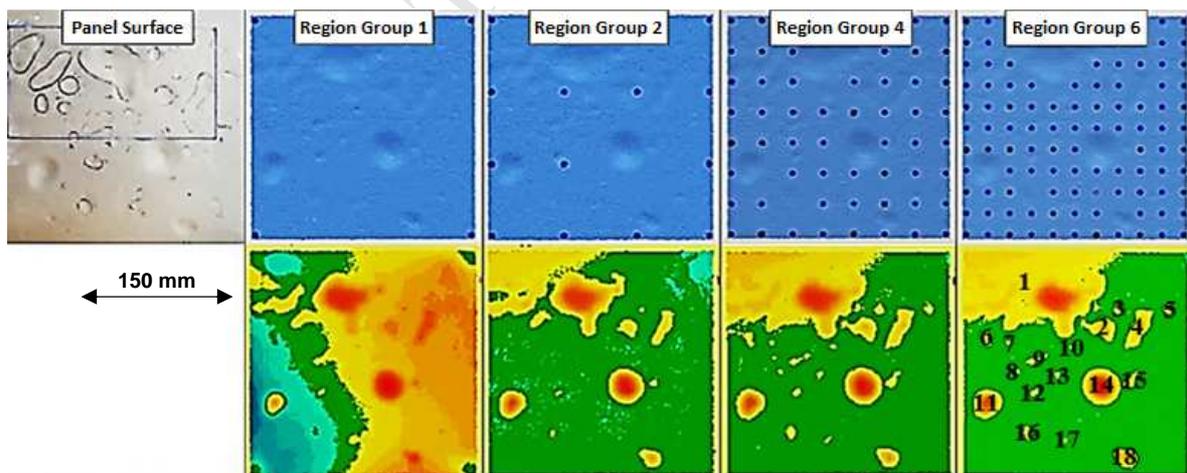
Figure 8: Illustration of flat panel convergence study; *Region Groups* comprise a grid of circular undamaged regions with spacings defined in Table 3

This study resulted in six *Region Groups* with different region spacings as listed in Table 3. Figure 8 shows the color map results for *Region Groups* 1, 2, 4 and 6, where green represents the undamaged surface based on a minimum dent depth value, and the other colors indicate dent depth. The final dent impressions are numbered in the color map results for *Region Group* 6. Many of the dent impressions were not identifiable in *Region Group* 1; however, as the spacing was decreased, consistent dent impressions developed. Figure 9 shows the convergence curve of the average percent different between successive decreases in spacing (Eq. 1) for the flat panel study for dent depth, length and area, respectively.

It was shown in the converged color map results of *Region Group 6* in Figure 8 that Dent 1 is one large dent impression, even though inspection personnel had identified several individual dents. This was confirmed using an eddy current (EC) surface profiling technique developed by the authors in Reference [37], which yielded damage map results comparable with those of the proposed 3D scanning method as shown in Figure 18.

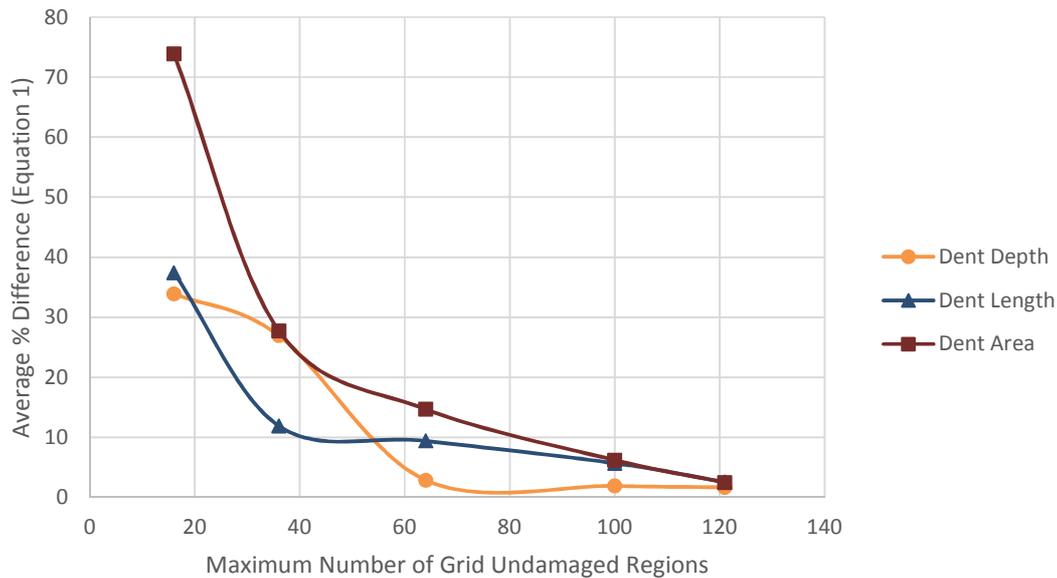
Figure 9: Average % difference evaluated using Equation 1 for *Region Groups* 2 to 6 demonstrating convergence of dent depth, length and area measurements on flat panel. Note: Measurements included in Equation 1 were only those from identifiable dent shapes for the current *Region Group*

The results of the flat panel convergence study showed that the accuracy of the measurements was improved when the spacing of the selected undamaged regions was decreased. This indicates that a convergence study based on decreasing the spacing between undamaged regions can be used to assess the accuracy of the recreated, undamaged panel surface and the resulting measurements of dent depth, length and area. Quantification of the dent area required the smallest spacing of 22 mm (*Region Group* 6) between undamaged regions, whereas dent length only required a spacing of 24.4 mm (*Region Group* 5) and dent depth a spacing of 31.4 mm (*Region Group* 4) to achieve convergence according to Equation 1. This indicates that dent area is the measurement that is the most sensitive to the accuracy of the undamaged surface fit, and that the undamaged region spacing required for convergence may differ based on the measurements required for the inspection. It is hypothesised that the degree of sensitivity observed for each measurement is a result of the degrees of freedom attributed to said

measurement. Dent depth is a single length measured between the static point cloud and the changing recreated panel surface, and may be considered as having one degree of freedom. Dent length is a length measured between two points whose locations depend on the changing recreated panel surface, and may be considered as having two degrees of freedom. Dent area may be approximated as having the number of degrees of freedom for length squared, or four degrees of freedom.

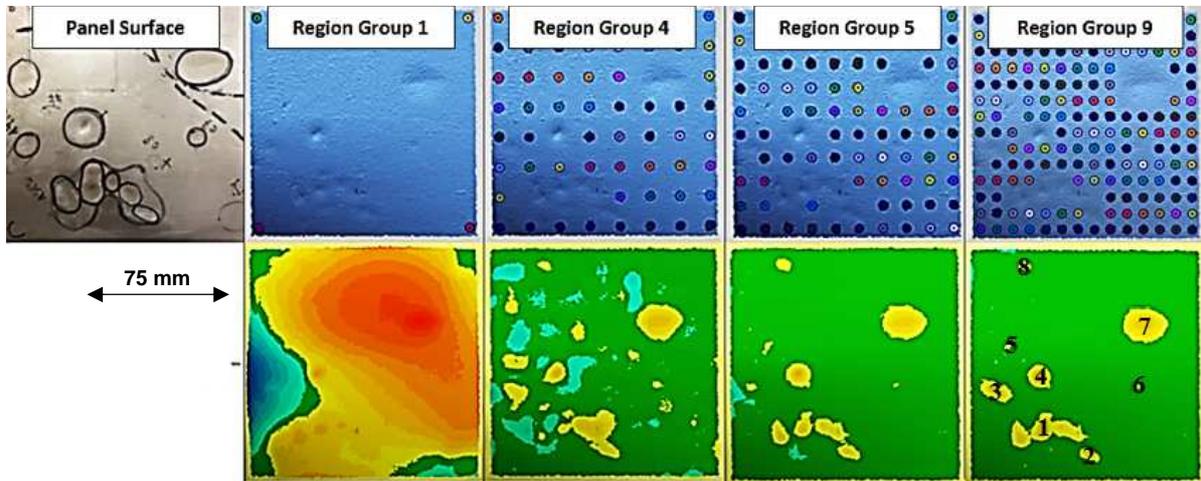
Figure 10: Illustration of curved panel convergence study; *Region Groups* comprise a grid of circular undamaged regions with spacings defined in Table 4

This study resulted in nine *Region Groups* with different region spacings as listed in Table 4. Figure 10 shows the color map results for *Region Groups* 1, 2, 4 and 6, where green represents the undamaged surface based on a minimum dent depth value, and the other colors indicate dent depth. The eight dent impressions are numbered in the color map results for *Region Group* 9. Many of the dent impressions were not identifiable in *Region Groups* 1-3; however, as the spacing was decreased, consistent dent impressions developed. Figure 11 shows the convergence results for the curved panel study for dent depth, length and area, respectively, based on Equation 1.

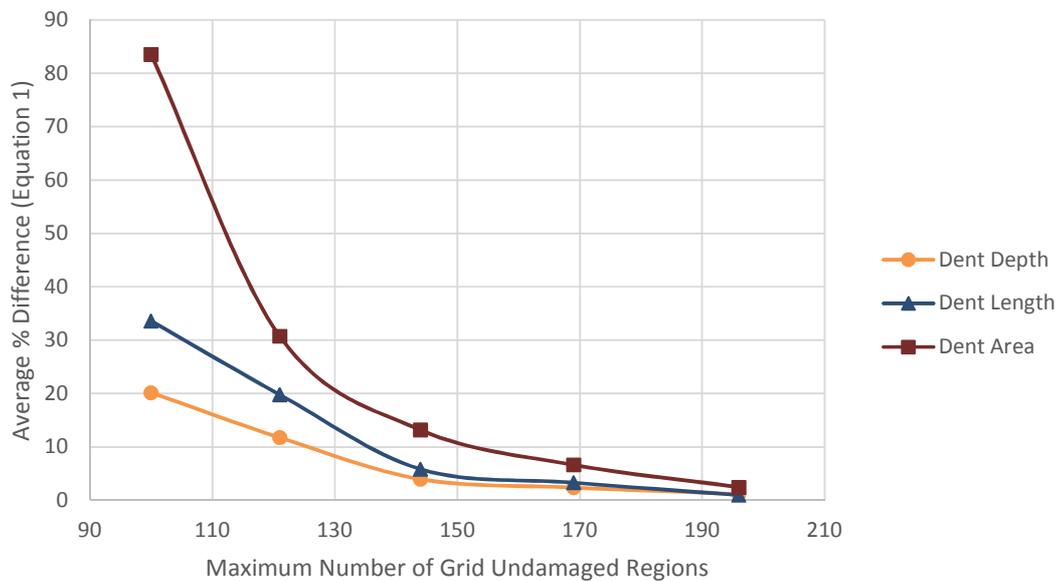
Figure 11: Average % difference evaluated using Equation 1 for *Region Groups* 5 to 9 demonstrating convergence of dent depth, length and area measurements on curved panel. Note: Measurements included in Equation 1 were only those from identifiable dent shapes for current *Region Group*

Figure 11 showed that dent area required the smallest region spacing of 9.23 mm (*Region Group* 9), whereas dent length only required a spacing of 10 mm (*Region Group* 8) and dent

depth a spacing of 10.91 mm (*Region Group 7*) to achieve convergence according to Equation 1. When comparing the flat and curved panels, it was seen that a smaller undamaged region spacing was required to achieve convergence in the curved panel study for all three measurements. For dent area, convergence occurred at a spacing of 9.23 mm for the curved panel as compared to 22 mm for the flat panel. This indicates that recreation of the undamaged surface for curved panels requires a finer resolution of undamaged regions than for flat panels in order to properly capture the surface curvature. It is also noted, however, that damage characteristics such as pattern, shape and size are also different between the two panels and contribute to the undamaged region spacing required for convergence. For both flat and curved panels, dent depth was seen to be the least sensitive measurement to the undamaged region spacing, while dent area was the most sensitive.

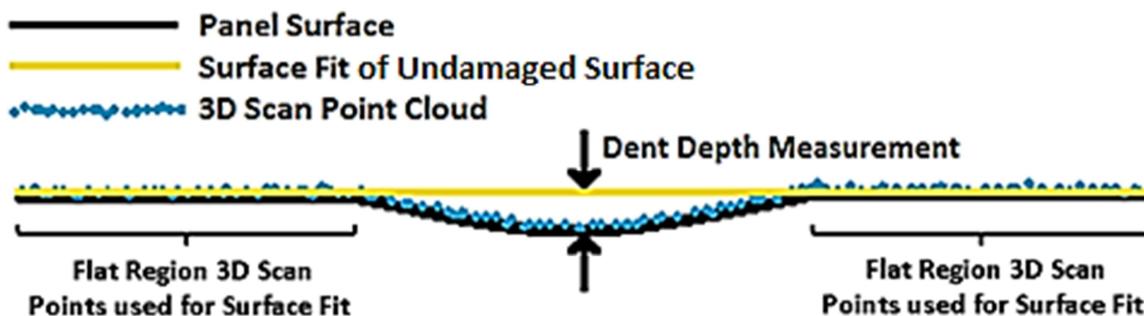
Figure 12: Illustration of the dent depth measurement. Scan data represents the point cloud rendering of the physical damaged panel surface, and the surface fit is an approximation of the original, undamaged panel surface

Once the 3D CAD surface approximating the undamaged panel was created, the deviation between the point cloud data and surface fit was quantified using the *Deviation Analysis* tool in Design X [36]. The *Deviation Analysis* tool measures the distance between the fitted surface and the point cloud data normal to the surface fit. The values obtained using the *Deviation Analysis* tool correspond to dent depth as illustrated in Figure 12.

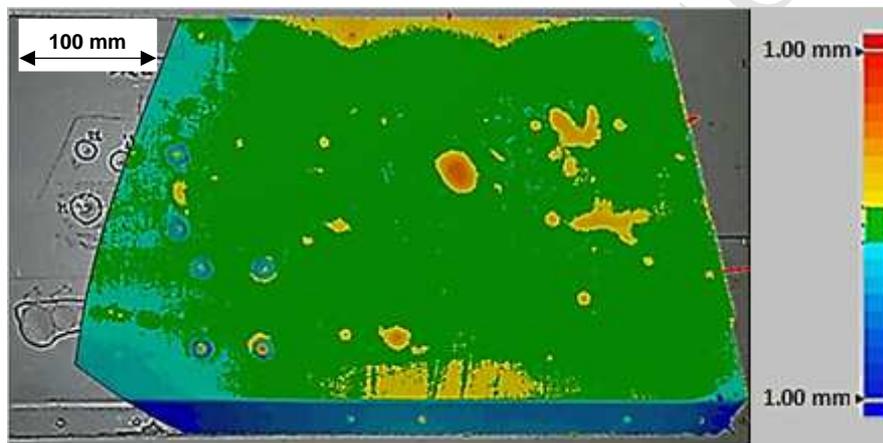
Figure 13: Deviation analysis color map (mm) with the results transposed onto an image of the physical panel

The deviation analysis produces a color map quantifying the difference between the point cloud representation of the damaged panel and the 3D CAD surface approximating the undamaged panel. Figure 13 shows the color map results for one of the flat aircraft panels transposed onto an image of the actual panel.

The 0.04 and 0.10 mm dents in Figure 14 were below the BVID cut-off, and the resulting core and face sheet damage would not be expected to affect residual panel strength. The 0.29 mm dent, however, resulted in more extensive damage including buckling and crushing of the cell walls. A conservative value of 0.1 mm was selected for the minimum dent depth, which is well below the commonly accepted BVID limit. On the color maps, for example in Figure 13, areas

that are green represent locations where the deformation of the panel is less than 0.1 mm from the recreated panel surface.

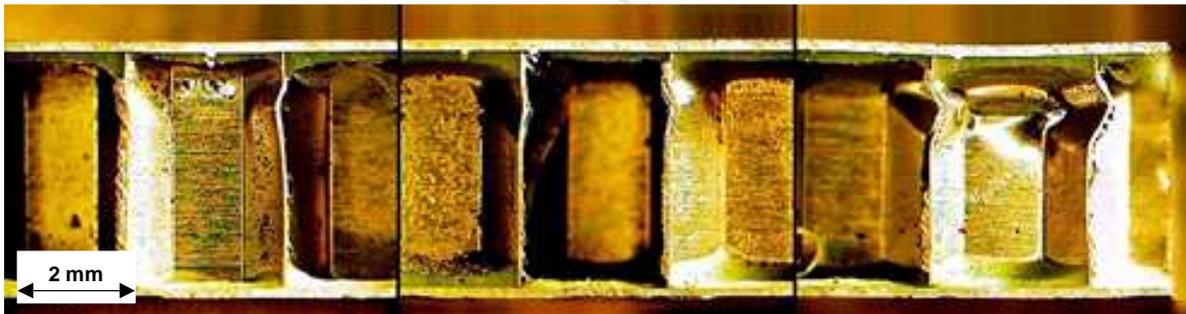
Figure 14: Core damage in experimental coupon for face sheet dent depths of 0.04 mm (left), 0.10 mm (middle), and 0.29 mm (right)

A series of three dents with different depths were created on an aluminum-faced honeycomb sandwich coupon using a 1 kg steel ball of 50.8 mm (2 in) diameter dropped at different heights. Dent depths of 0.04 mm, 0.10 mm, and 0.29 mm were measured using the 3D scanning method, with only the 0.29 mm dent qualifying as BVID. The coupon was subsequently cut through the centers of the dents using an automated diamond blade saw, and underlying core damage was identified using a microscope. The core damage is shown in Figure 14.

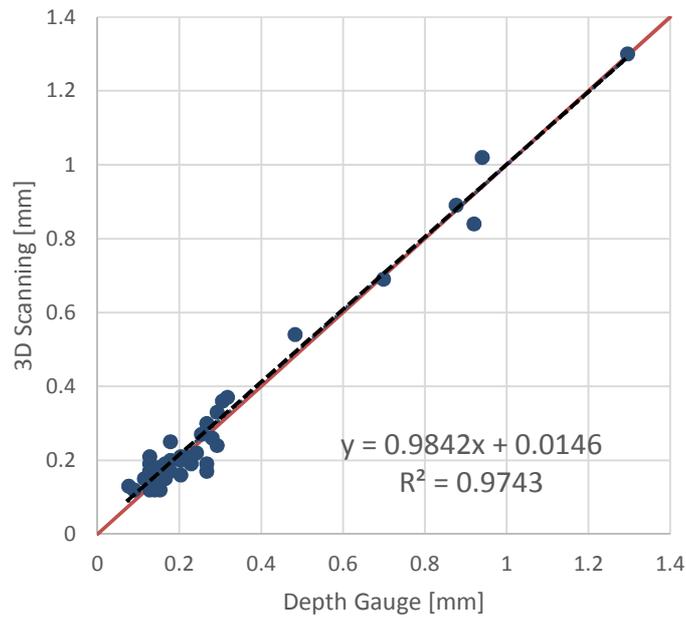
Figure 15: Dent depth (3D scanning) plotted against dent depth (depth gauge) for flat panels. The red line represents identical measurements and the dotted line is the linear data fit.

Figure 15 shows that for the 54 flat panel dents, a maximum absolute difference of 0.09 mm and deviation of 0.04 ± 0.06 mm for a 95% confidence interval were obtained between the 3D scanning and depth gauge measurements. Figure 16 shows that for the 74 curved panel dents, a maximum absolute difference of 0.095 mm and deviation of 0.04 ± 0.05 mm for a 95% confidence interval were obtained. The solid lines with slopes of 1 indicate identical measurements between both methods, and the flat and curved panel results yielded linear fit R^2 values of 0.9743 and 0.9209, respectively.

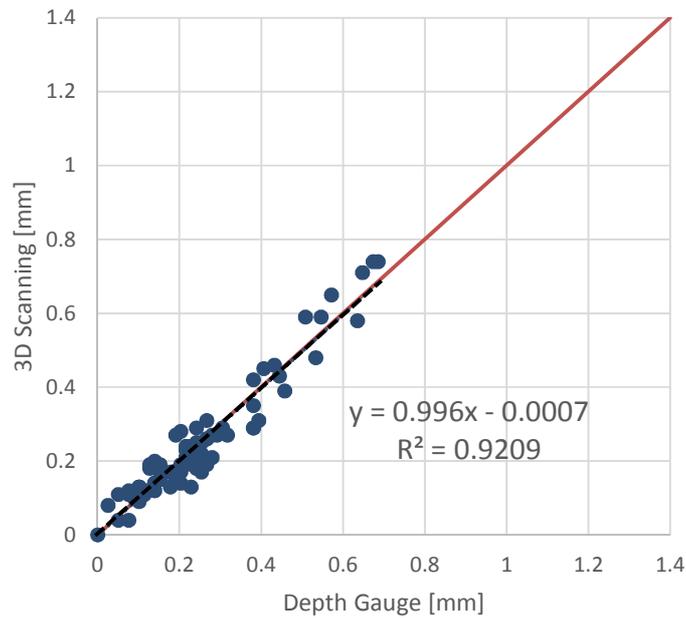
Figure 16: Dent depth (3D scanning) plotted against dent depth (depth gauge) for curved panel. The red line represents identical measurements and the dotted line is the linear data fit.

The 3D scanning inspection method was validated by comparing dent depth data to measurements taken using the depth gauge. The results of these comparisons are shown in Figures 12 and 13 for the flat and curved panels, respectively.

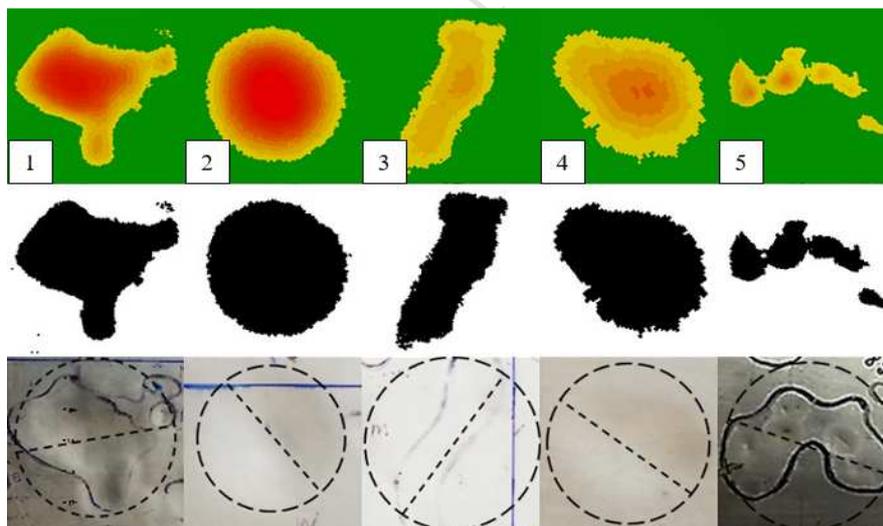
Figure 17: Dent shape comparison; i) 3D scanning method; ii) ImageJ image processing; iii) manual method of area approximation using dent length as the diameter of a circle. Scale information shown in Table 5.

Figure 17 illustrates five individual dent regions identified using the 3D scanning method and ImageJ postprocessing, and compares them to the dent areas calculated using the manual technique performed in the field. The method commonly described in the SRM conservatively approximates each dent as being circular with a diameter equal to the largest dent length measured using a ruler. Table 5 lists the areas of each dent as calculated using both the proposed 3D scanning method and the method outlined in the SRM. Dent length and area describe the in-plane size information of a damage region. However, the collective dent depth, length and area information obtained by the proposed method describe the 3D geometry of a damage region, where dent depth describes the extent of damage normal to the panel surface, and dent length and area describe the extent of damage within the plane of the panel surface. Here, damage is defined based on the SRM in terms of dent depth, length and area.

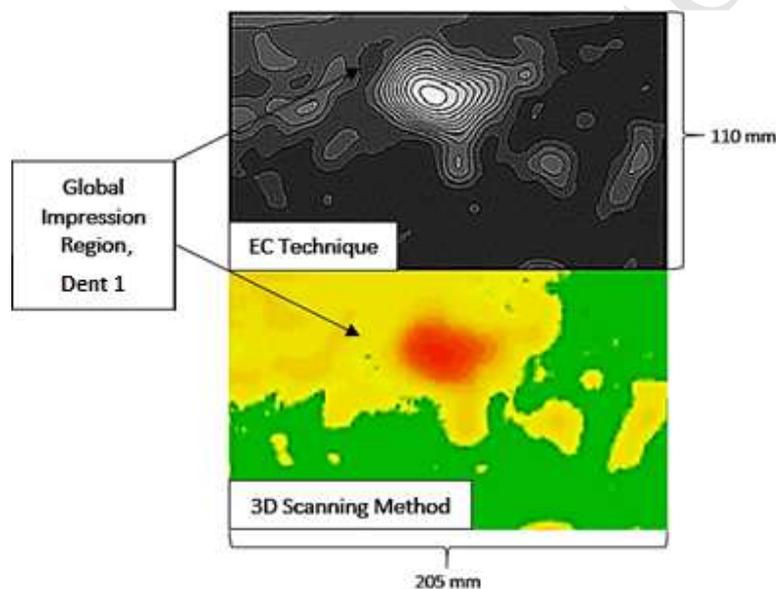
Figure 18: Dent 1 identified as global impression region using 3D scanning method (*Region Group 6*), and confirmed with eddy current results [37]
