Analysis of the Hydrogen Embrittlement Susceptibility of Industrial Zn-Ni Brush Plating Process

A thesis

Mechanical, Industrial and Aerospace engineering

October 2022

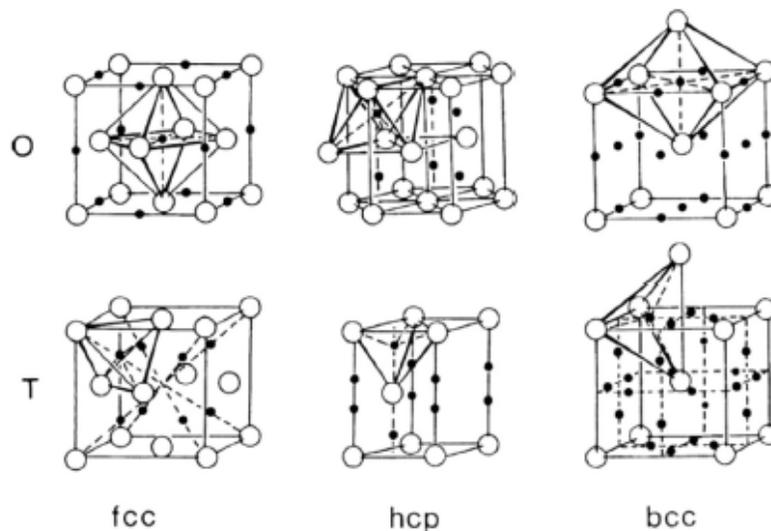
Figure 1-1 Interstitial sites (octahedral (O) sites and tetrahedral (T) sites) in FCC, HCP and BCC lattices [8]

After absorption into the structure of the metal, hydrogen tends to find itself in the interstitial sites in the lattice structure. In the case of Face-Centered Cubic (FCC), Hexagonal Close Packed (HCP) and Body-Centered Cubic (BCC) structures, hydrogen is likely to occupy the octahedral and tetrahedral interstitial sites [8]. Figure 1-1 demonstrates the octahedral (O) and tetrahedral (T) sites for these lattice structures. Octahedral sites are preferred by hydrogen atoms at temperatures beyond 100°C [9].

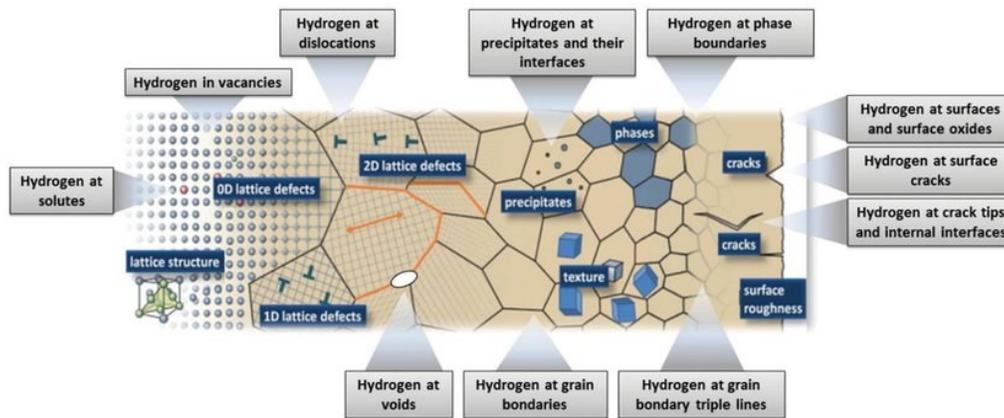
Figure 1-2 Schematic illustration of hydrogen traps sites [11]

Figure 1-2 illustrates various hydrogen traps in the microstructure [11].

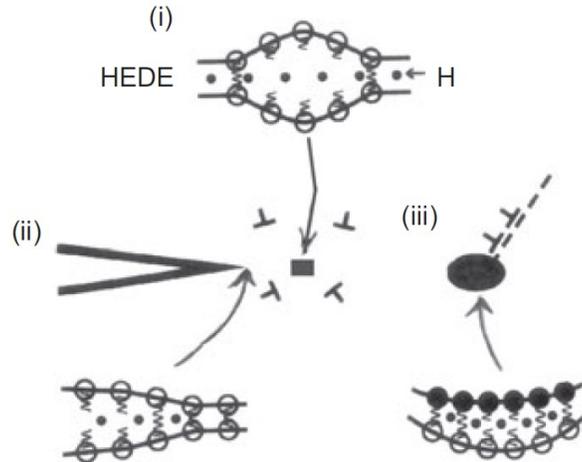
Figure 2-1 schematic illustration of HEDE mechanism showing the separation of atoms due to interatomic bonds by (i) presence of hydrogen in the lattice structure (ii) hydrogen being dissolved and (iii) presence of hydrogen at particle-matrix interfaces [48]

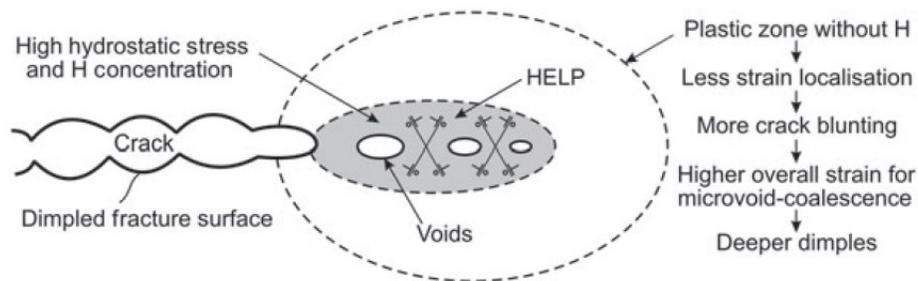
Figure 2-2 Schematic illustration of HELP mechanism demonstrating the coalescence of micro-voids and plasticity being localized in areas of high hydrogen concentration [48]

This mechanism was first proposed by Beachem in 1972 [32] based on fractographic observations. Alongside the HEDE mechanism, HELP is also widely discussed in research surrounding the mechanisms of HE and carries equal importance as HEDE. Beachem [32] stipulated that fracture occurred due to hydrogen facilitating dislocation movement given that the fracture surface had ductile features. Hydrogen tends to concentrate near crack tips thus leading to localized deformation near the crack tip and facilitates dislocation movement [32,48]. Therefore, subcritical crack growth occurs due to localized micro-void coalescence and creates ductile features such as dimples on the fracture surface [32,48]. A schematic illustration of this mechanism is shown in Figure 2-2 [48].

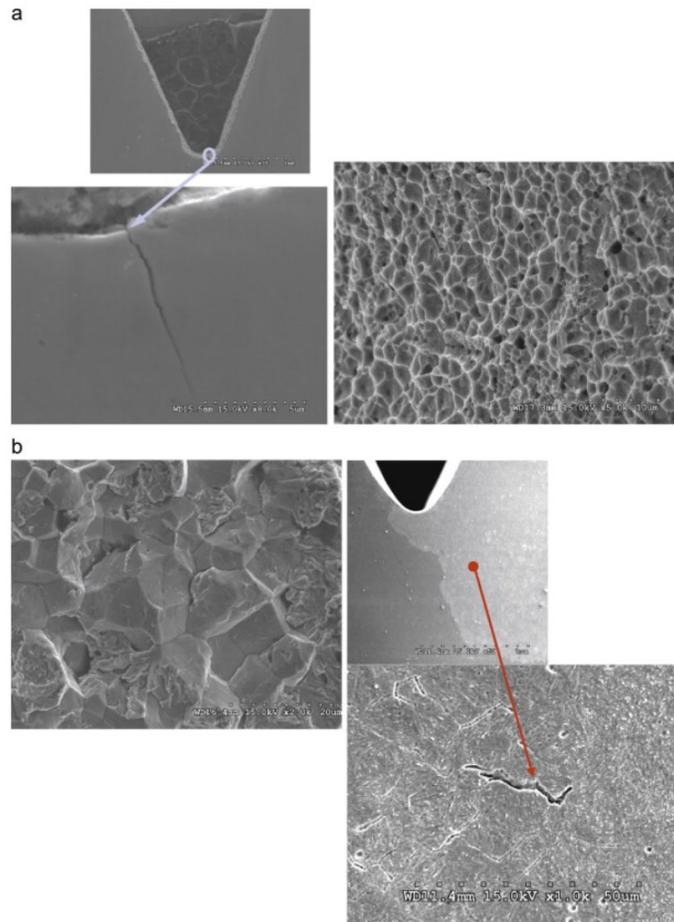
Figure 2-3 a) Fracture surface of the uncharged sample showing ductile fracture initiating at the notch b) Fracture surface of the charged sample showing intergranular fracture initiating ahead of the notch [53]

As mentioned earlier, the interactions between hydrogen and the metal are not yet fully understood and the mechanisms of HE are not yet completely clear. The factors that influence these interactions and mechanisms include: 1- the source of hydrogen (gaseous or electro-chemical) 2- the global and local content of hydrogen in the material 3- hydrogen concentration gradient 4- the local trapping process of hydrogen or its distribution 5- microstructure [36]. Depending on these factors, the effects of the presence of hydrogen could differ and at times show opposite and contradictory characteristics [37,50-52]. It is also important to note that the effect of hydrogen on the plasticity of material is not just limited to the HELP mechanism and could manifest itself in other mechanisms discussed in the literature such as hydrogen-enhanced strain-induced vacancy (HESIV) [6,45] and adsorption induced dislocation emission (AIDE) [37,44,48]. The HESIV mechanism is based on the notion that the presence of hydrogen increases the formation and clustering of strain induced vacancies while the AIDE mechanism stipulates that the absorption of hydrogen facilitates both the nucleation and the subsequent movement of the dislocation away from the crack tip leading to the formation of comparatively shallow dimples on the fracture surface. Under sustained load, the AIDE mechanism will result in the formation of micro-voids and nano-voids that contribute to crack growth [48]. These mechanisms could work in tandem to embrittle a metal. An example of the synergy between HELP and HEDE mechanisms was reported by Novak et al. [53]. In their work, notched samples manufactured from heat treated 4340 high strength steel were charged using hydrogen gas and subsequently subjected to a four-point bending test. It was revealed that hydrogen charging will cause fracture to initiate ahead of the notch root at carbide/matrix interface and exhibit intergranular fracture features as shown in Figure 2-3.b. It was stipulated that the brittle intergranular fracture occurs as a result of a pile-up and impingement of dislocations at the interface of grain-boundary carbide and matrix due to their facilitated movement resulting from the HELP mechanism. These dislocations transported hydrogen along with them to the carbide/matrix interface, increasing hydrogen concentration at the carbide/matrix interface thus activating the HEDE mechanism which manifests itself in the form of intergranular fracture.

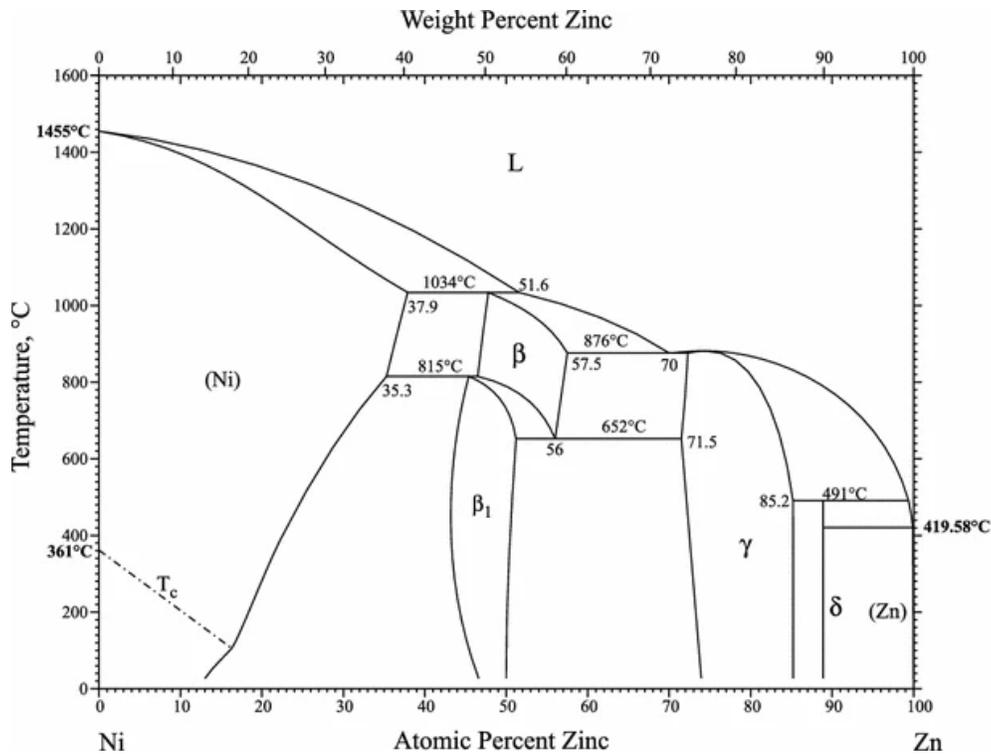
Figure 2-4 Zn-Ni phase diagram [63]

As discussed in chapter 1, Cd is used as a protective coating on aircraft components such as landing gears. However, Cd and its compounds are extremely toxic [56]. The poisonous nature of its salts will make it difficult to dispose of them after electro-plating and the permissible levels of Cd that can be discharged into the environment are extremely low and subject to severe restrictions in many countries [56]. Moreover, the use of cyanide baths for Cd electroplating further exacerbates the issue of toxicity in Cd electro-plating [56]. Therefore, Zn-Ni is gaining traction as an alternative to Cd [57-59]. Zn-Ni coatings are found to provide better corrosion resistance for steel than galvanized Cd coating as well as pure Zn coating [59,60]. The Ni content of the coating plays an important role in its corrosion protection properties. It is reported in the literature that a Ni content between 10-15% provides optimum resistance to corrosion which corresponds to γ Zn-Ni [61,62]. The Zn-Ni phase diagram in Figure 2-4 shows the composition range of the γ phase.

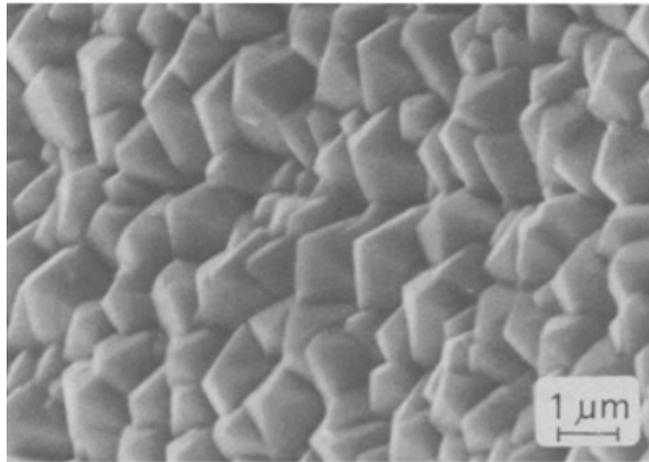
Figure 2-5 Electro-deposited Zn-Ni coating with 8.5% Ni at a current density of 5mA/cm² [64]

Ni coatings deposited from an acidic chloride bath. Figures 2-5 and 2-6 show the SEM micrographs of the morphologies of Zn-8.5%Ni and Zn-14%Ni coatings demonstrating their pyramid structure.

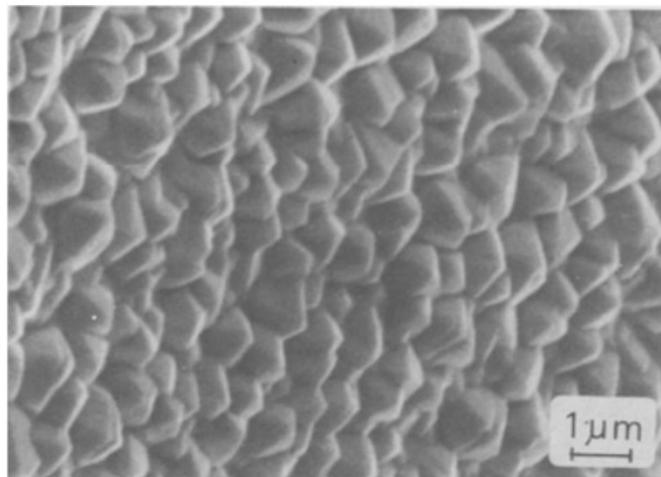
Figure 2-6 Electro-deposited Zn-Ni coating with 14% Ni at a current density of 5mA/cm² [64]

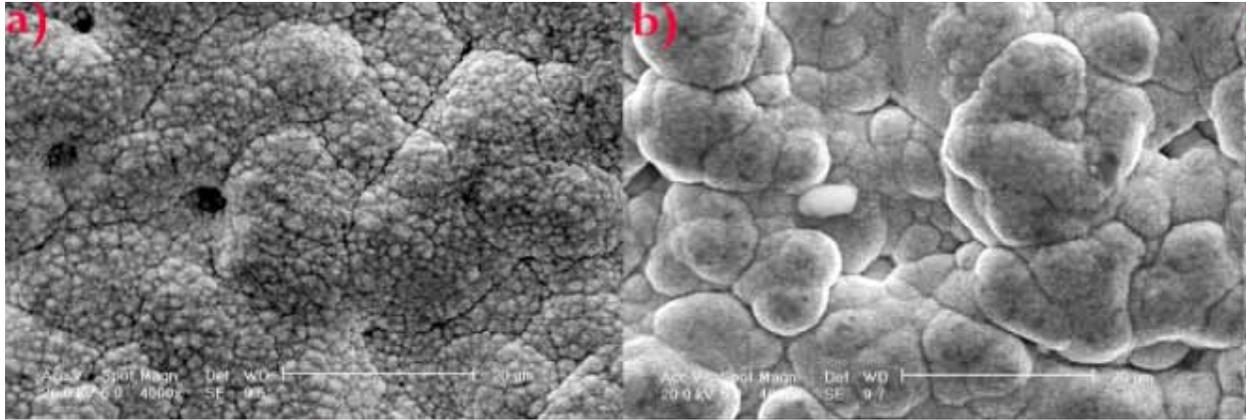
Figure 2-7 Zn-Ni coating deposited at a) 48 mA/cm² and b) 30 mA/cm² [65]

On the other hand, Rajagopalan et al. [65] reported a platelet-like morphology for Zn-Ni coatings deposited from an alkaline solution. Figure 2-7 shows the morphology of the deposited coatings plated at 30 mA/cm² and 48 mA/cm². This was also confirmed by Conde et al. [59] as they obtained a similar morphology from their alkaline bath as shown in Figure 2-8. Alkaline baths are preferred in applications where the substrate material is more susceptible to HE such as high strength steel as they are reported to cause less HE compared to acidic baths [59]. The solution used in the present research is alkaline as well which is preferred for electro-plating embrittlement susceptible parts such as landing gears.

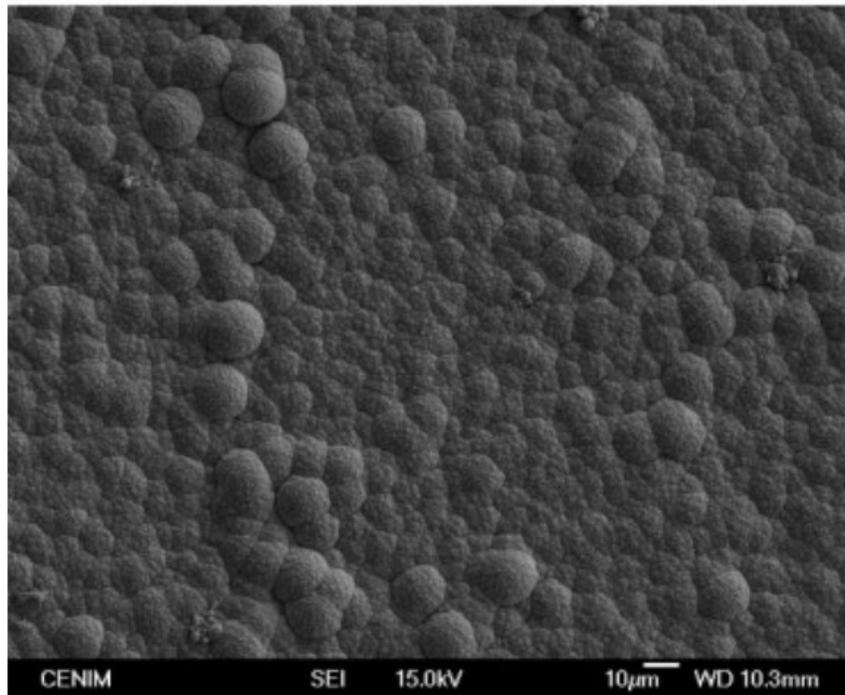
Figure 2-8 SEM micrograph of Zn-Ni coating deposited at 15 mA/cm² with 14% Ni [59]

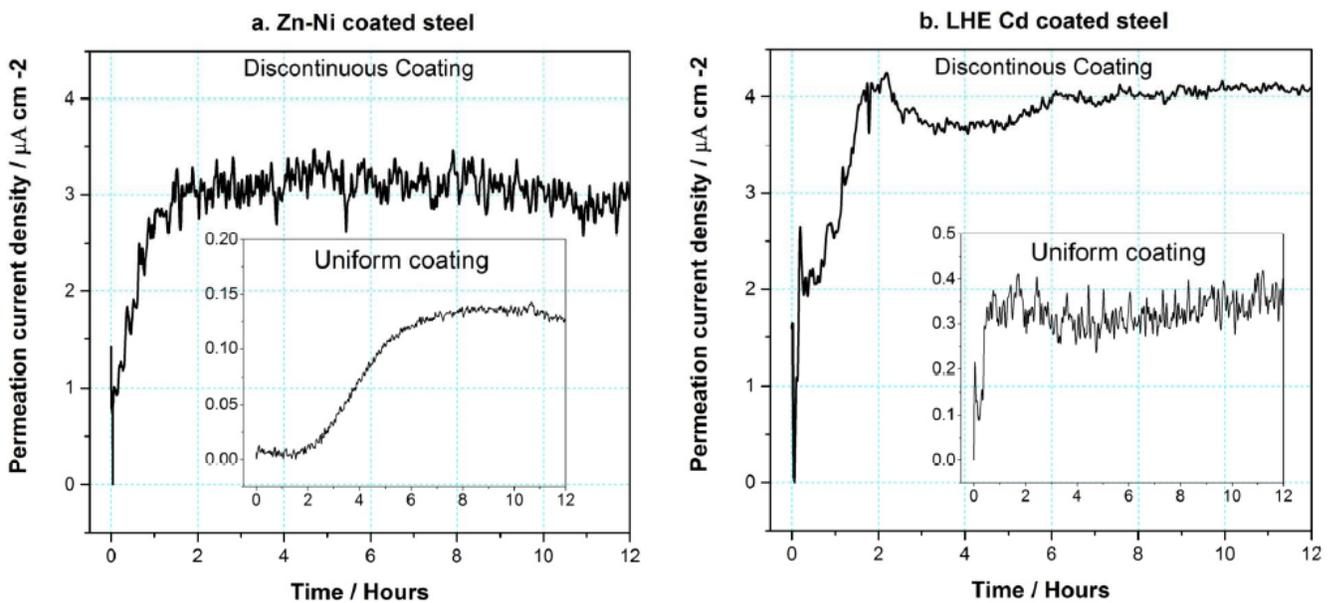
Figure 2-9 Permeation current density plotted against time for both Zn-Ni and Cd coatings [71]

It is also important to note that the diffusion of hydrogen through these coatings is largely dependent on the existence of micro-cracks, discontinuities, pores and defects in the coating and such features can affect HE susceptibility both during the electro-plating process and in-service environments [69,70]. Rajagopalan et al. [71] concluded that micro-cracks, coating discontinuities and porosity facilitate the diffusion of hydrogen in a coating that will otherwise significantly impede this diffusion. Figure 2-9 shows that Cd and Zn-Ni coatings with microcracks and discontinuities recorded a much higher rate of hydrogen permeation when studied using Devanathan-Stachurski double cell. The diffusion coefficient and the permeation flux were also quantified as shown in Table 2-1. Diffusion coefficient is an indication of the capacity of a substance to diffuse across a unit area in a timespan of 1s as a result of concentration gradient of that substance while the permeation flux is the amount of substance that diffuses across a unit of area in 1s [72,73].

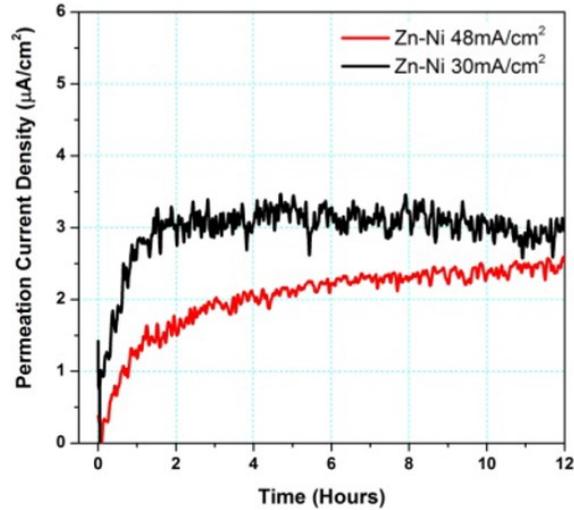
Figure 2-10 Hydrogen permeation current transient for the Zn-Ni coatings plated at 30A/cm² and 48A/cm² [65]

Plating parameters such as current density and bath pH affect the permeability of the coating and the HE susceptibility of the electro-plating process as well. Carr and Robinson [74] reported that Zn-Ni plating in a bath with a pH of 2 leads to significantly less hydrogen uptake compared to a bath with a pH of 5 despite hydrogen concentration being higher at a lower pH. This is explained by the formation of a thin pure Ni layer at the early stages of the deposition at lower pH which acts as a strong diffusion barrier for hydrogen. The influence of current density was investigated by Rajagopalan et al. [65] showing that coatings plated at a higher current density allowed less hydrogen permeation as demonstrated by the permeation current transients in Figure 2-10. Moreover, Ghaziof et al. [75] reported that increase in plating current density results in higher Ni deposition at the expense of hydrogen thus leading to a higher Ni content in the coating and less hydrogen diffusion.

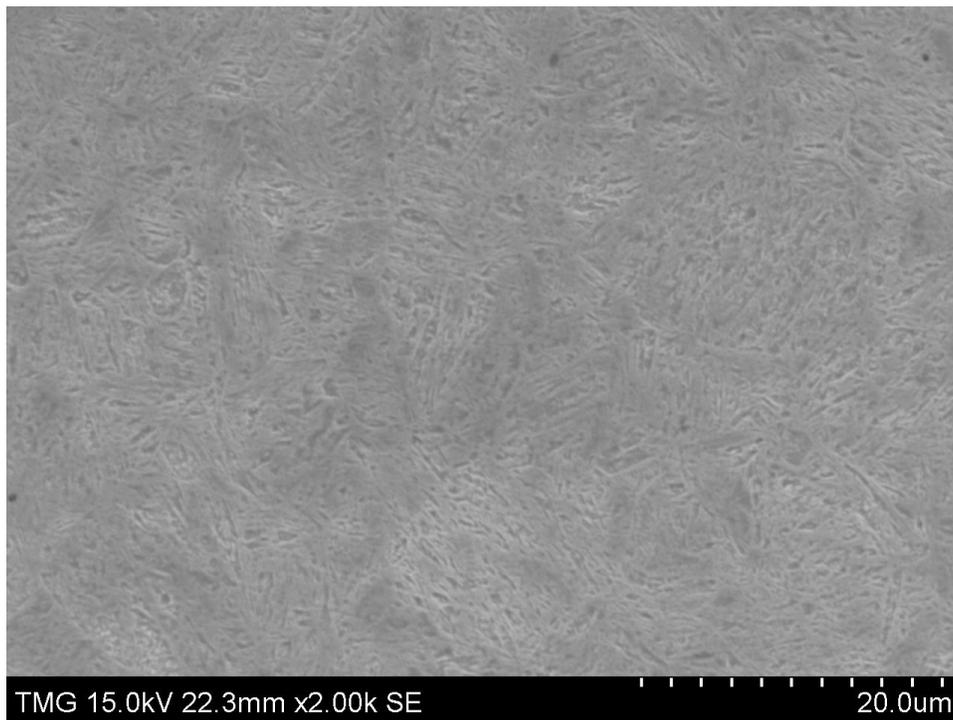
Figure 3-1 SEM image of the microstructure of the samples used in this research

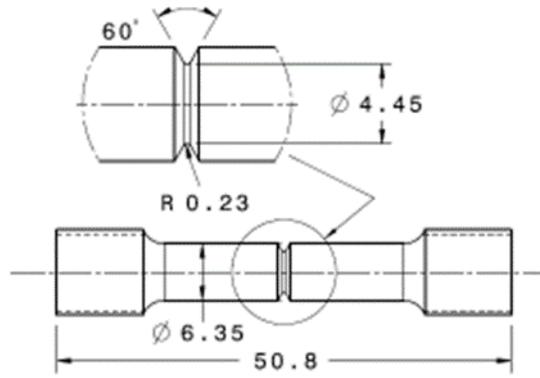
Figure 3-2 Layout of type 1a.1 sample (dimension are in mm) [26]

The notched bar samples shown in Figure 3-2 were used for HE evaluation testing. These samples correspond to the sample type 1a.1 of ASTM F519 [26]. The samples were machined from the heat-treated SAE 4340 steel and were subsequently subjected to a stress relief bake at $190\pm 14^{\circ}\text{C}$ as per AMS 2759/11 [85] for 4 h after machining. Figures 3-3 and 3-4 show images of an as-received sample and its notch respectively.

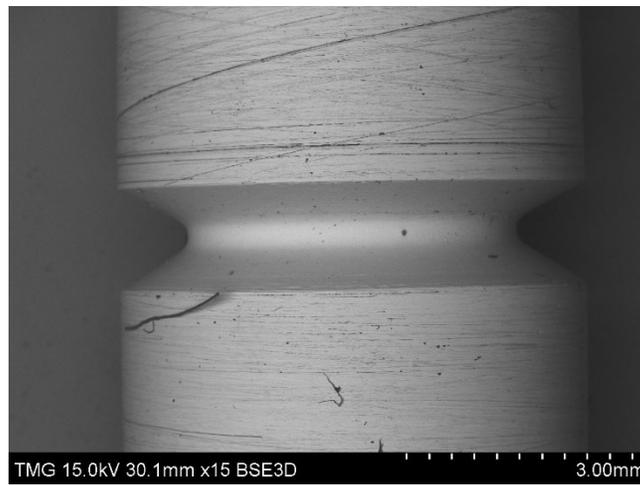
Figure 3-3 SEM image of an as-received test sample

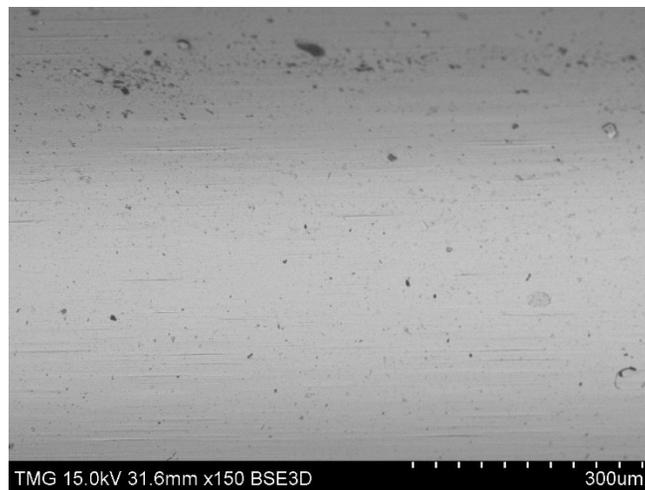
Figure 3-4 SEM image of the notch of an as-received test sample

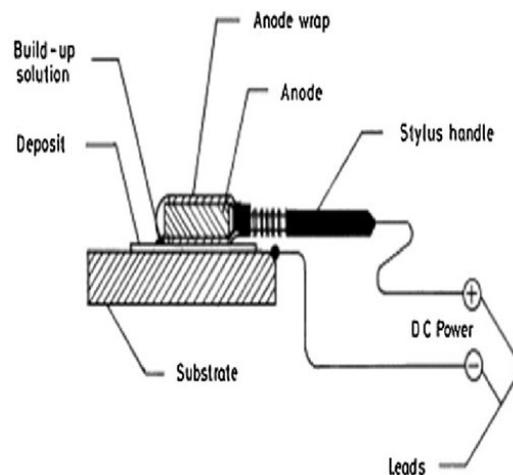
Figure 3-5 Schematic representation of the brush plating setup [86]

The plating process analyzed in this research is brush plating. A quick plating process that is used in aerospace industry to repair damaged coatings. The setup of this process is portable consisting of a rectifier, a brush (which is connected to the anode) and a plating solution instead of a bath. The part to be plated (substrate) is attached to the cathode, the coating on the substrate is deposited by pouring the plating solution on it and simultaneously rubbing the brush against the substrate. Figure 3-5 is an illustration of the brush plating setup.

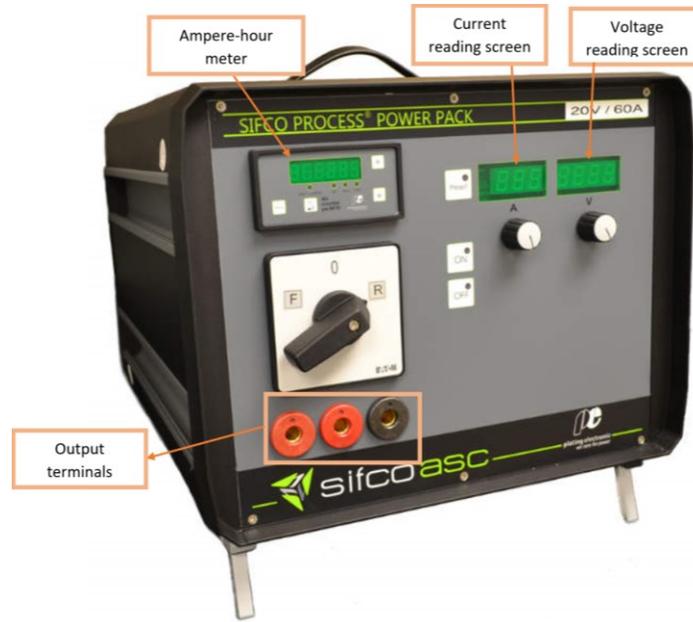
Figure 3-6 Rectifier used for brush plating

- 1- The plating voltage which is usually kept constant in the brush plating process.
- 2- The plating current usually varies during brush plating. However, it can be fixed at a constant value instead of plating voltage depending upon the user requirements.
- 3- The total electric charge, Q (in ampere-seconds (A.s) or ampere-hours (A.h)), passed through the system during the plating process which is displayed on the ampere-hour meter.

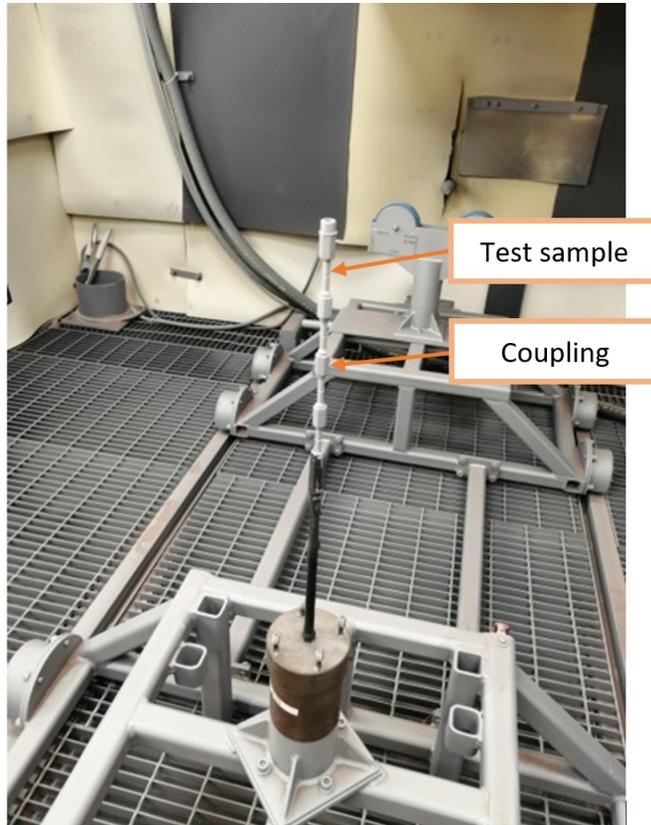
Figure 3-7 Batch of 4 samples attached to each other for sandblasting inside the chamber

The industrial procedure of plating the test samples requires certain preparations beforehand. First, the samples are visually inspected to make sure that there are no signs of damage to the notch and the samples surface. Afterwards, they are sandblasted in order to create an appropriate surface roughness to ensure proper coating adhesion. In this research, all the experiments except for one were carried out using sandblasted samples. Sandblasting was performed using an automated setup to ensure its uniformity. Samples are attached to each other and placed in the sandblasting chamber as shown in Figure 3-7. Subsequently they are sandblasted by a robotic nozzle at a pressure of 25 psi (0.172 MPa). The robotic nozzle maintains a distance of 350 mm and is positioned at an angle of 70° from the samples. After sandblasting, the samples are scrubbed and observed using a low magnification optical microscope to reassure the integrity of the notch before conducting brush plating.

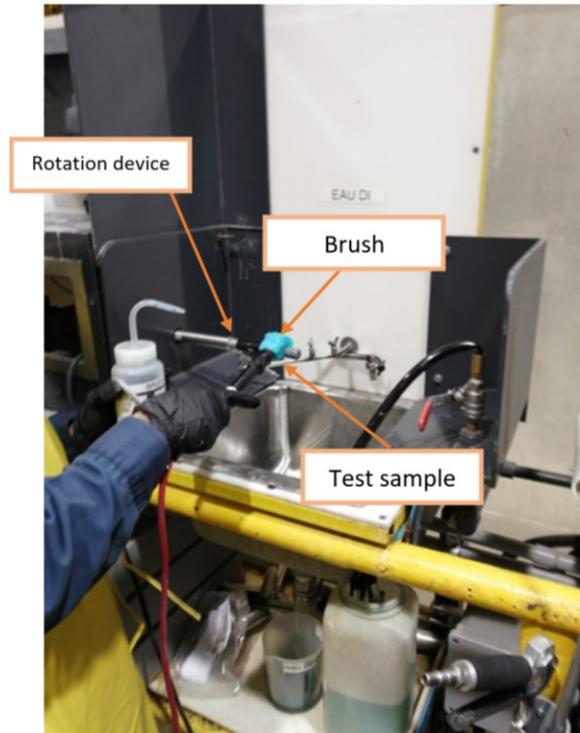
Figure 3-8 Brush plating setup

During plating, the samples are connected to the cathode of the rectifier and rotated at a constant rate of 60 rpm to ensure a uniform deposition of coating. The brush is attached to the anode and is manually kept in contact with the sample surface as the plating solution is poured onto it until the coating is built up to the desired thickness. This setup is shown in Figure 3-8.

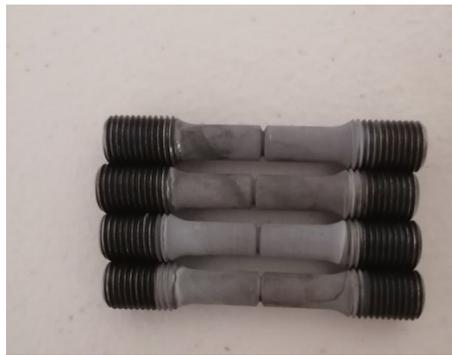
Figure 3-9 Batch of samples plated with Zn-Ni

Plating is done at 10 V and terminates when 200 A.s of electric charge has been reached which will theoretically deposit a coating of around 11 μm thick. However, this theoretical thickness will not be achieved in practice as will be shown in the next chapter when the average coating thicknesses are measured. Figure 3-9 shows a batch of samples plated with Zn-Ni.

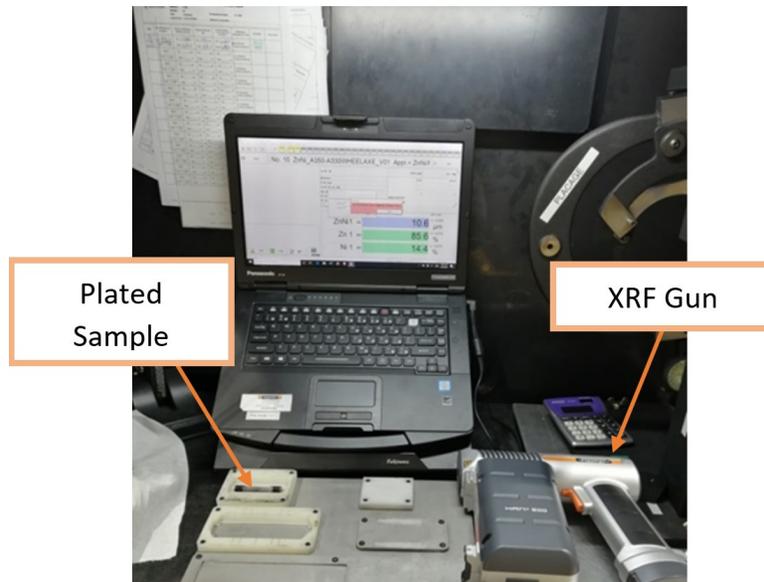
Figure 3-10 The XRF gun used to measure the coating thickness and Ni content

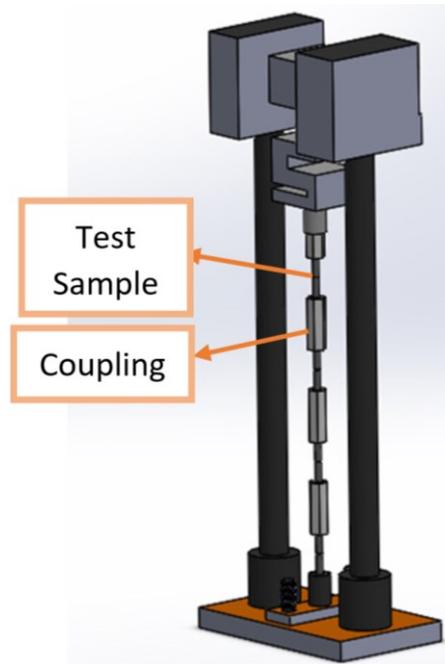
Figure 3-11 A schematic representation of a batch of samples attached to each other and placed in the sustained load test setup

SLT is conducted in accordance with ASTM F519 [26] to evaluate HE in electroplated samples. During SLT, type 1a.1 samples are subjected to a sustained tensile load at 75% of the notched fracture strength (NFS) for a duration of 200 h. The NFS of the samples used in this research is 38.59 kN which is the average value obtained from 10 tests conducted by Green Specialties Ltd. Therefore, a sustained tensile load of 28.94 kN (75% of NFS) was applied during SLT. Each test contained a batch of 4 samples fastened to each other using couplings and subsequently mounted in a tensile test setup as shown in Figure 3-11. The tensile test machine used in this study was equipped with a load cell of 50 kN and was programmable to maintain the required applied load for a duration of at least 200 h. In case any of the four samples fractures during the SLT, the test is halted to replace the fractured sample with a dummy sample and then the test is resumed. The replacement dummy samples are shown in Figure 3-12.

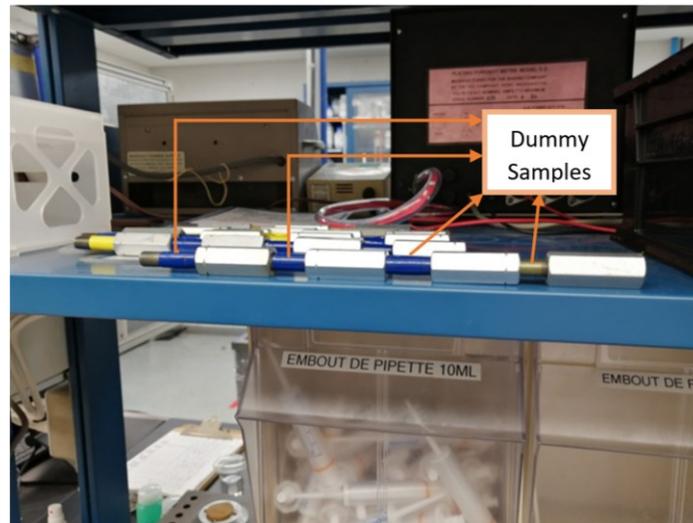
Figure 3-12 Dummy samples used to replace fractured samples in SLT

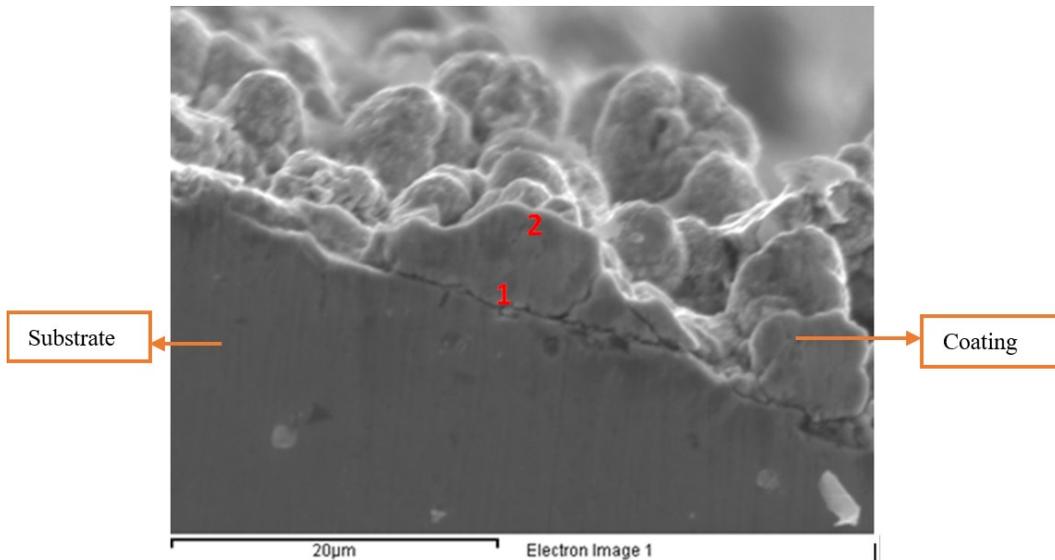
Figure 4-1 Image of the Zn-Ni coating showing the two spots on the coating marked for elemental analysis

The Ni content of the coating seems to increase when coating thickness is reduced. This is an indication that the electro-plating process begins with the deposition of a Ni-rich layer of coating and the Ni content drops as the coating becomes thicker. This can further be proven using an EDS analysis to obtain the Ni content of the coating at its interface with the substrate and away from it. Figure 4-1 shows an SEM image of a coating plated under standard conditions and the EDS analysis of the two marked points are brought in Table 4-5. The existence of a Ni-rich layer at the interface of the coating and substrate is in accordance with the literature [66,77]. However, in the case of the Zn-Ni coating in this research, it is clear that the diffusion of hydrogen into the substrate was not impeded by the Ni-rich layer at the coating/substrate interface as opposed to what is reported by Hillier et al. [77]. Analysis of the coating morphology and characteristics in section 4-1-2 will reveal more insights as to why that is the case.

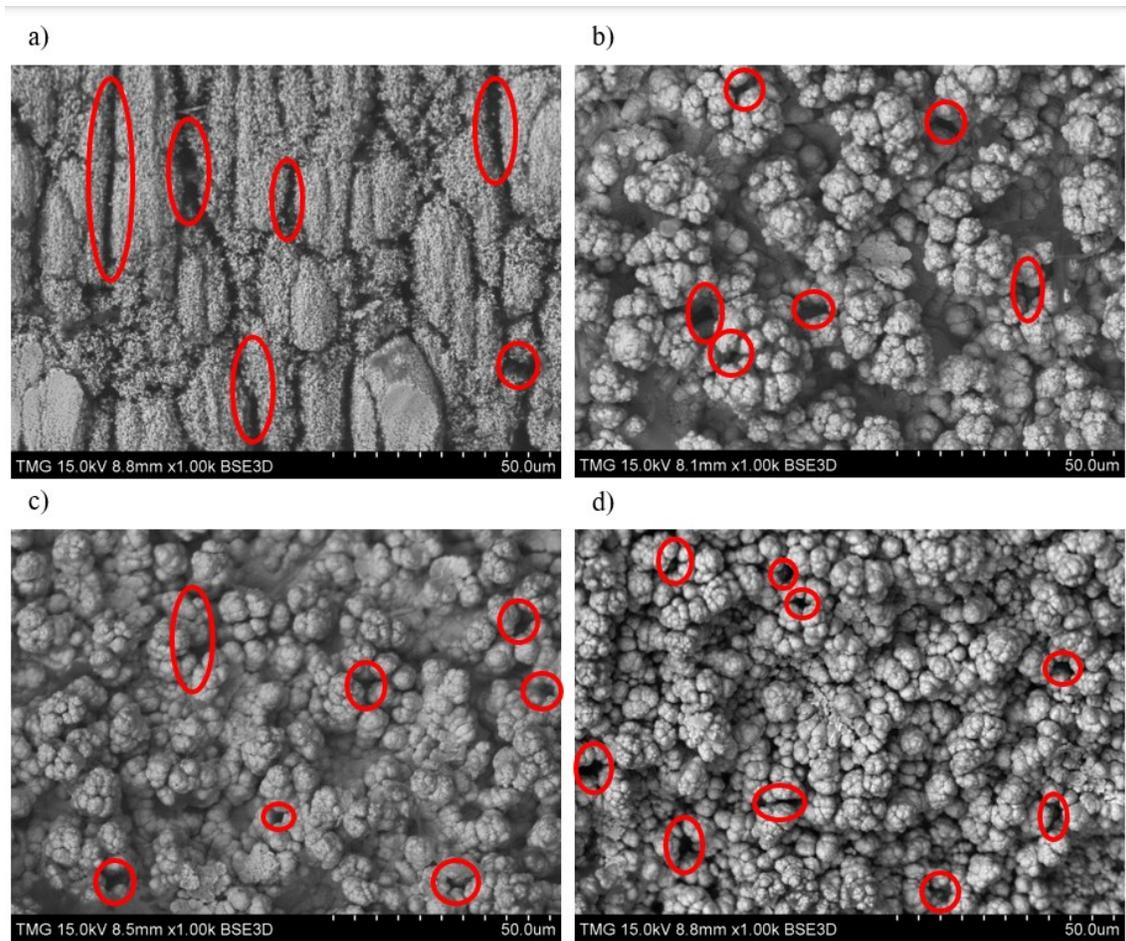
Figure 4-2 Evolution of coating morphology showing samples plated at a) 0.66 A/cm² b) 2.0 A/cm² c) 3.3 A/cm² d) 5.3 A/cm²

Another characteristic of the coatings is the existence of intermittent gaps and pinholes between the platelets some of which are marked in Figure 4-2. An SEM image of the coating of one of the samples plated under standard conditions is shown in Figure 4-3 demonstrating similar noticeable gaps and pinholes on the coating surface. Moreover, visible micro-cracks and discontinuities also exist across the thickness of the coating as demonstrated in Figure 4-4.

Plating current density (A/cm ²)	Average platelet size (µm)
0.66	12.35 ± 0.8
2.0	5.80 ± 0.5
3.3	3.67 ± 0.5
5.3	2.50 ± 0.3

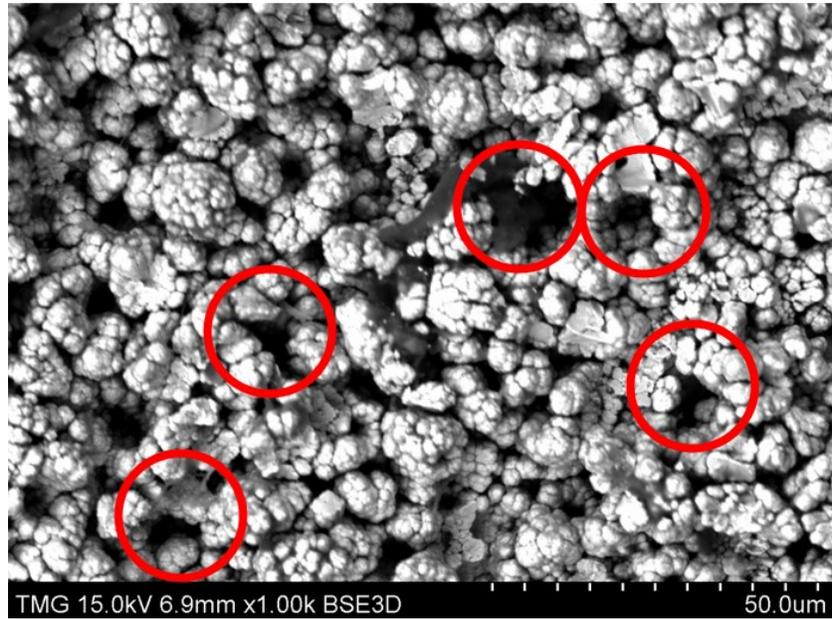
Figure 4-3 Coating morphology of a sample plated with standard plating parameters

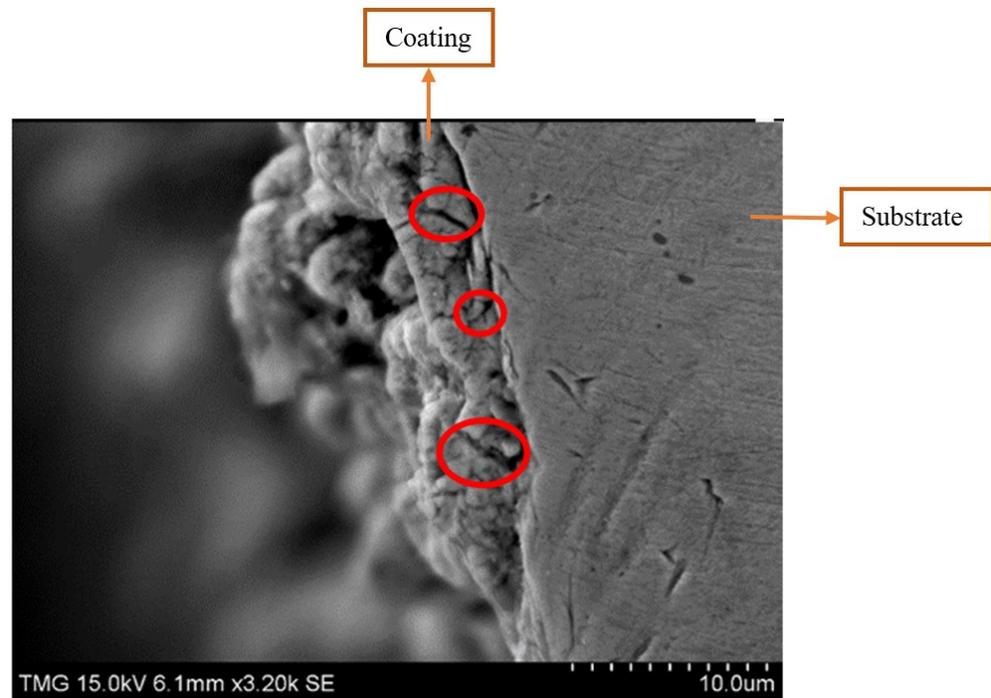
Figure 4-4 Cross sectional image of a sample where through thickness micro-cracks in the coating are visible

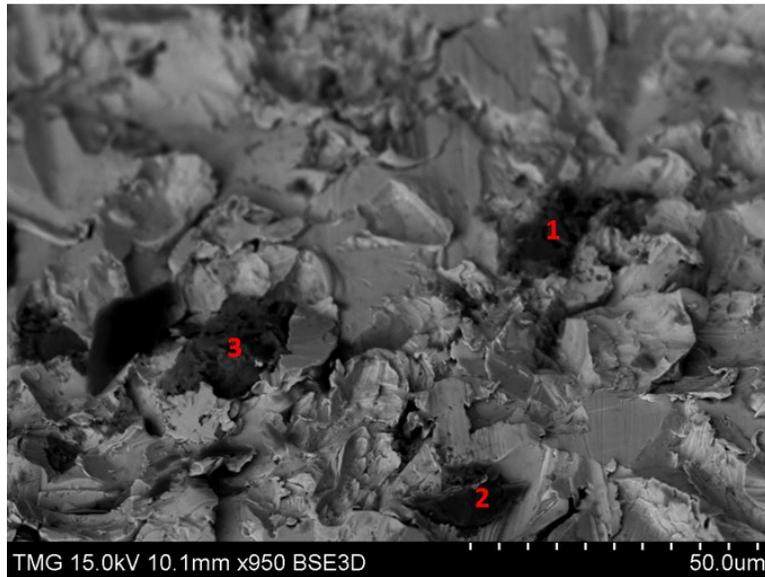
Figure 4-5 SEM micrograph at the notch of a sample after sandblasting showing 3 alumina residue particles marked for EDS and elemental analysis

The pre-plating sandblasting procedure created a uniform surface roughness on the samples but left noticeable alumina (Al_2O_3) residue. Figure 4-5 shows the SEM micrograph of the notch of a sandblasted sample with alumina residue particles on it and the elemental analysis spectra of spots marked as 1, 2 and 3 are shown in Figures 4-6, 4-7 and 4-8 respectively. The atomic percentages of the elements of each analysis are shown in Table 4-7 indicating the presence of alumina on specimen surface after sandblasting. Further, Figure 4-9 shows the low magnification SEM micrograph of the notched sample to better demonstrate the spread of sandblasting residue on the surface as well as the notch root of the sample.

Element	Spectrum 1 (%at)	Spectrum 2 (at%)	Spectrum 3 (at%)
Al	37.94	34.18	27.60
O	46.33	56.62	54.77
Fe	0.74	0.75	0.24
C	14.98	7.45	17.39

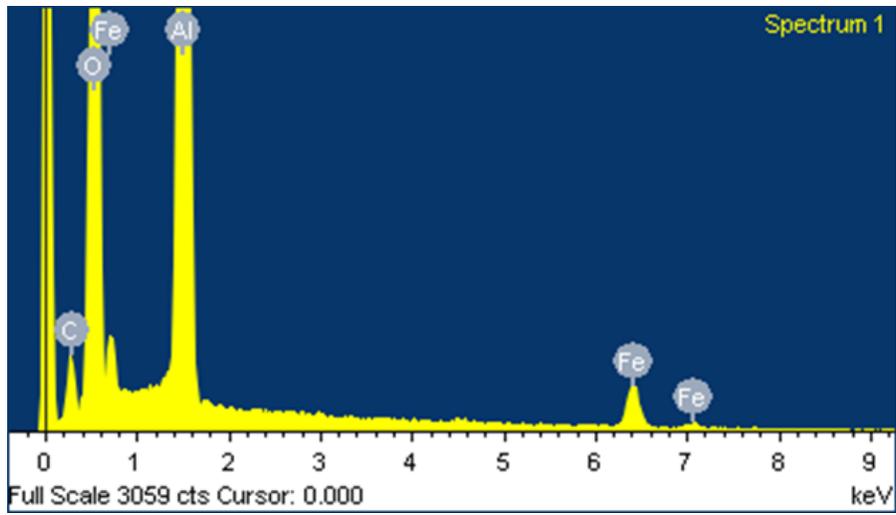
Figure 4-6 EDS analysis of particle 1 in figure 4-5

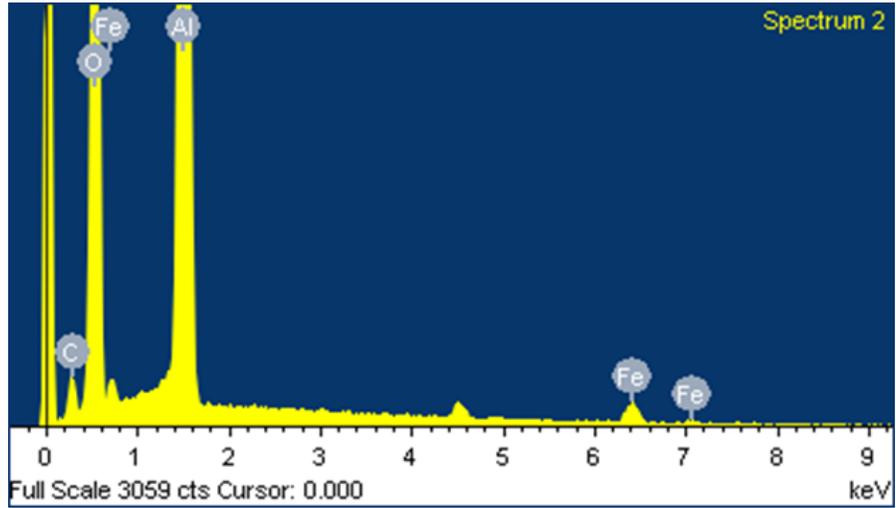
Figure 4-7 EDS analysis of particle 2 in figure 4-5

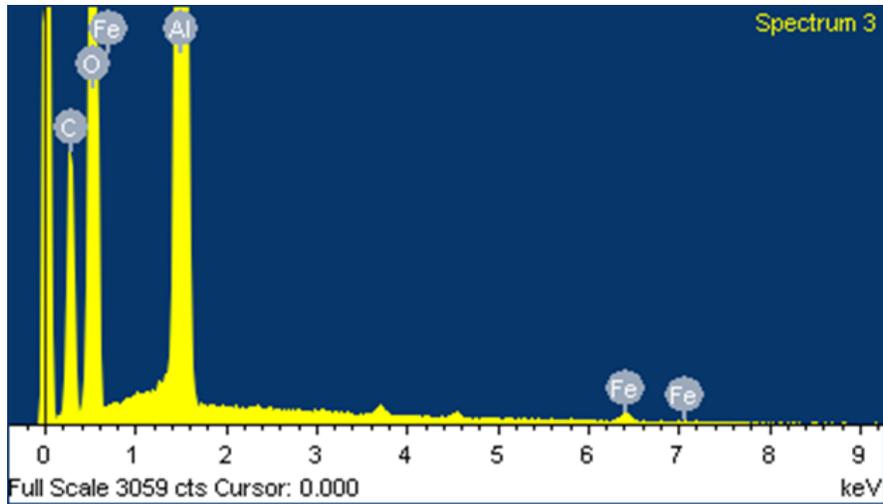
Figure 4-8 EDS analysis of particle 3 in figure 4-5

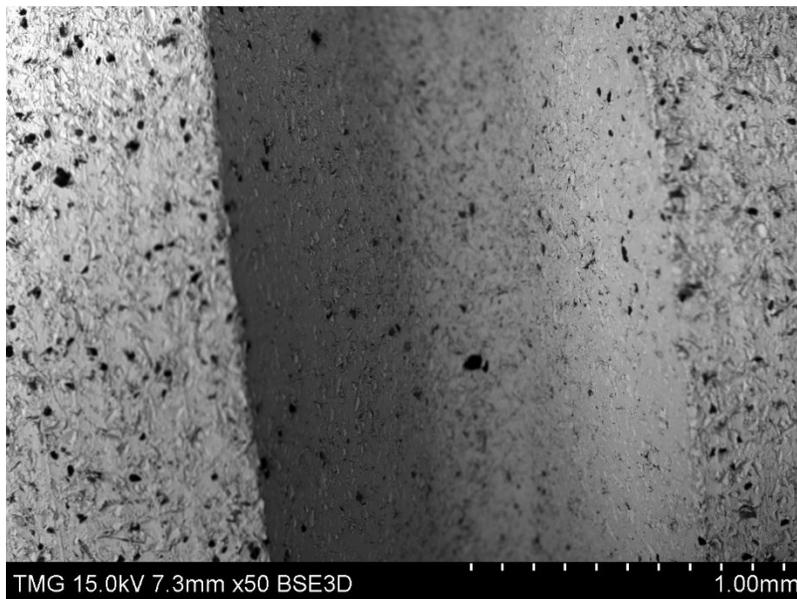
Figure 4-9 SEM image of the notch and surrounding areas of a sandblasted samples showing the visible residual alumina at low magnification

The substantial alumina residue on the samples suggests that the sandblasting might have been severe which could introduce surface defects that can facilitate fracture especially in a notched sample. This can be better demonstrated by observing the notch roots after SLT. Figure 4-10 shows the notch root images of a sandblasted sample prior to plating with visible cracks on it. Figure 4-11 shows the depth of the cracks on the notch root. Figure 4-12 shows the same sample with its coating stripped in which the cracks can still be seen on the notch. The stripping processing was done using ammonium hydroxide (NH_4OH) as the stripping solution and the sample was stress relieved at 190°C for 4 h to ensure that the cracks are not the result of residual stresses. Therefore, it can safely be concluded that sandblasting increases the risk of fracture during the SLT. Evidently, the adhesion of the coating is noticeably worse for the sample without sandblasting. Thus, the parameters of sandblasting should be optimized to mitigate the risk of failure as much as possible while also providing an adequate adhesion between the coating and the substrate. It is also possible to completely replace sandblasting with another surface preparation measure such as grinding with an abrasive as recommended in the literature [91].

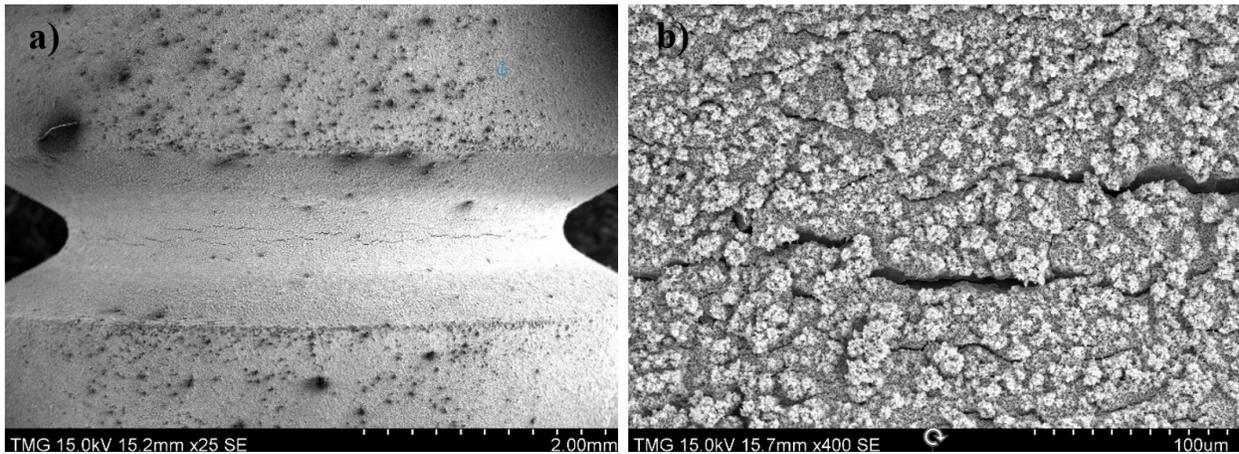
Figure 4-10 SEM image of the notch of a sandblasted sample plated with standard plating parameters after the end of the SLT showing a) the existence of cracks on the notch b) a higher magnification image to better show the presence of deep cracks

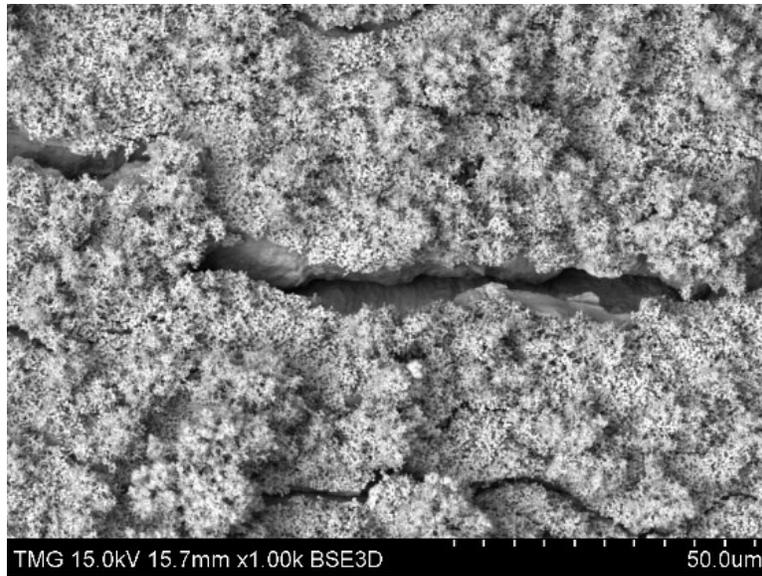
Figure 4-11 SEM image of the cracks in figure 4-10b demonstrating their depth

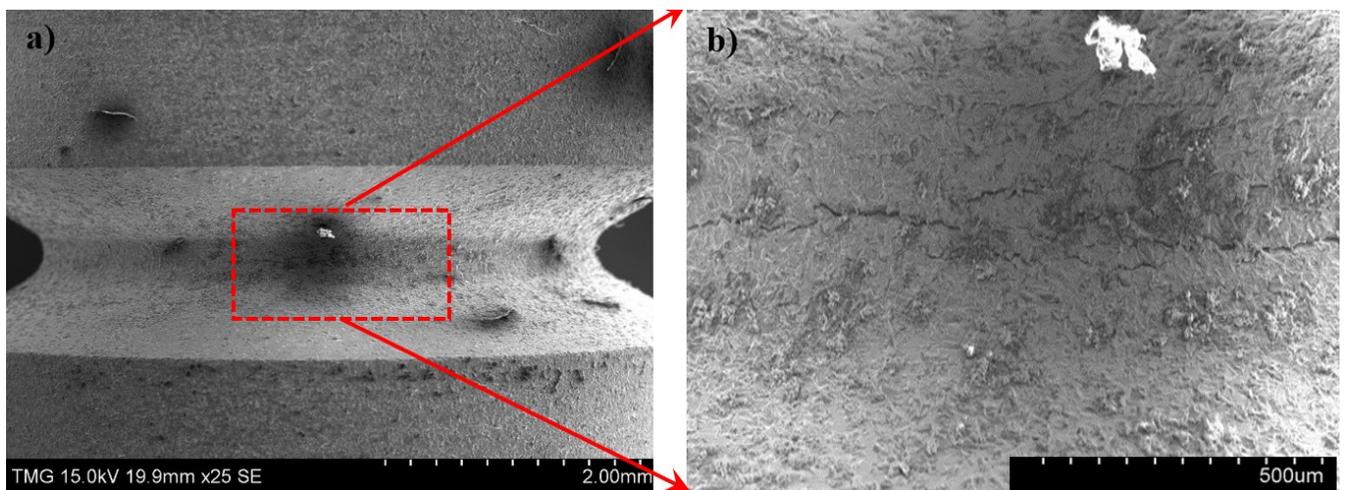
Figure 4-12 SEM image of the notch of the sample in Figure 4-10 after its coating was stripped showing a) the notch b) a higher magnification image of the notch to better show the cracks
