Analysis of the Hydrogen Embrittlement Susceptibility of Industrial Zn-Ni Brush Plating Process

A thesis

Mechanical, Industrial and Aerospace engineering

October 2022

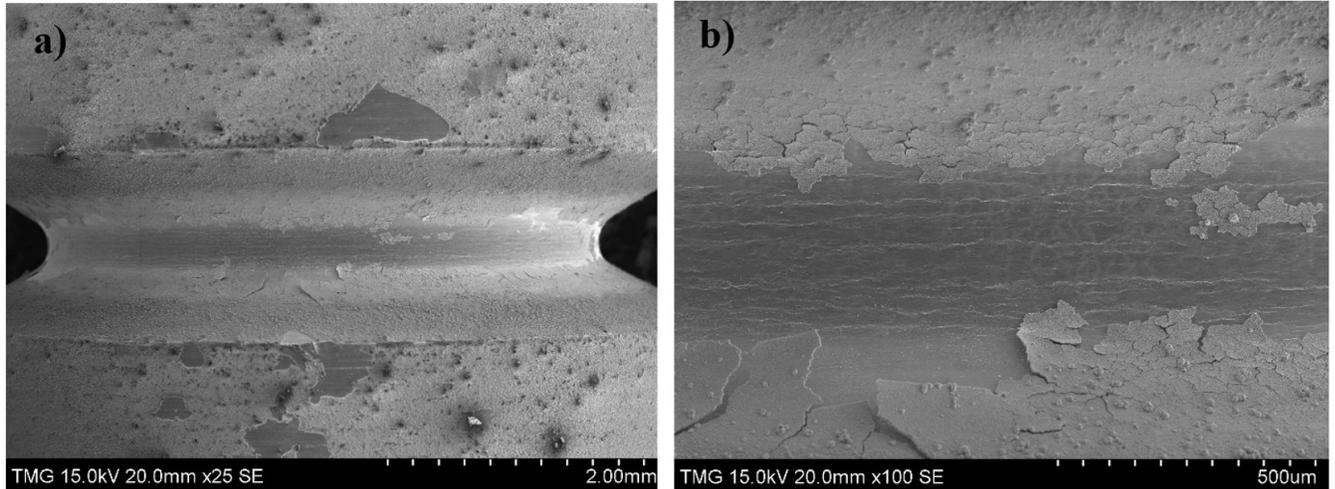
Figure 4-13 image of the notch of a sample without sandblasting and plated with standard plating parameters after the end of the SLT showing a) the notch b) a higher magnification image of the notch to better demonstrate the absence of cracks

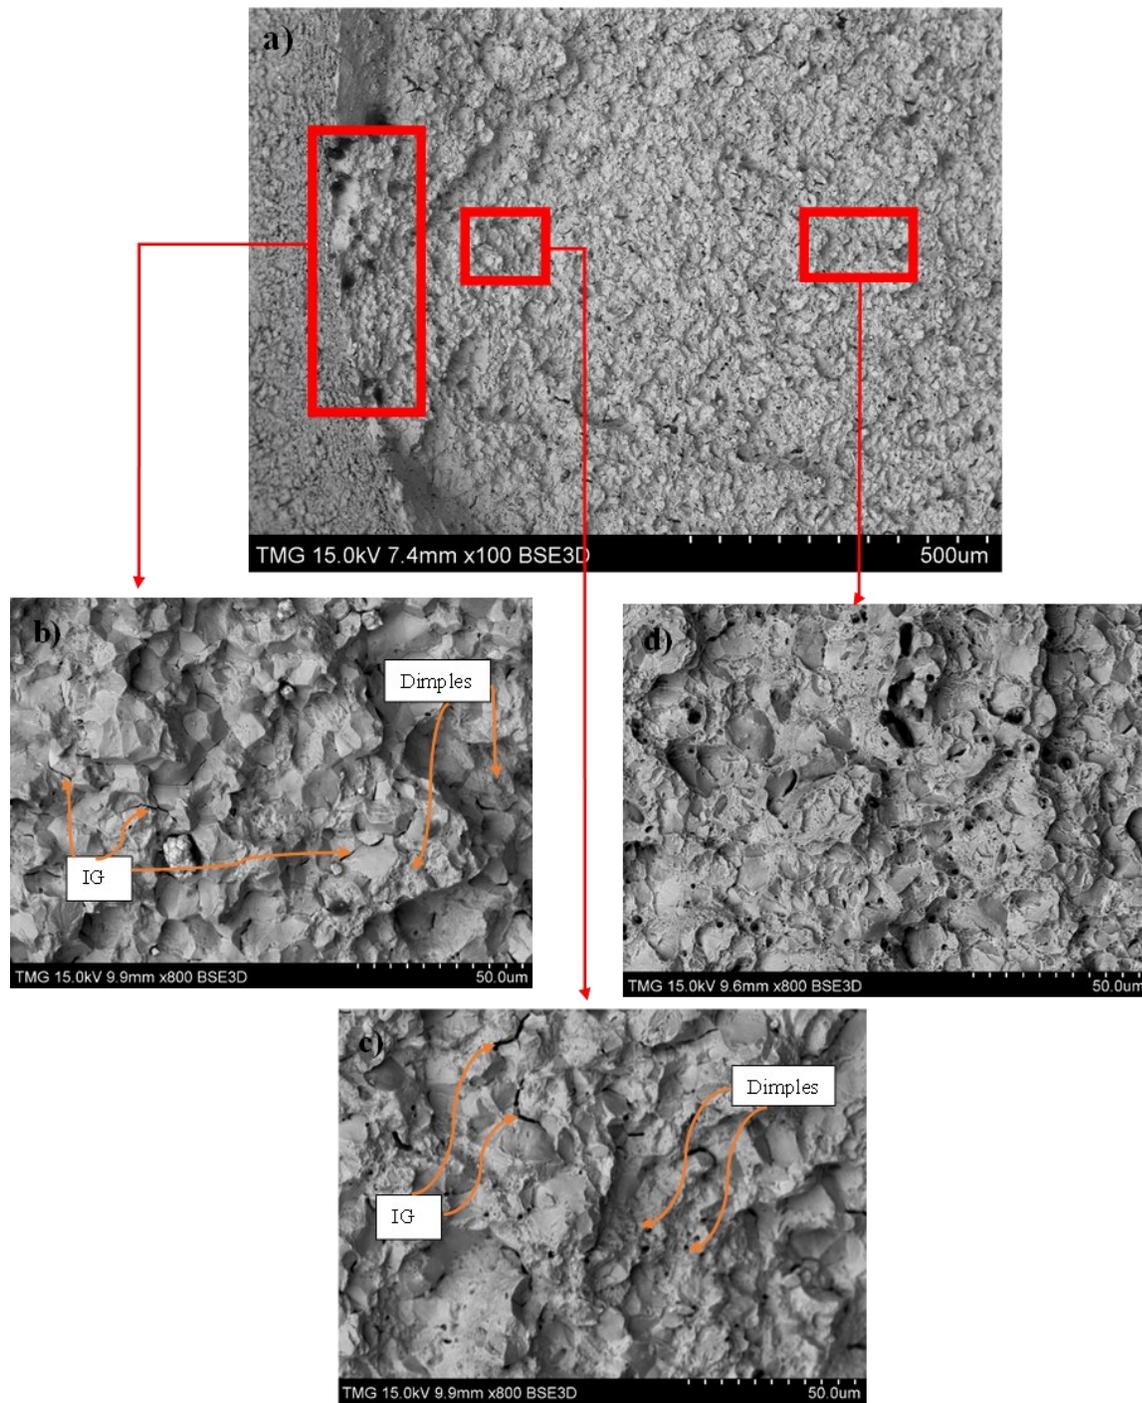
Figure 4-14 SEM image of the surface of the first fractured sample from Test 1 showing a) fracture initiation region on the edge of the surface b) intergranular fracture at fracture initiation region c) dimples and ductile features becoming more dominant away from the fracture initiation region d) ductile fracture features at the centre of the fracture surface

Fractography of the embrittled samples revealed a combination of ductile features in the form of dimples and micro-voids and brittle features in the form of intergranular fracture. Figure 4-14 shows SEM images of the fracture surface of one of the fractured samples that were plated under standard conditions without baking. At a low magnification, ridge patterns can be seen on the fracture surface of the specimen that converge towards the edge of the fracture surface (Figure 4-14a). This indicates the region from which the main crack must have initiated. Upon focusing on this area, intergranular fracture features were observed (Figure 4-14b). The presence of these intergranular features is a manifestation of the HEDE mechanism that was described in chapter 2. Dimples and micro-voids can also be seen alongside intergranular fracture. However, away from this fracture initiation region as shown in Figure 4-14c, dimples and surface features associated with ductility such as micro-voids begin to overtake the brittle intergranular fracture features. Further, towards the center of the fracture surface as shown in Figure 4-14d, the intergranular features completely disappear and fracture was dominated by dimples and micro-void coalescence. It should also be noted that intergranular features were not observed anywhere else on the surface and they were only seen in the crack initiation region at the edge of the fracture surface. This is expected considering that hydrogen content is higher at the interface of the coating and the substrate compared to the center of the specimen [92]. Thus, intergranular fracture is expected to occur at the edge rather than at the center.

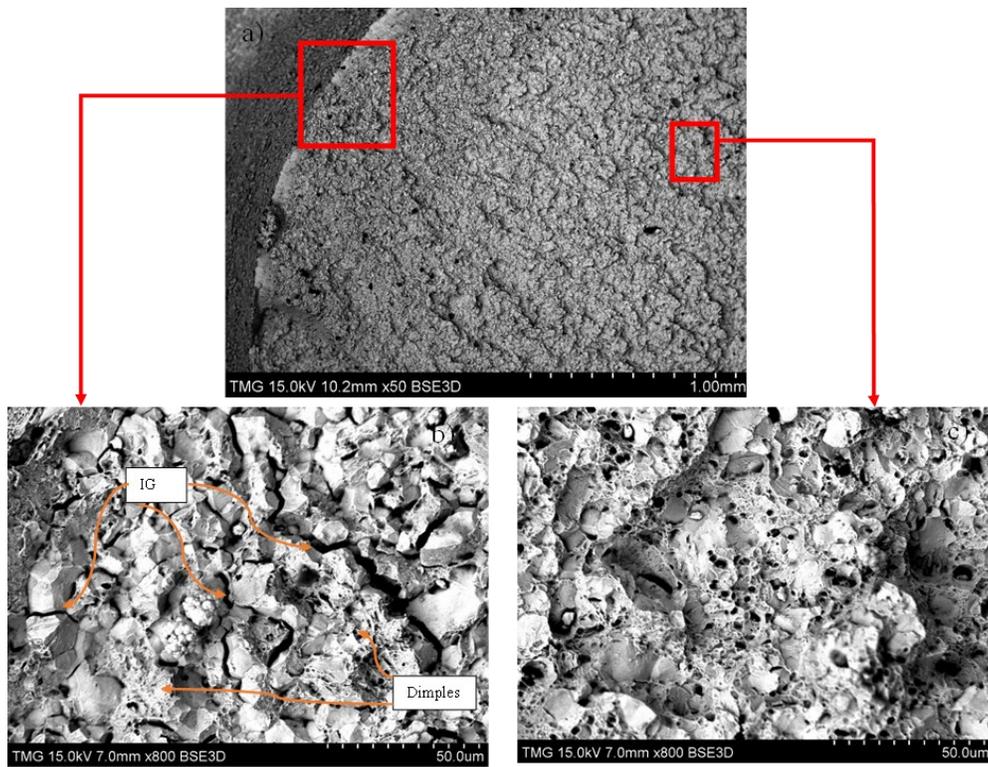
Figure 4-15 SEM images of the surface of the second fractured sample from Test 1 showing a) fracture initiation region on the edge of the surface b) intergranular fracture at fracture initiation region accompanied by dimples and voids c) ductile features away from the fracture initiation region

samples, it is noticeable that different samples have varying degrees of mixture of intergranular and ductile features in their fracture initiation regions. For example, the sample in Figure 4-17 has a visibly more mixed fracture initiation region compared to that in figure 4-14. However, all of these samples showed similar levels of embrittlement severity and they all failed very early in their SLT cycles. Therefore, the existence of more ductile features alongside intergranular features has no bearing on the severity of embrittlement and does not indicate less embrittlement. It must be noted that many HE mechanisms such as HELP, HESIV and AIDE manifest themselves in the form of dimples and micro-voids on the fracture surface as discussed in chapter 2 and work in synergy with each other [48,54,55]. Therefore, it is plausible to assume that fracture has occurred through a combination of HEDE and other HE mechanisms.

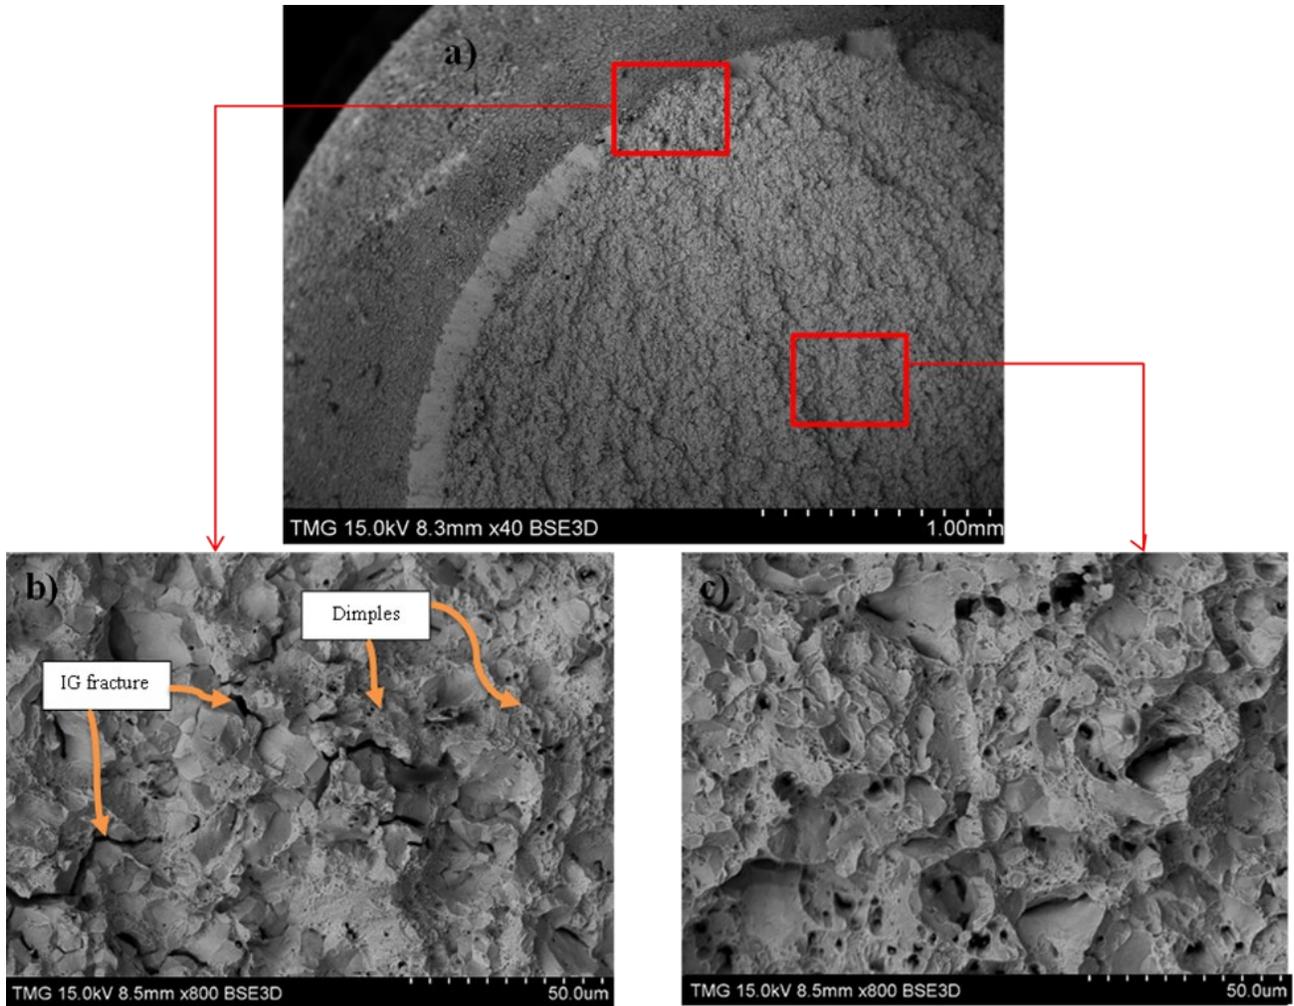
Figure 4-16 Fracture surface of the first fractured sample from Test 6 showing a) fracture initiation region on the edge of the surface b) intergranular features at fracture initiation region c) ductile fracture surface away from the fracture initiation region

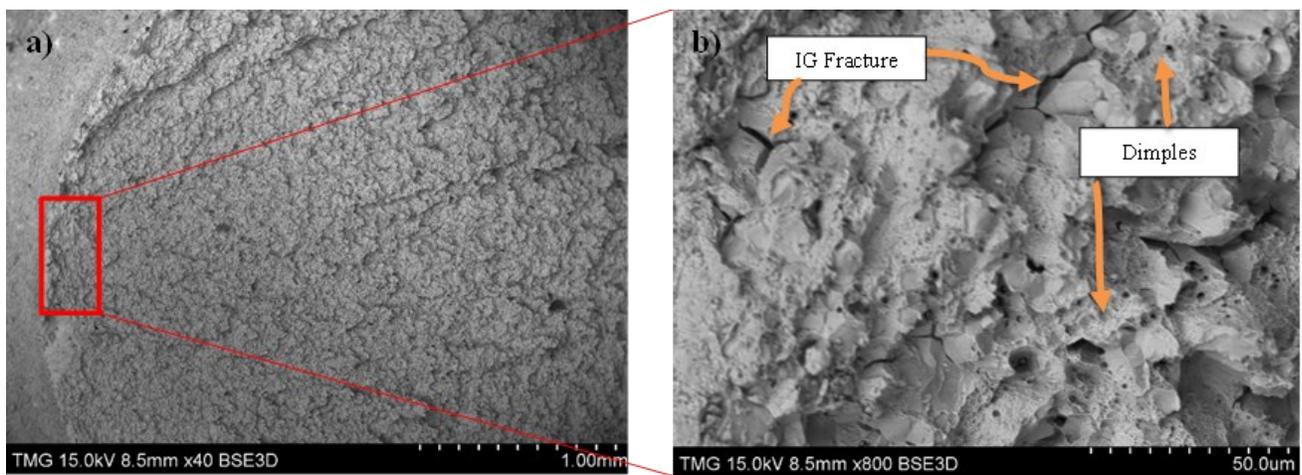
Figure 4-17 Fracture surface of the second fractured sample of Test 6 showing a) the fracture initiation region and b) the intergranular fracture alongside ductile dimples at the fracture initiation region

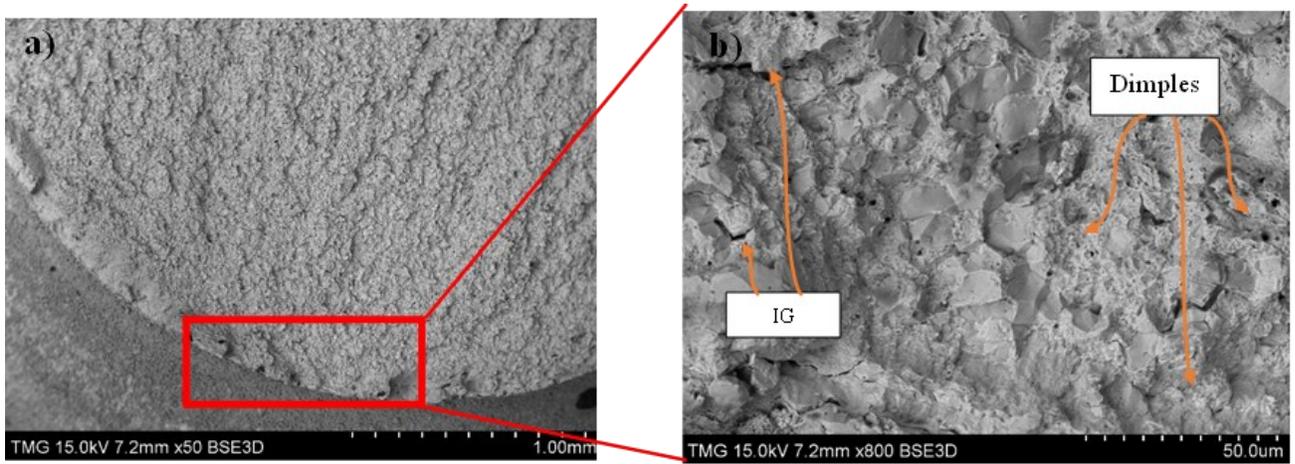
Figure 4-18 Fracture surface of the first fractured sample of Test 7 showing a) the fracture initiation region and b) the intergranular fracture alongside ductile dimples at the fracture initiation region

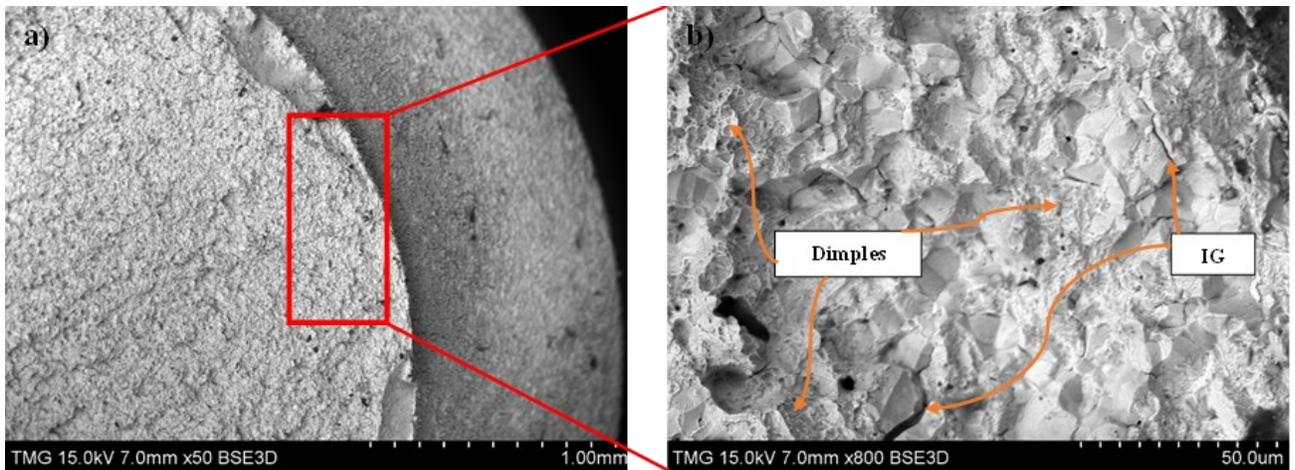
Figure 4-19 Fracture surface of the second fractured sample from Test 7 showing a) the fracture initiation region and b) the intergranular fracture alongside ductile dimples at the fracture initiation region
