**Geomorphological Assessment of the
Sedimentary Dynamics of the Sunday River, Quebec**

A Thesis
In
The Department
of
Geography, Planning and Environmental

Presented in Partial Fulfillment of the Requirements
for the Degree of Master of Sciences (Geography, Urban and Environmental Studies) at
Concordia University,
Montreal, Quebec, Canada

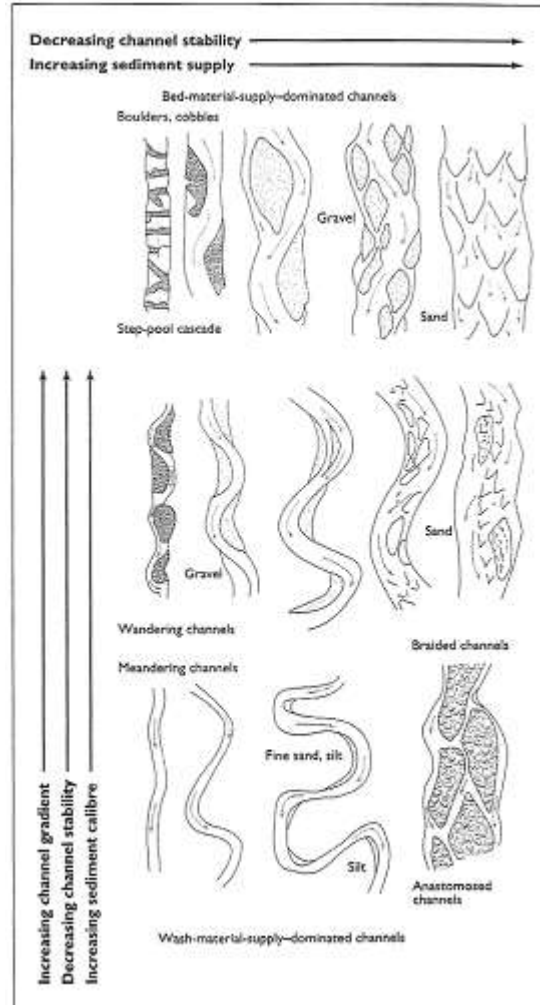
Figure 2.2 Channel patterns and their relations to slope, sediment size, sediment load and resulting stability. From Trenhaile (2007), based on Church (1992).

The mutual adjustments and variations between variables such as slope, sediment supply, discharge, grain size and bank stability lead to varying channel patterns which are adjusted to the characteristics of their physical environment and (local) climate. This results in identifiable 'equilibrium' channel patterns, several of which are represented in Figure 2.2.

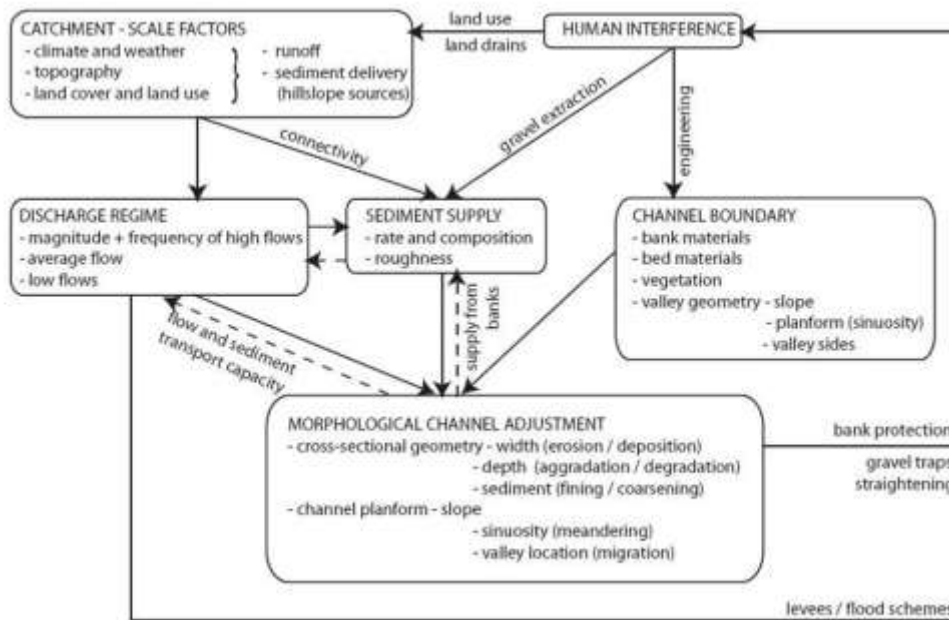
Figure 2.4 Linkages between factors influencing channel morphology showing the impact of human interference (from Raven et al. 2010).

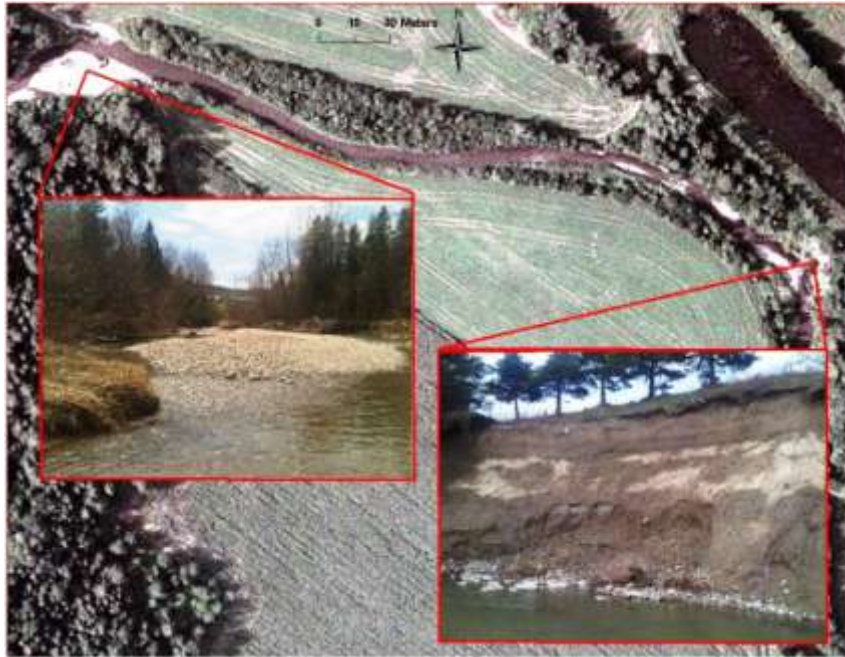
Figure 4.2 Problematic mid-channel bar and eroding bank, downstream Sunday River

Estimates of volume of eroded material were generated for the steep bank below the artificial lake (Figure 4.2). Figure 5.15 shows the extent of the erosion of this bank between 2009 and 2011.

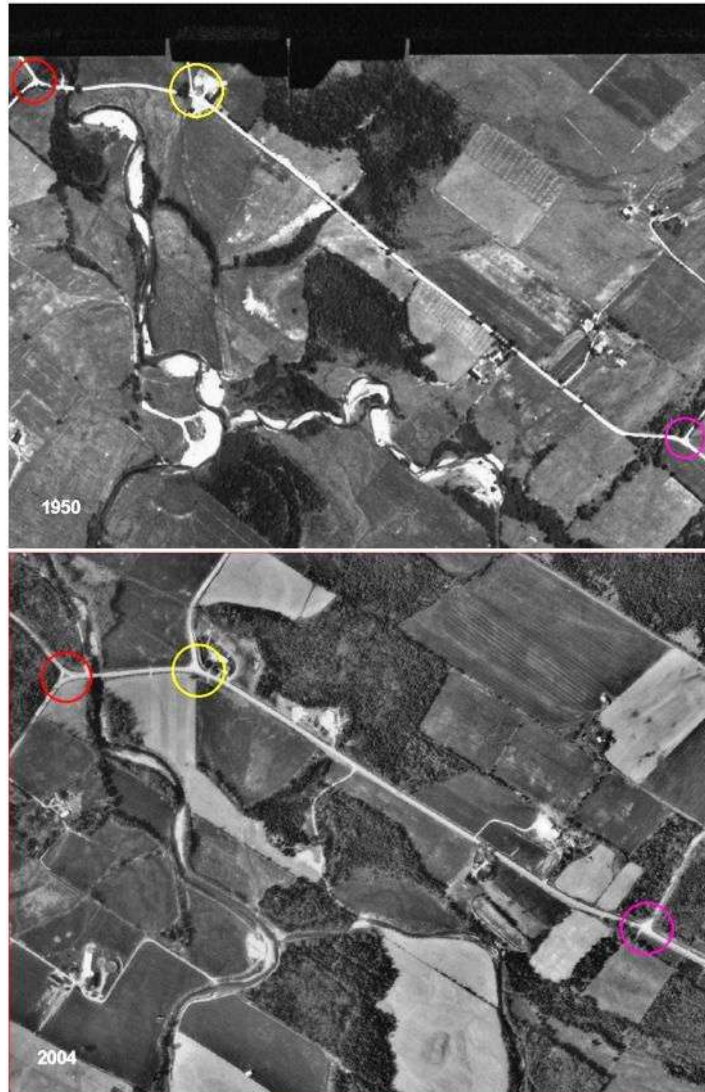
Figure 4.4 Aerial photographs from 1950 and 2004 showing georeferencing targets.

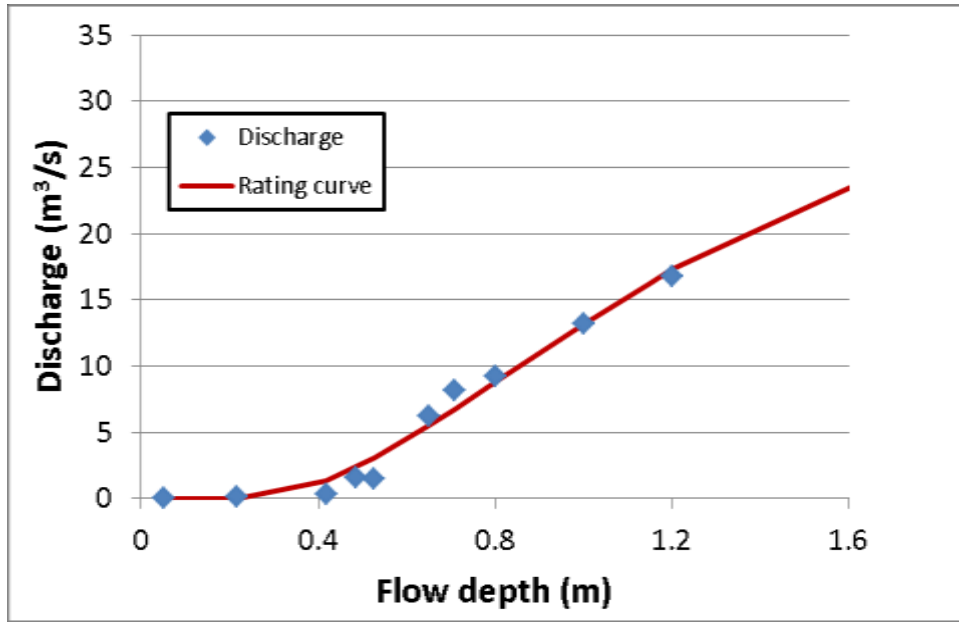
Figure 4.6. Rating curve at Station 1 on the Sunday River.

where Y is flow depth and Q is discharge (Figure 4.6)

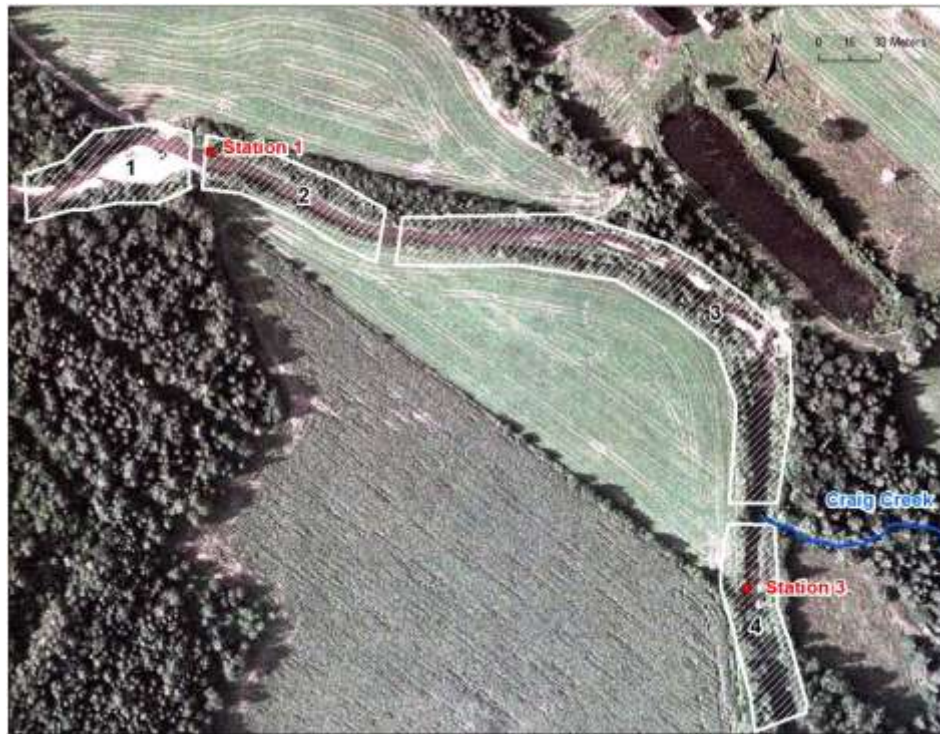
Figure 4.7 Sediment zones in model reach

The Wolman method (Wolman 1954) was employed with random sampling at evenly spaced cross-sections (spacing was determined using a standard GPS). Sediment samples were analyzed in each cross section by picking up whatever sediment happened to be directly under the big toe as one meter footsteps were taken perpendicular to the longitudinal axis of the channel. A total of 719 sediment samples were collected on the channel bed and bar surfaces of the Sunday River. Of these, 379 were collected in the 500m study reach; the data was grouped into 4 discrete zones to facilitate its use in the sediment modeling module of HEC-RAS (Figure 4.7).

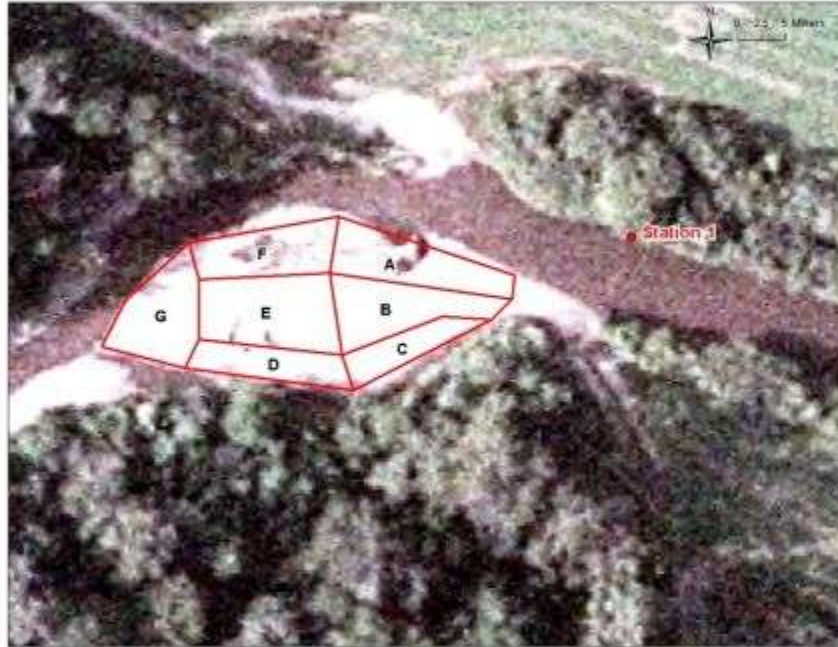
Figure 4.8 Mid-channel bar sediment zones

Another 237 were collected from the surface of the mid-channel bar itself. Additionally, sediment samples of the sub-surface of the mid-channel bar were collected in order to analyze differences in sediment size distribution due to bed armouring. In total, 19.14 kg of sediment were acquired from 7 sections of the bar (Figure 4.8).

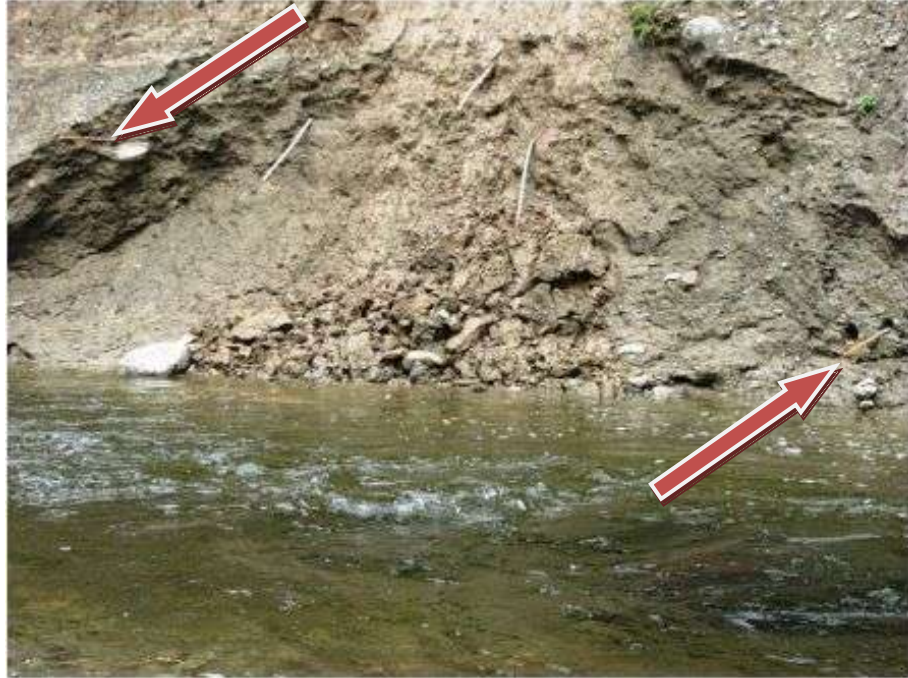
Figure 4.9 Erosion pins after one or more bank failures. Note the orange pins to the left and right of the 3 mangled pins in the center of the photograph. This photo is of a lower section of the bank in Figure 4.2.

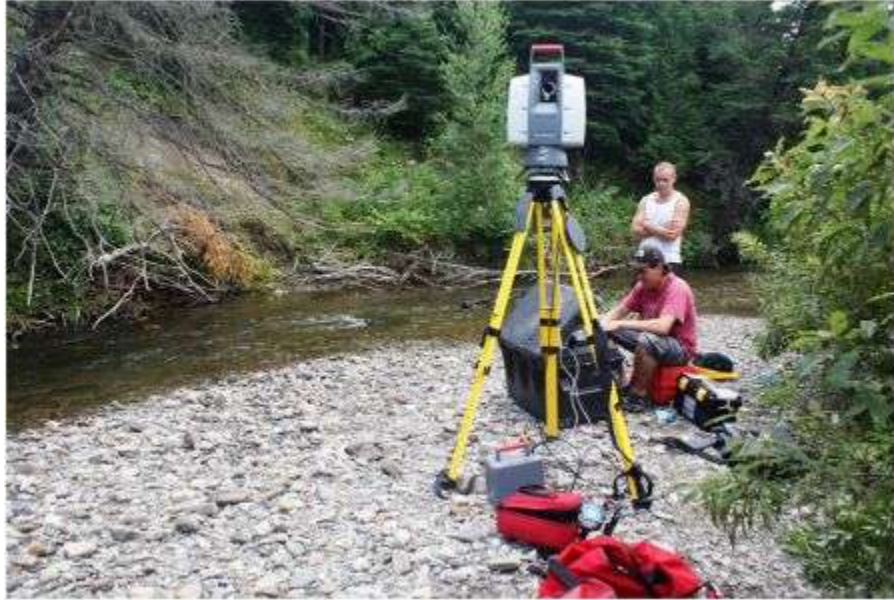
Figure 4.10 Leica Scan Station 2 in operation on the Sunday River.

This bank was ultimately analyzed using a Leica Scan Station 2 terrestrial laser scanner (TLS), otherwise known as ground LIDAR (Figure 4.10). A second site was also investigated using TLS. The second site is a series of two meanders (one wavelength) where the Sunday River borders a saw mill. Mill workers allege that the banks here erode an average of “a foot or two” per year. These banks are characterized by what is predominantly coarse sediment. The sites were surveyed twice in 2009, once in August and again in November. At the first site (Figures 4.2 & 4.9), another survey was also taken in June 2010.

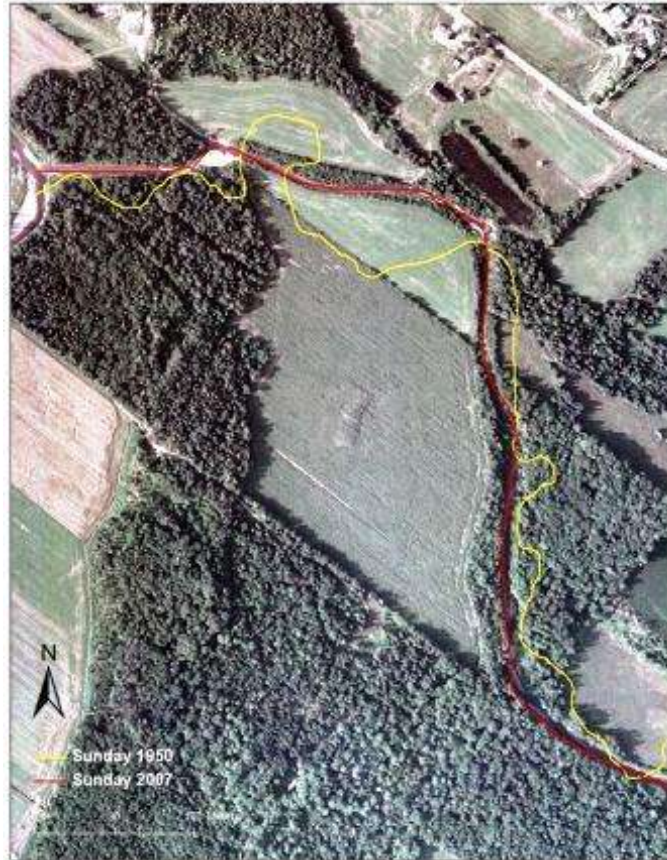
Figure 5.3 Channel paths in 1950 and 2007 overlaid on a satellite image from 2007. The channel has been displaced up to 100 meters in the downstream most reach.

Figure 5.3 shows the earliest (1950) and most recent (2007) channel paths measured from aerial images that were available for study. One can easily see the development of a meander bend around a mid-channel bar at the top of the image. According to the accounts of local farmers, the meander bend re-establishes itself within the span of 2-3 years after re-linearization by means of removal of the bar.

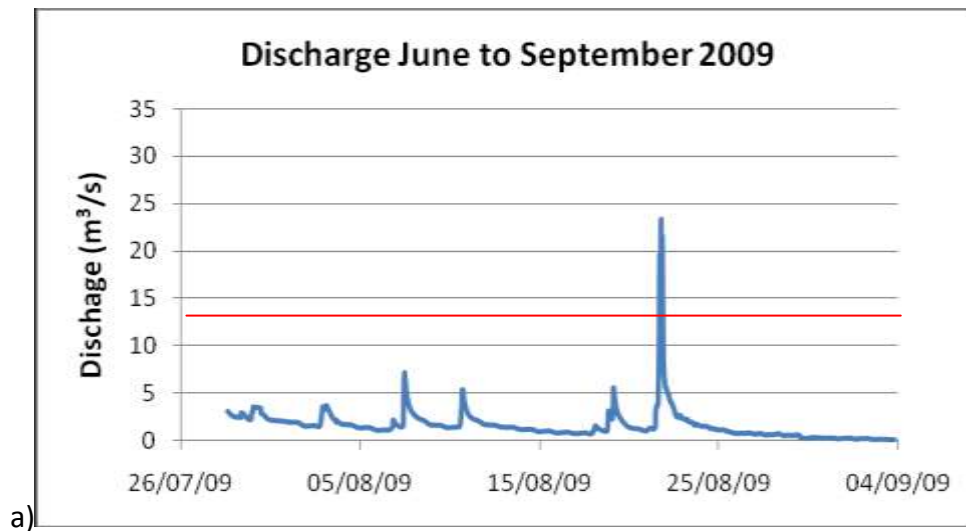
Figure 5.5 Hydrographs showing discharge measured at Station 1 for a) June through September 2009 and b) June 2010 through May 2011. The red lines indicate the bank full stage while the orange circle in b) demarks the estimated 50-year recurrence flood that occurred in late April 2011.

During the study period, discharge (as computed from the rating curve (equation 4.2)) varied between $0.02 \text{ m}^3/\text{s}$ and $30.2 \text{ m}^3/\text{s}$ (Figure 5.5). It should be noted that there is a higher level of uncertainty associated with estimated discharges above bankfull (approximately $14.7 \text{ m}^3/\text{s}$) as this is the upper limit of the dataset used to generate the

rating curve. The maximum discharge occurred on April 28, 2011 and corresponded to a water level at Station 1 of 2.1 m above the bed, approximately 0.9 m above bankfull level. Although no historical discharge data exist to confirm it, it is estimated, based on the recollections of local farmers, that the recurrence interval of a flood of this magnitude is approximately 50 years. The estimated bankfull discharge of $14.7 \text{ m}^3/\text{s}$, corresponding to a water surface elevation of 212.5m, was attained or exceeded once in August 2009 and three times during the spring of 2011 (once in March, twice in April). Thus, it is theorized that there were several events capable of transporting significant amounts of bedload sediments during the study period.

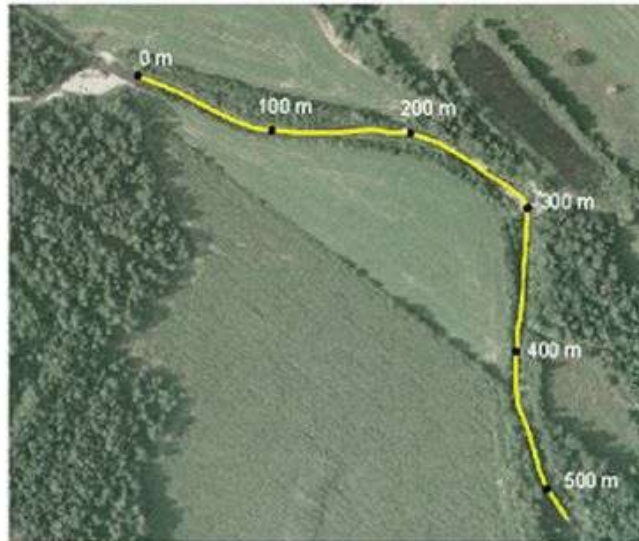
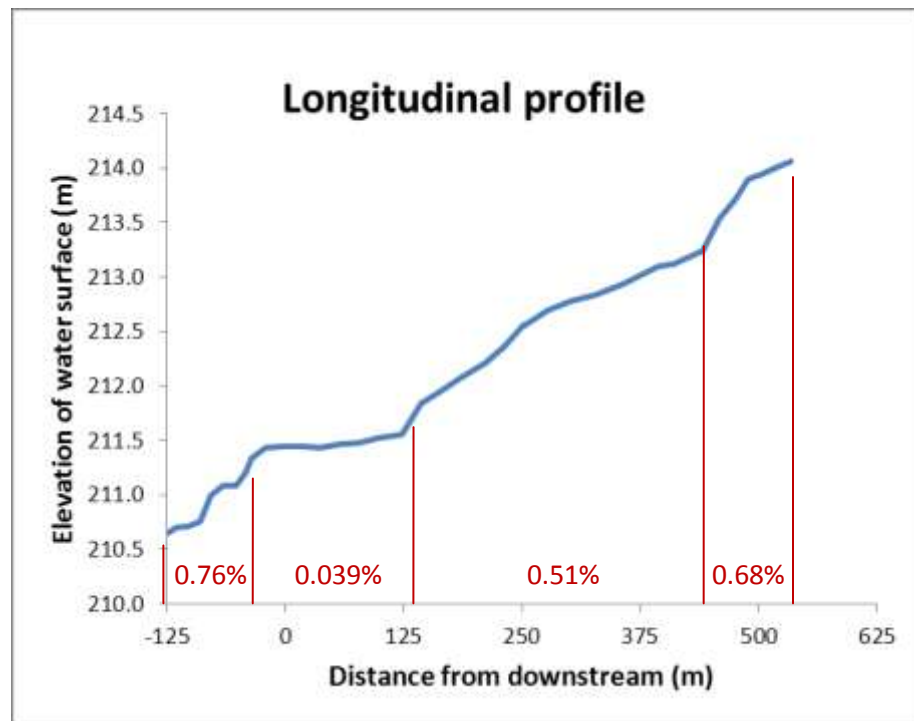
Figure 5.6 Longitudinal profile of the study reach of the Sunday River. Distance is measured from station 1 (which corresponds to 0 on Figure 5.6 a). The four slope zones in b) are presented in Figure 5.7.

The upstream end of the point bar acts as a sort of damn, holding back water at its upstream limit. As the water flows around the bar, a narrow channel incises itself somewhat, creating the steep slope. However, as was observed in the field, it is theorized that at higher flows nearing bankfull level water flows around and over the bar, resulting in a lower and more uniform slope throughout the two downstream-most slope zones (Figure 5.6 and 5.7).

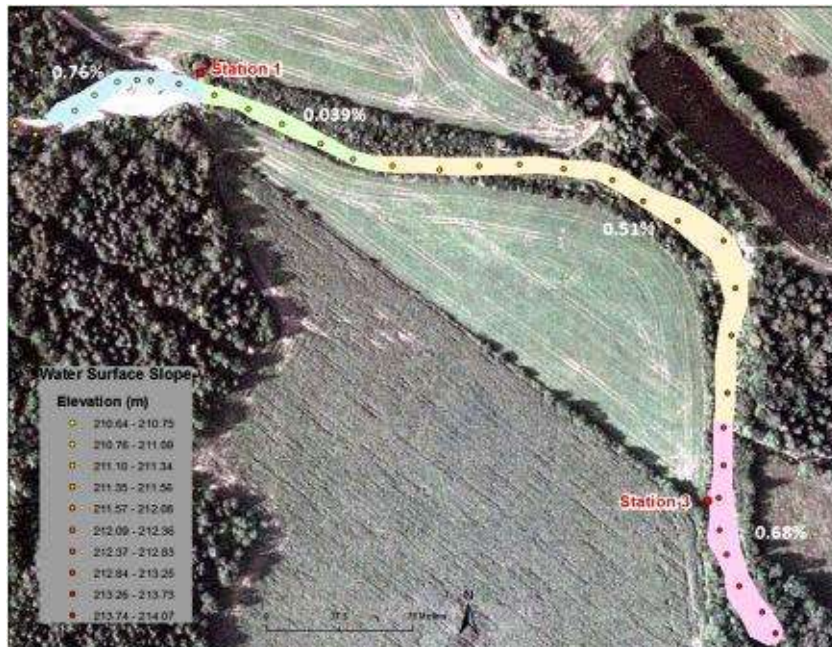
Figure 5.7 Study reach with water surface elevation points measured November 7th 2010 (which corresponds to the medium discharge) for the four slope zones (see Figure 5.6).

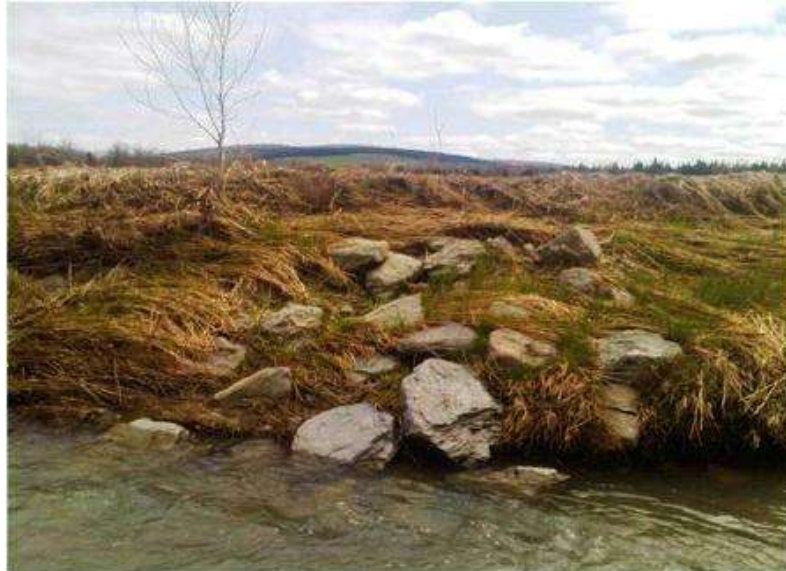
Figure 5.11 Rip Rap as bank fortification on the left bank in zone 2.

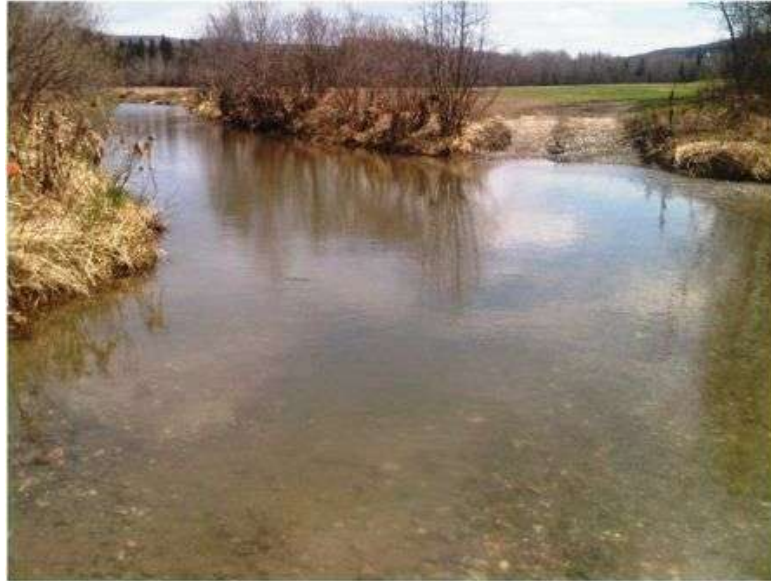
Figure 5.12 Tractor crossing as seen from the right bank immediately upstream of the mid channel bar.

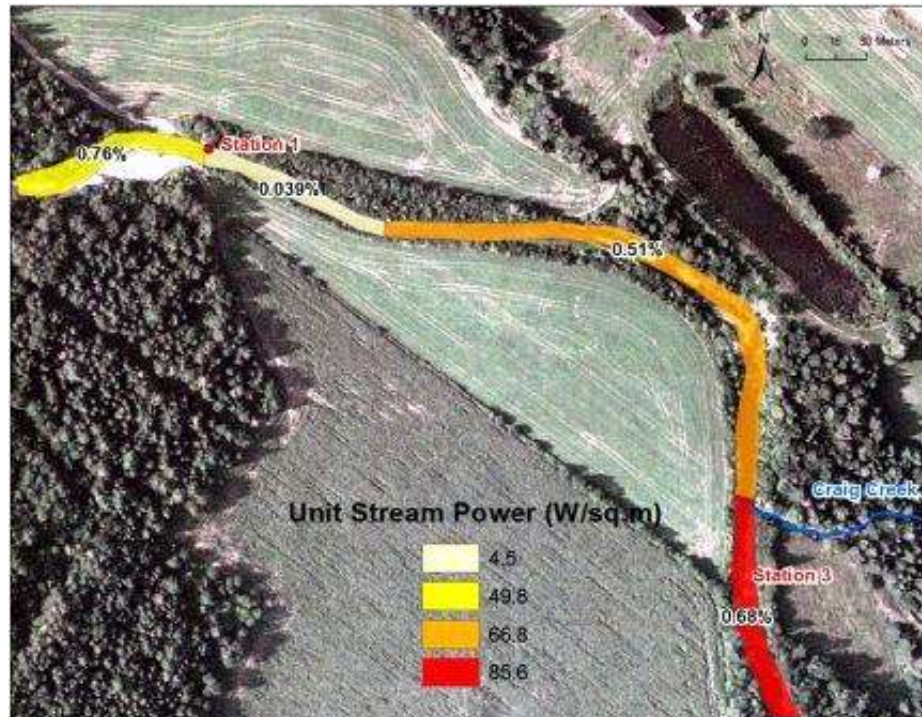
Figure 5.13 Unit stream power at bankfull stage ($14.7 \text{ m}^3/\text{s}$) in the study reach, calculated using zone averaged width and water surface slope (indicated for each zone).

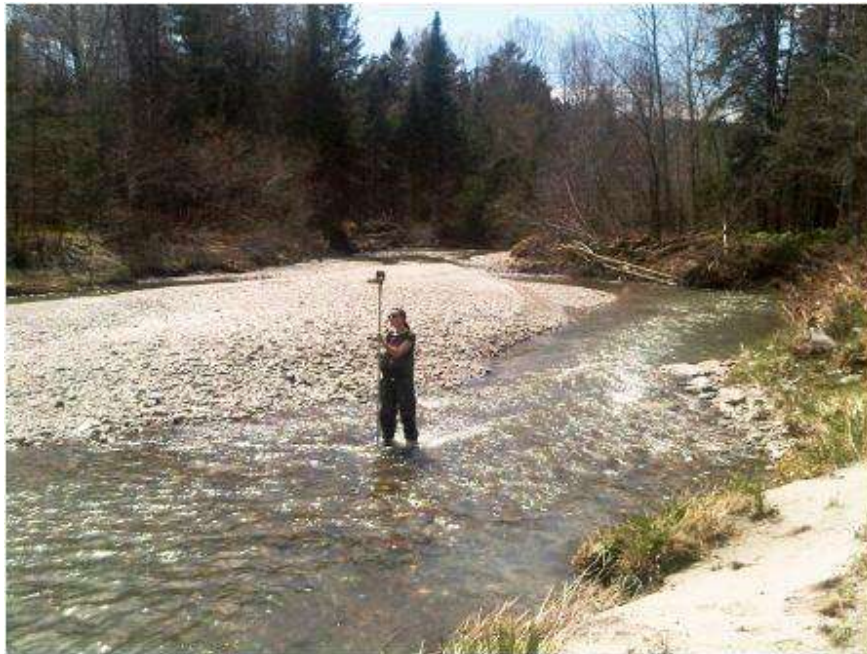
Figure 5.14 The mid-channel bar in the downstream portion of the study reach, sediment zone 1 (Figure 4.7). Note the re-meandering trend in the channel downstream of the bar. It is possible that the large boulders to the right of the riffle section were intentionally placed as rip rap.

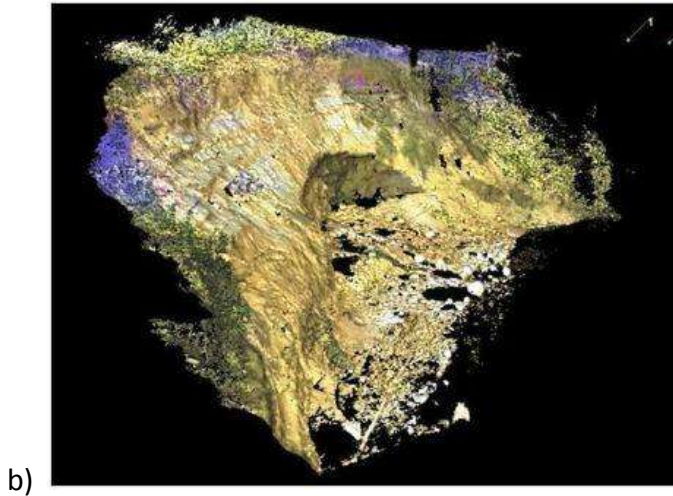
Figure 5.16 Side view of the lidar generated point cloud in a) 2009 and b) 2010 of the bank in Figure 5.15 with vegetation removed, looking upstream from the right bank.

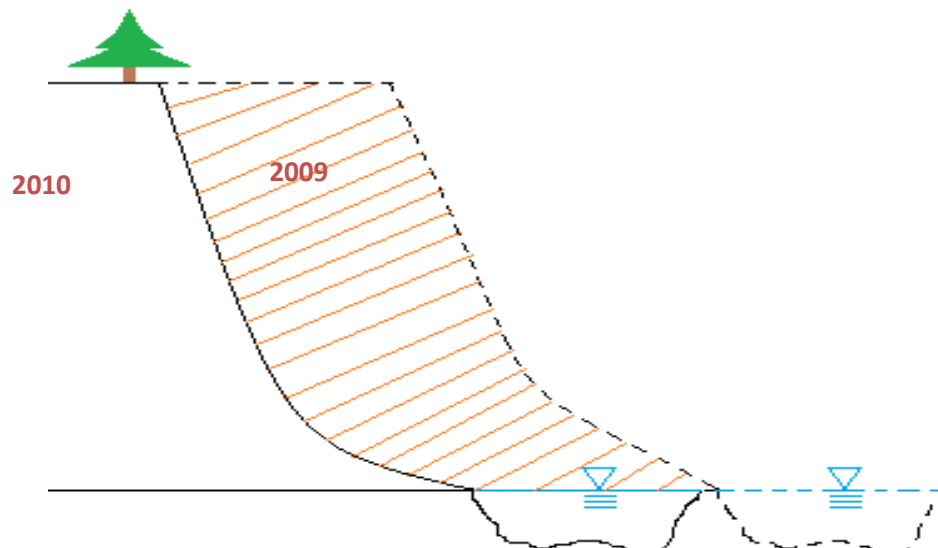
Figure 5.17 Schematic representation of the bank regression for the bank shown in Figure 5.15.

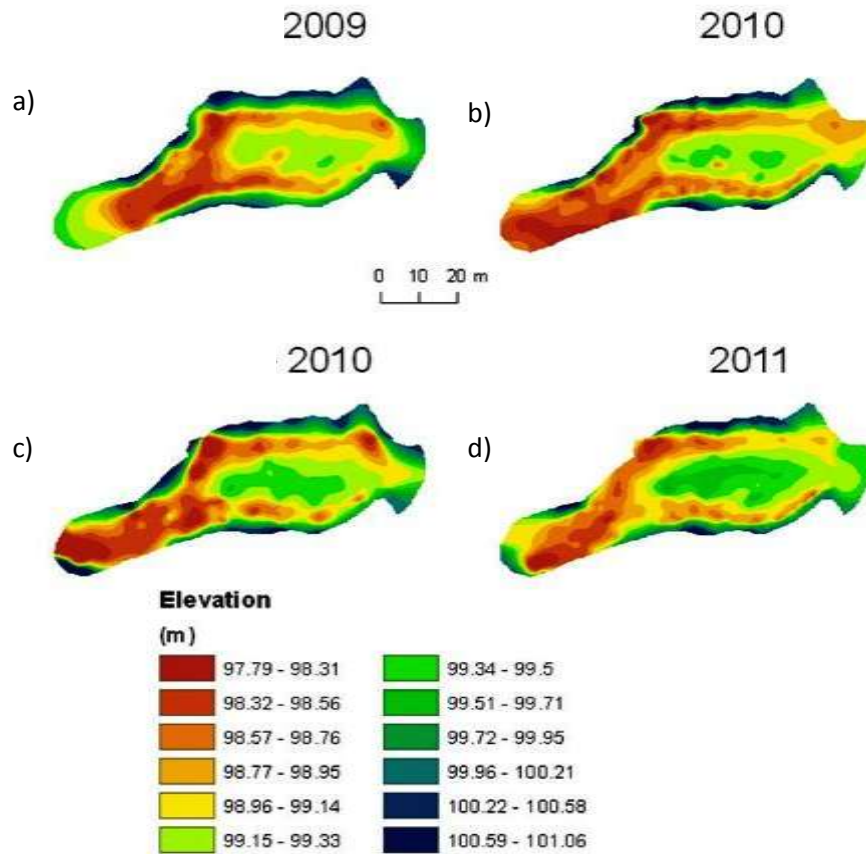
Figure 5.18 DEMs of the mid channel bar generated from topographic data acquired a) July 14 2009, b) June 4 2010, c) November 7 2010 and d) May 12 2011.

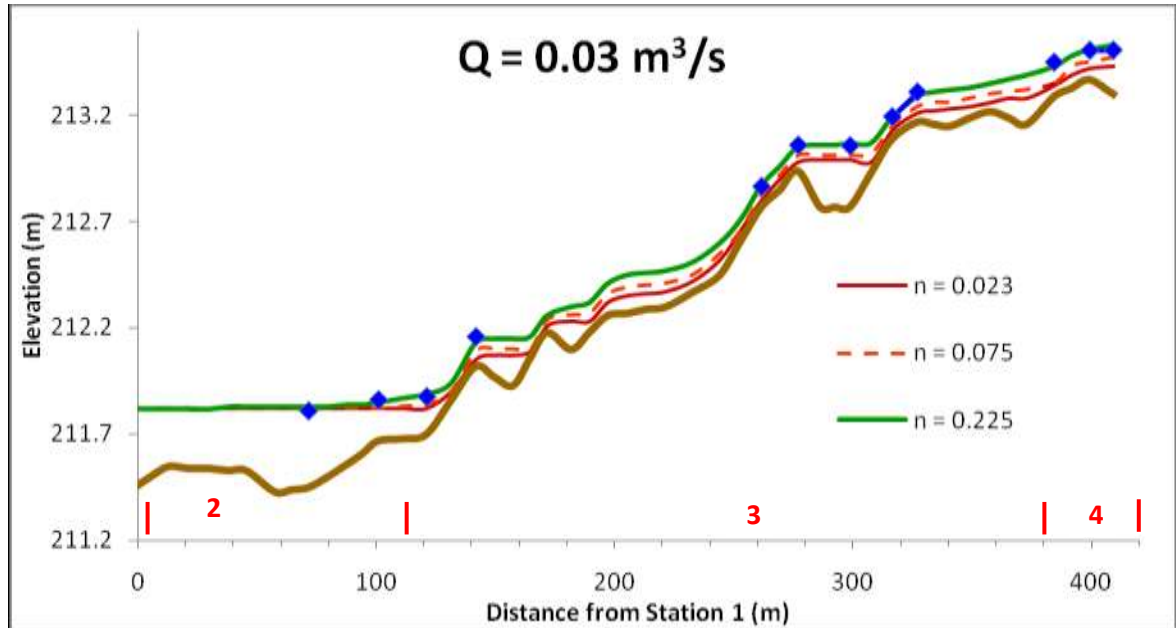
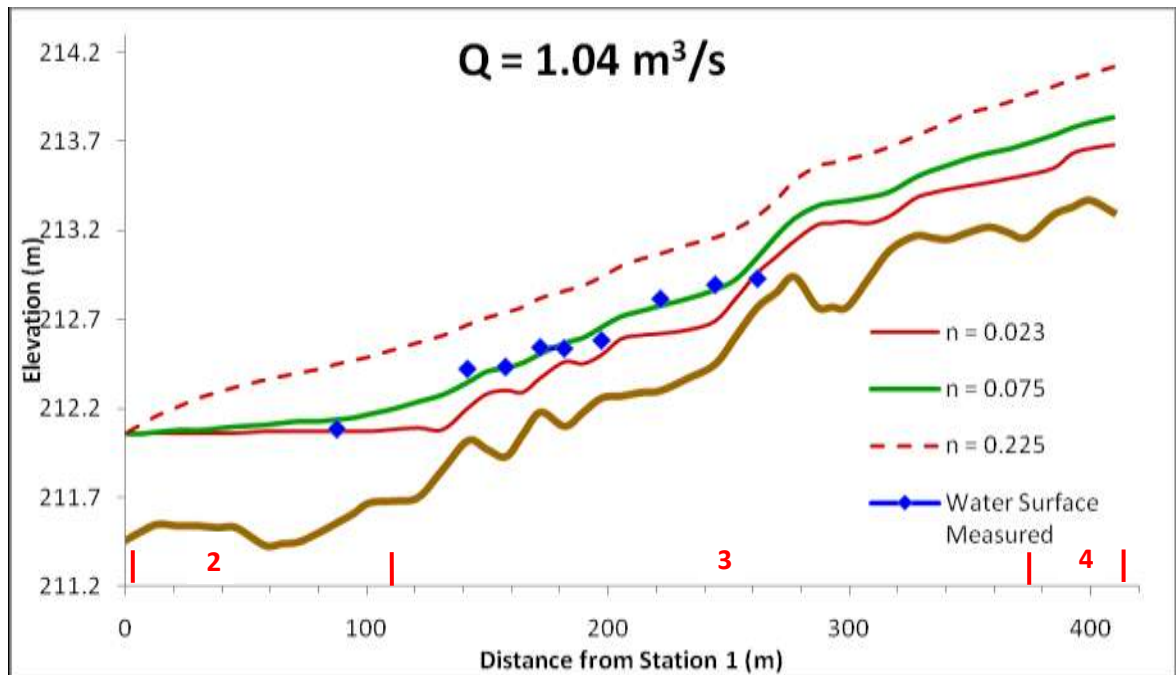
Figure 5.20 Comparison of water surface profiles as modelled by HEC-RAS for a) low flow as measured August 20 2010 and b) medium flow as measured May 12 2011, at varying Manning's n values. The n values which generate a water surface slope closest to the field measurements is indicated as a thick green line in each case. The zones (Figure 5.7) are represented in red at the bottom of the graphs.

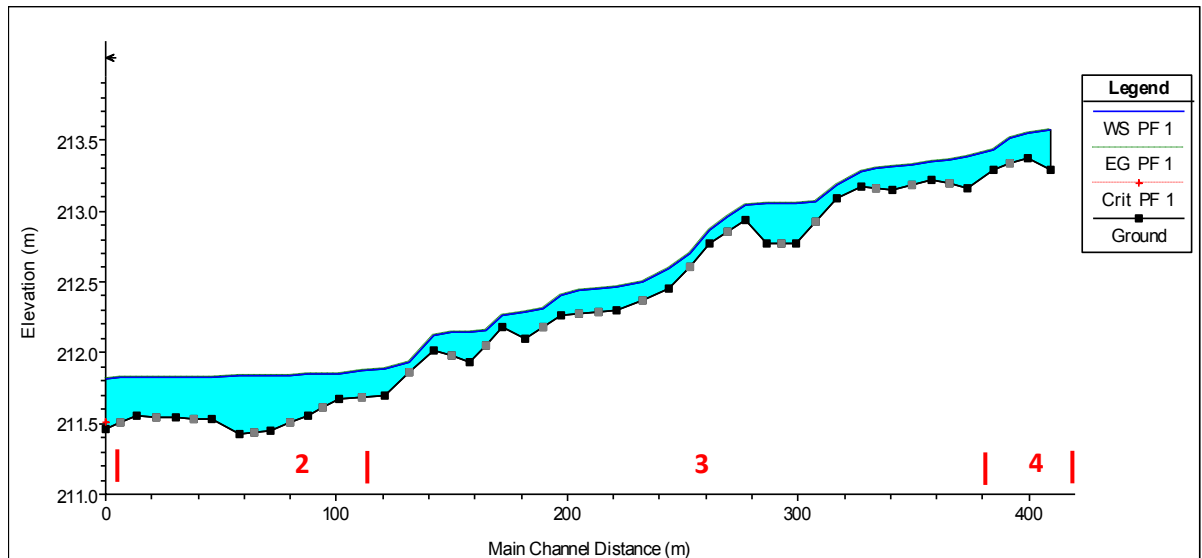
Figure 5.21 Water surface profiles generated by HEC-RAS for discharges recorded on a) August 20 2010 ($0.03 \text{ m}^3/\text{s}$), b) May 12 2011 ($1.04 \text{ m}^3/\text{s}$) and c) Nov 5 2010 ($6.24 \text{ m}^3/\text{s}$). The extent of slope zones 2, 3 and 4, (Figure 5.7) are indicated in red above the x-axis. Main channel distance is measured from Station 1 (Figure 4.10).

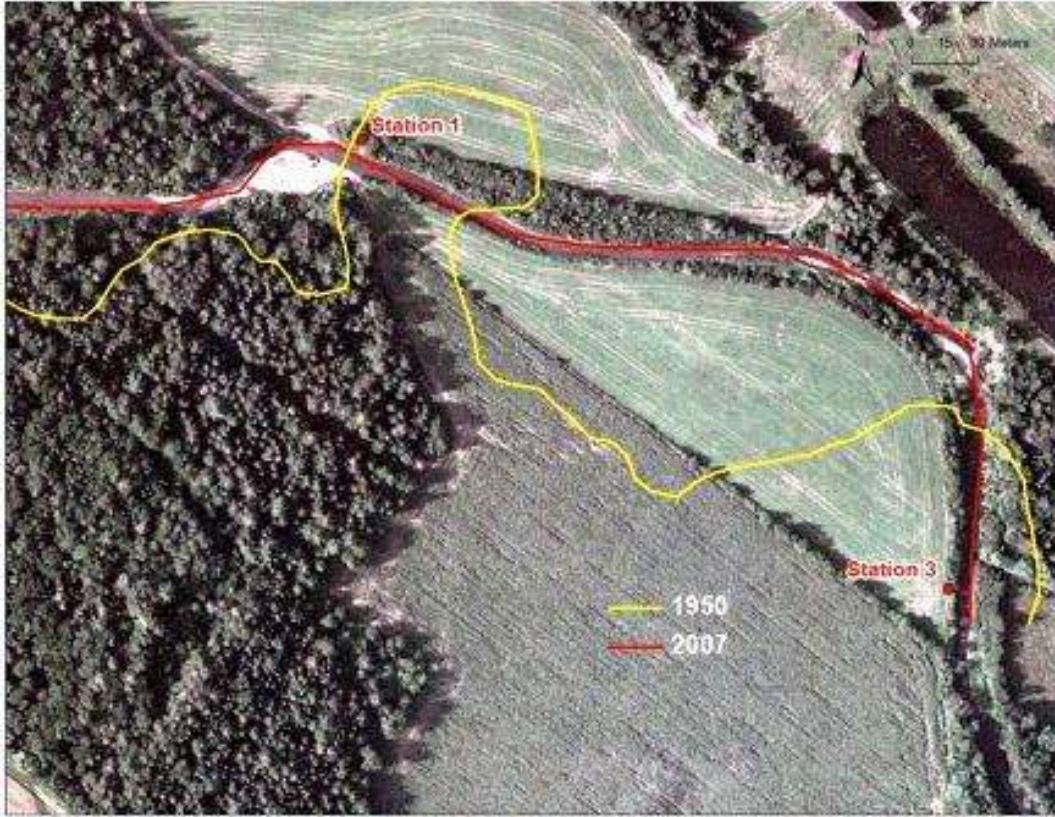
Figure 5.22 Model reach with channel path in 1950 and 2007.

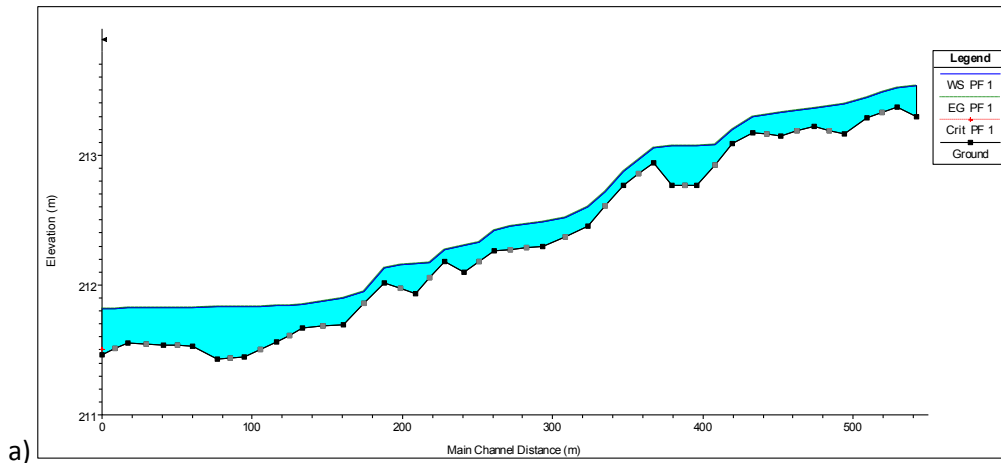
Figure 5.23 HEC-RAS profile plots for discharges of a) $0.03 \text{ m}^3/\text{s}$, b) $1.04 \text{ m}^3/\text{s}$ and c) $6.24 \text{ m}^3/\text{s}$ where channel length has been increased to approximate that from 1950.

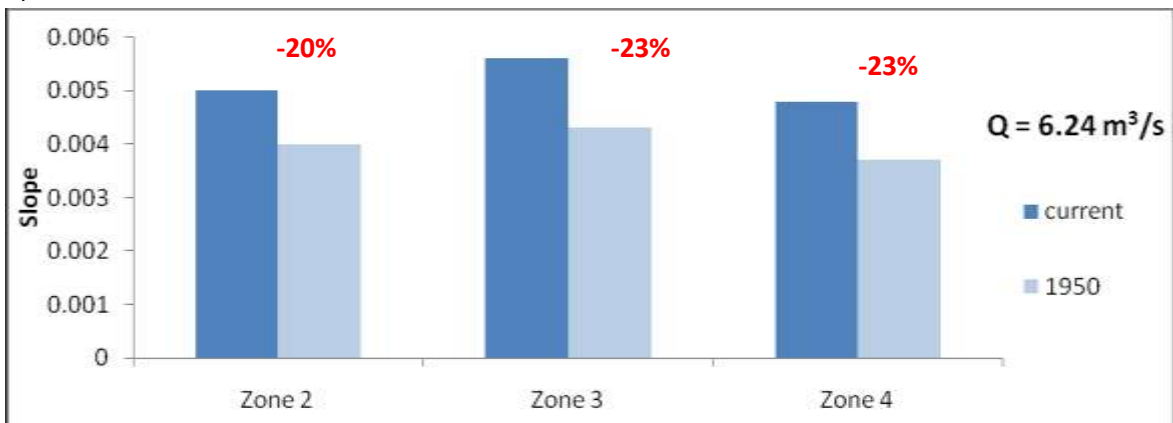
Figure 5.24 Relative change in slope in the 3 slope zones (Figure 5.7) for the current channel length of the Sunday River compared to one similar to that in 1950 (Figure 5.22). Slope values are given for three discharges: medium, high and bankfull.

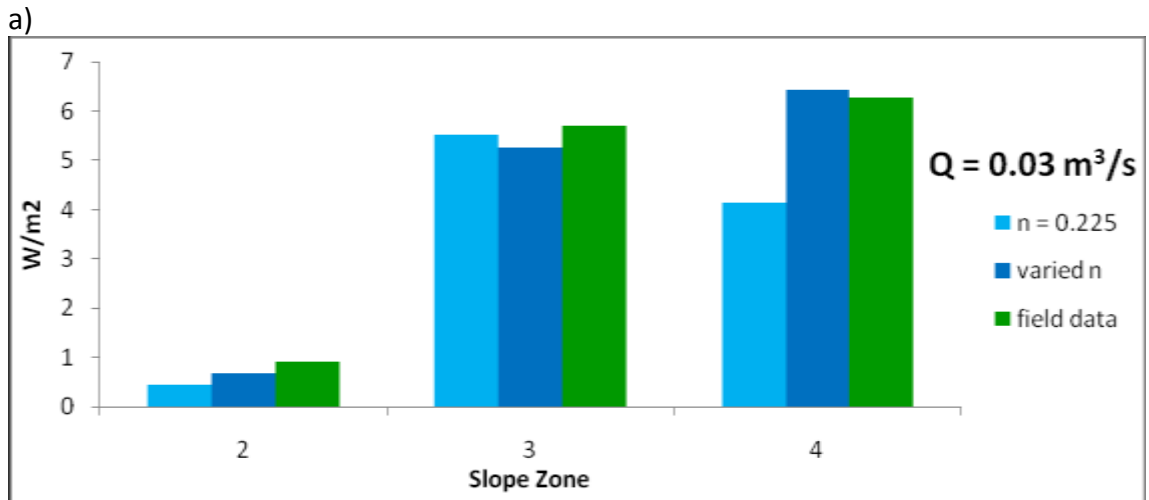
Figure 5.26 Shear stress for three slope zones in the model reach as calculated from simulation data versus field data. In the low flow case a), shear stress was better approximated in HEC-RAS by using a Manning's n of 0.3 in slope zone 2, 0.2 in zone 3 and 0.4 in zone 4. However, for the simulation using Manning's n of 0.225, the n that best reproduced water surface levels, did produce relatively close approximations of shear stress. This was not the case for the medium flow case b). Rather, it was found that the Manning's n value of 0.075 that produced the most accurate water surface levels resulted in overestimated shear stress values. A Manning's n of 0.035 in zone 2, 0.018 in zone 3 and 0.015 in zone 4 was found to be necessary in order to reproduce shear stress values as calculated from field data.

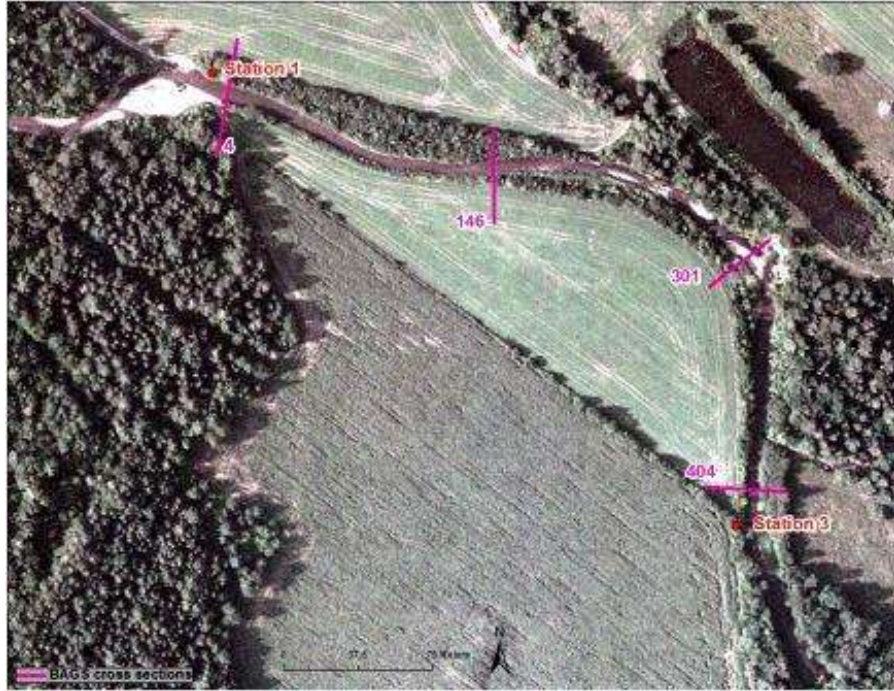
Figure 5.27 Four transects used in BAGS sediment modelling software. Transect numbers represent approximate distance in metres from station 1.
