**IMPROVING PERFORMANCE OF PORTLAND-  
LIMESTONE CEMENTS IN SULFATE EXPOSURES  
USING SUPPLEMENTARY CEMENTING MATERIALS**

A Thesis  
In the Department  
of  
Building, Civil and Environmental Engineering

Presented in Partial Fulfillment of the Requirements  
For the Degree of  
Doctor of Philosophy (Civil Engineering) at  
Concordia University  
Montreal, Quebec, Canada  
November 2013

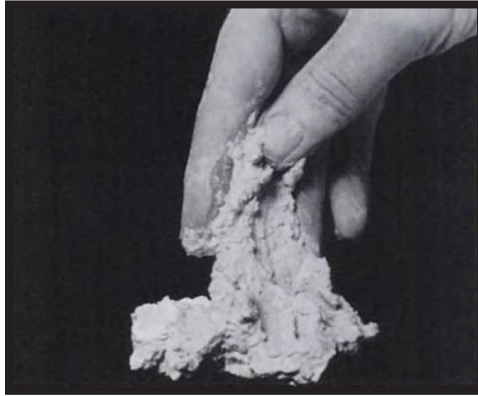
**Fig. 2-4: Conversion of hardened concrete to a non-cohesive substance (Scrivener and Young-1997)**

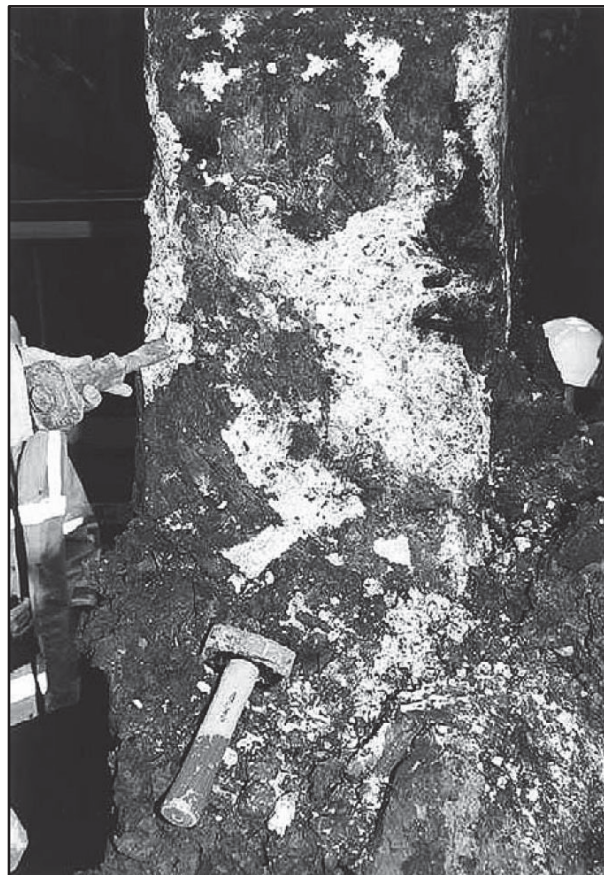
**Fig. 2-8: Damage due to TSA at the base of a 30-year old bridge column (Longworth-2003)**

In soil adjacent to the bridges, considerable amount of sulfate ions was found that were mostly formed due to oxidation of pyrite ( $\text{FeS}_2$ ), which was present in the regional soil. The construction practice (excavation and backfilling) and soil disturbance had led to more oxidation of pyrite and development of more sulfate ions. The aggregates used in the construction were carbonate rich aggregates holding calcium carbonate and dolomite; besides, the affected areas were wet. Subsequently, “a soft white crystalline mush, composed mostly of thaumasite” was found around aggregates in TSA affected zones (Fig. 2-9).

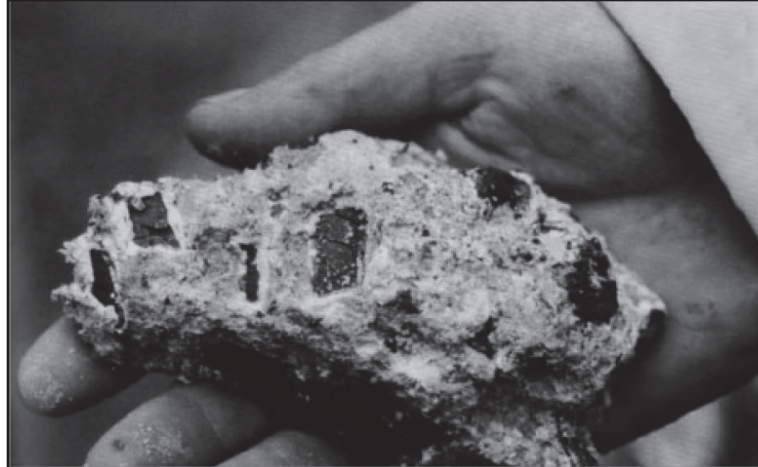
**Fig. 2-9: Formation of thaumasite around dolomite aggregates  
(Modified image – Report of the Thaumasite Expert Group-1999)**

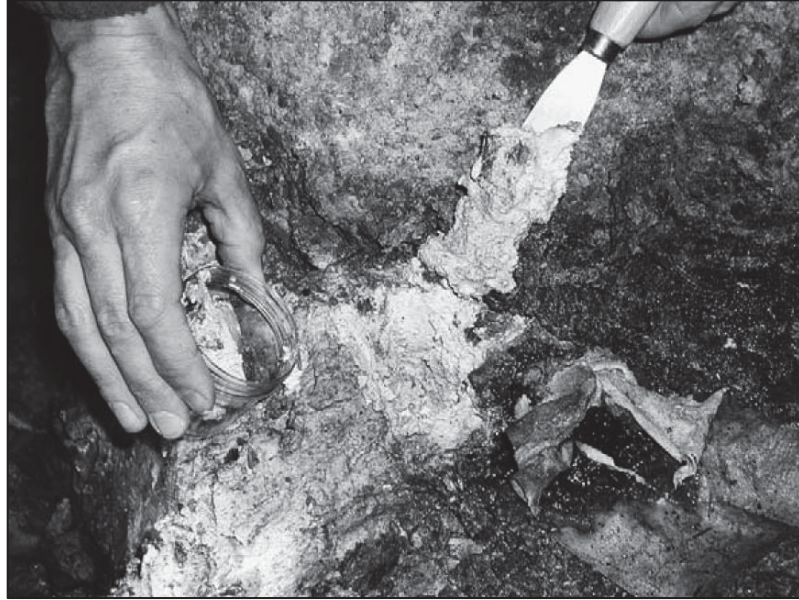
**Fig. 2-13: Concrete altered into a soft mush like material on base of a tunnel lining in contact with drainage water (Romer et al.-2003)**

Several deteriorated tunnel constructions in Switzerland were investigated by Romer et al. (2003). It was detected that generally deterioration in shotcrete linings of tunnels occurred due to presence of sulfate bearing ground water. Thaumasite formation was found mainly where the sulfate and carbonate bearing ground water was in contact with porous concrete. Many cases of deterioration due to thaumasite sulfate attack were spotted near the drainage system as can be seen in Fig. 2-13.

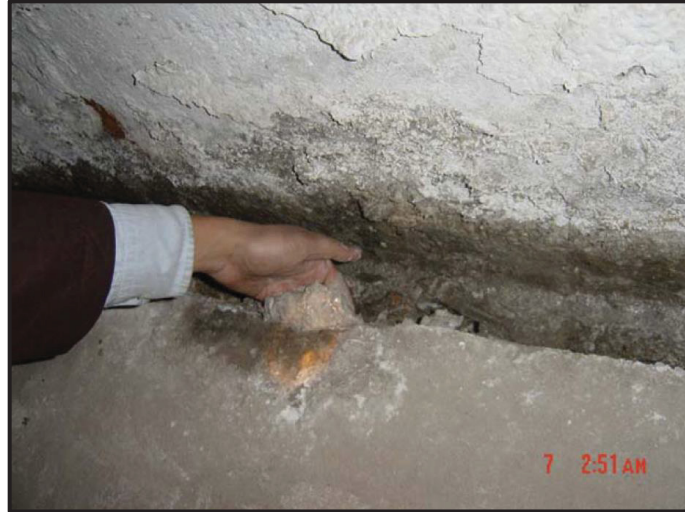
**Fig. 2-14: Thaumasite sulfate attack found in drainage channels in form of development of a white pulpy mass (Ma et al.-2006)**

A tunnel in the Bapanxia hydraulic power plant, constructed in 1970's, in China was investigated and deterioration owing to thaumasite sulfate attack was found in drainage channels where expansion, cracking and softening in concrete was observed. At some points concrete lost its integrity completely and “cement paste transformed into a white, pulpy mass with no strength” as seen in Fig. 2-14. Groundwater in the region contains noticeable amounts of sulfate and carbonate ions. The relative humidity in the tunnel is more than 85%, and the temperature within the tunnel ranges between 4°C to 10°C. Carbonation on surface of concrete was found as another source for carbonate ions. All the visual observations and field investigations along with laboratory study on site samples confirmed severe thaumasite sulfate attack in the structure.

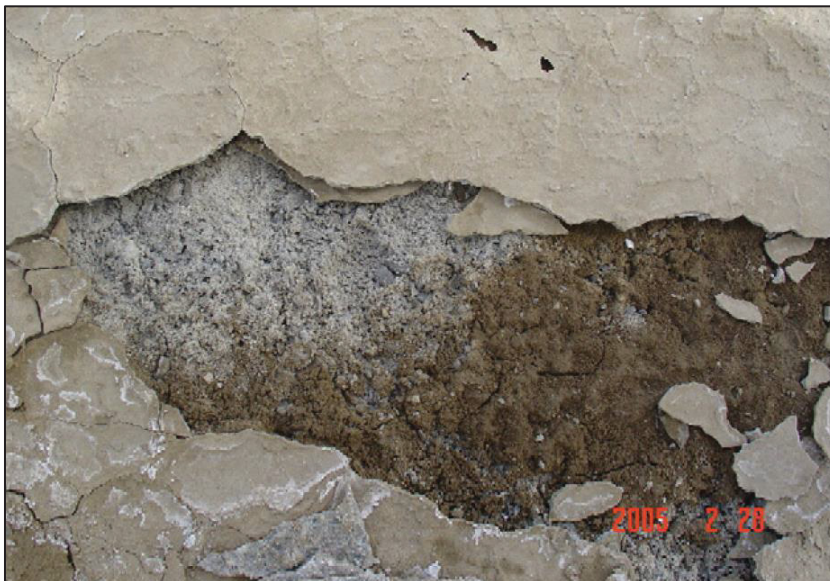
**Fig. 2-15: Concrete slab of Yongan dam damaged by TSA (Mingyu et al.-2006)**

The main reasons found for such fast deterioration were usage of an ordinary Portland cement containing 9% limestone filler in construction of the dam, presence of great amounts of sulfate salts in the region’s soil as well as the mixing water, and frequent low temperature in the area. All these factors were in favor of an intense thaumasite sulfate attack.

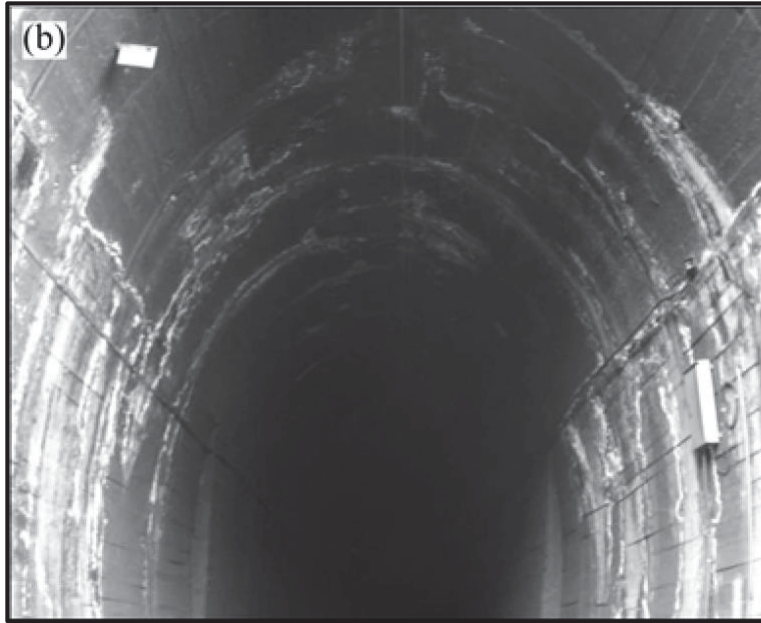
**Fig. 2-16: General image of deteriorated tunnel in Chuxiong, China (Long et al.-2011)**

Thaumasite sulfate attack was detected in the severely deteriorated concrete lining of a tunnel constructed in 1960's in the form of soft, white, mushy powder and a light grey mud (Fig. 2-16 and Fig. 2-17). Sulfate ions were found available in groundwater in contact with the concrete as well as coal powder scattered in tunnel due to movement of trains loading coal through the tunnel. The annual average temperature in the area was 12°C, and the environment was humid, making favorable condition for formation of thaumasite and causing swelling and flaking on concrete surface.

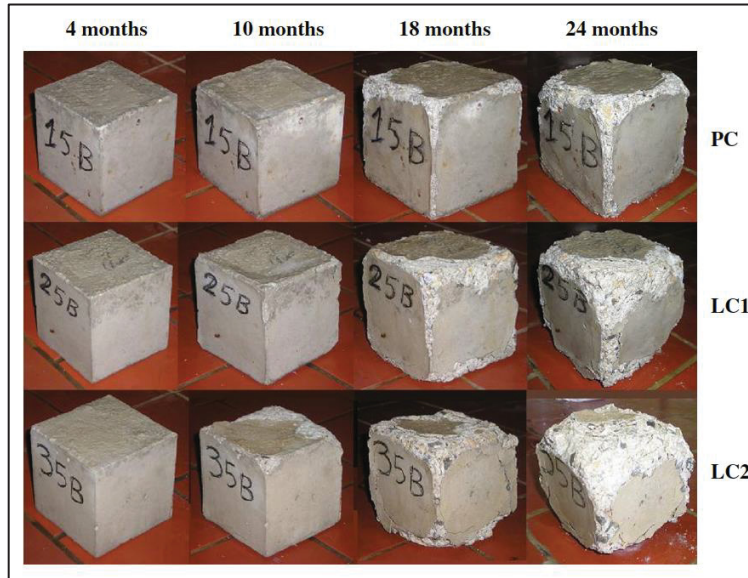
**Fig. 2-18: Deterioration of concrete specimens containing limestone as aggregate and filler during 24 months of exposure to magnesium sulfate solution at 5°C (Sotiriadis et al.-2012)**

shows the visual condition of concrete cubes, and Fig. 2-19 depicts the mass changes during the 2-year immersion in magnesium sulfate solution at 5°C.

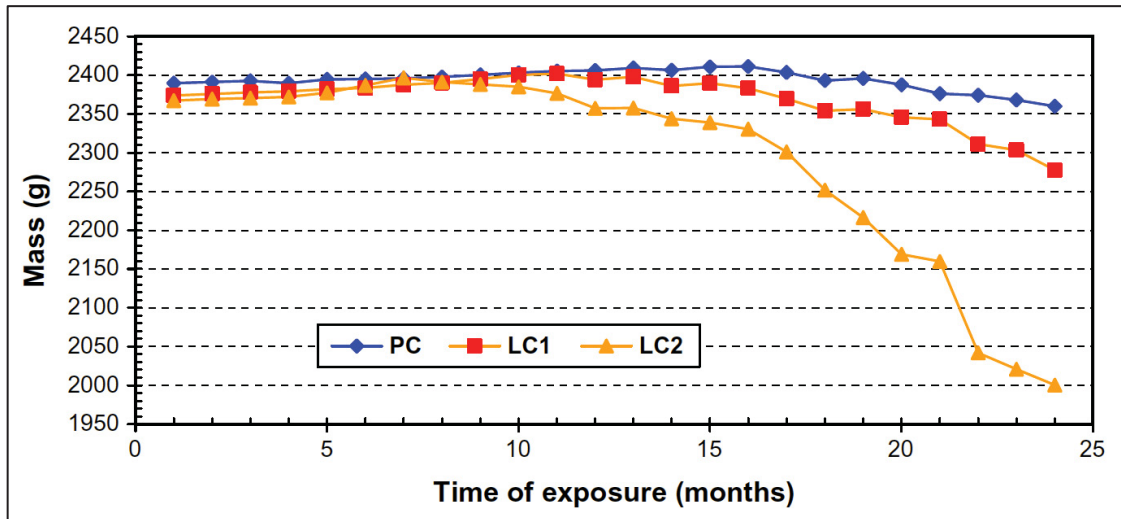
**Fig. 2-19: Mass changes of concrete specimens containing limestone as aggregate and filler during 24 months of exposure to magnesium sulfate solution at 5°C (Sotiriadis et al.-2012)**

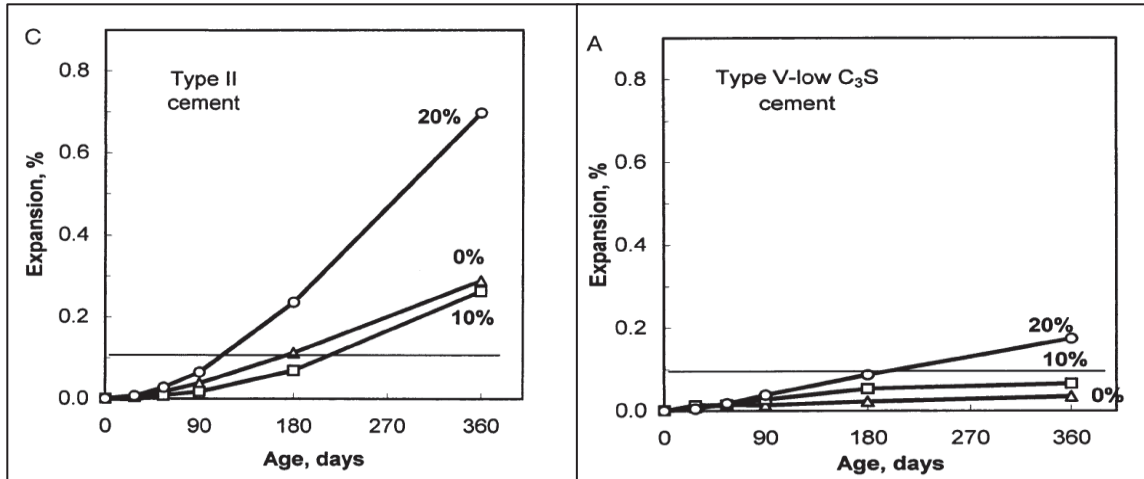
Fig. 2-20: Mortars expansions – ASTM C1012 (Gonzalez and Irassar-1998)

Gonzalez and Irassar (1998) studied effect of addition of limestone filler (10% and 20%) on resistance of mortars against ettringite sulfate attack. Mortar prisms were prepared with Type II and Type V cement, and their expansion was measured according to ASTM C1012 for one year (Fig. 2-20). They concluded that addition of 20% limestone powder to both sulfate resistant cement and Type II cement leads to a considerable increase in expansion of mortar prisms, but 10% addition does not have such effect. In addition, their experiments showed 40% and 20% reduction in compressive strength of 25 mm mortar cubes after a one-year exposure to sodium sulfate solution for Type II cement containing 20% and 10% limestone filler, respectively.

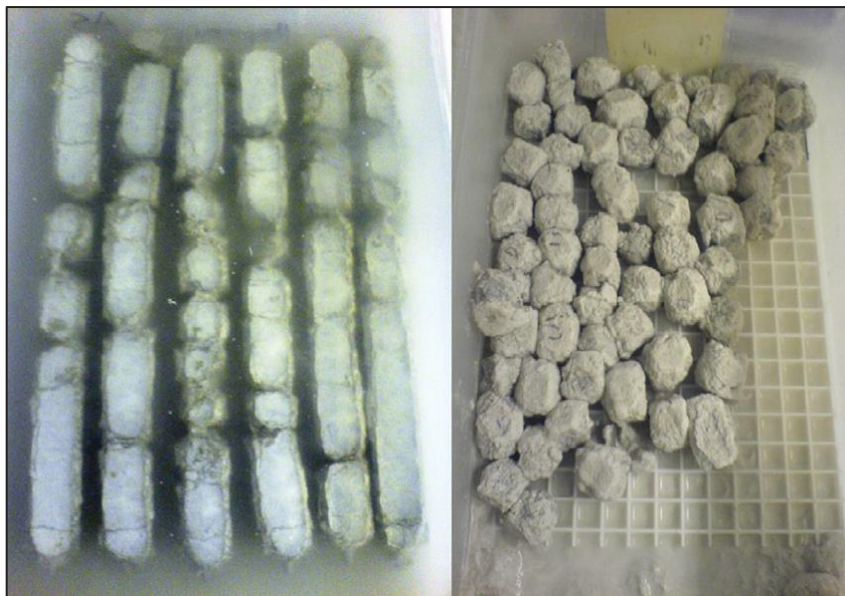
**Fig. 2-23: Disintegration of mortar prisms in TSA: Type I cement after one year (left), Laboratory ground PLC after three months (right) (Ramezaniapour and Hooton-2013b)**

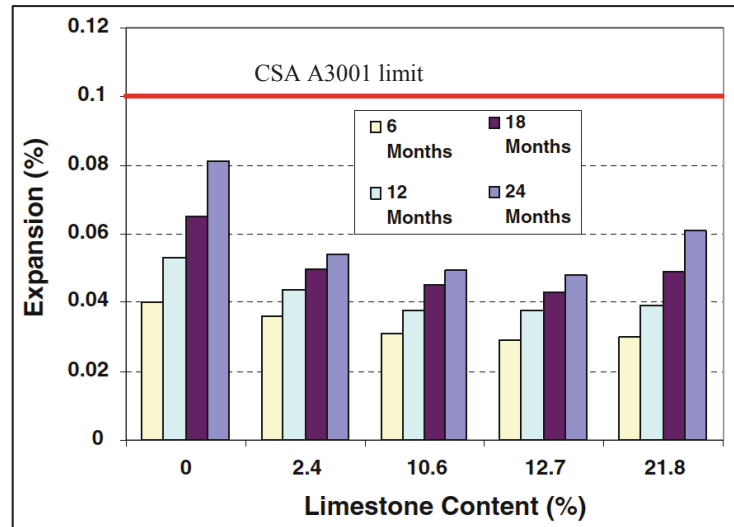
Fig. 2-24: Expansion of mortar bars made with 70% cement and 30% slag according to CSA A3004-C8 procedure A – 23°C (modified from Ramezani pour and Hooton-2013a)

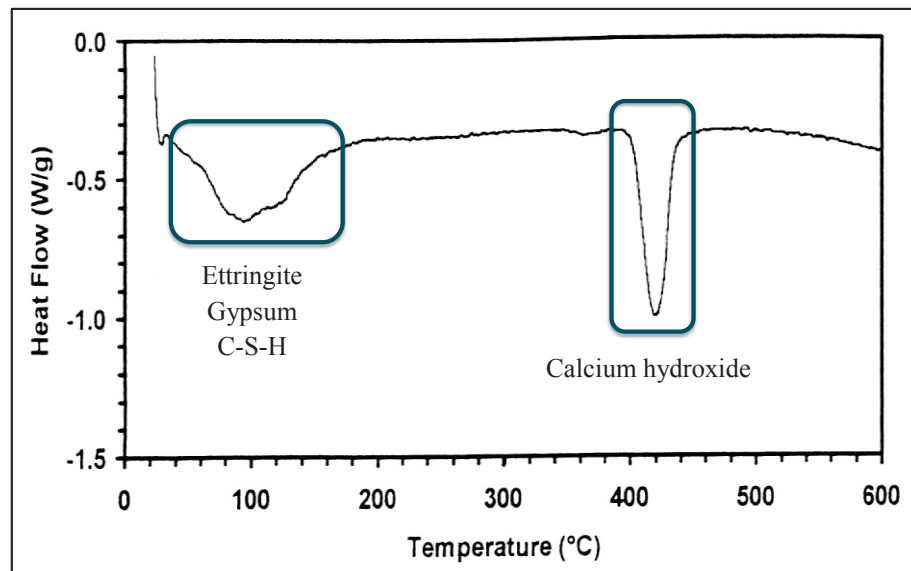
**Fig. 2-28: DSC curve for unaffected part of Portland-limestone cement paste sample stored in sulfate solution at 5°C for 196 days (modified graph from Hartshorn et al.-1999)**

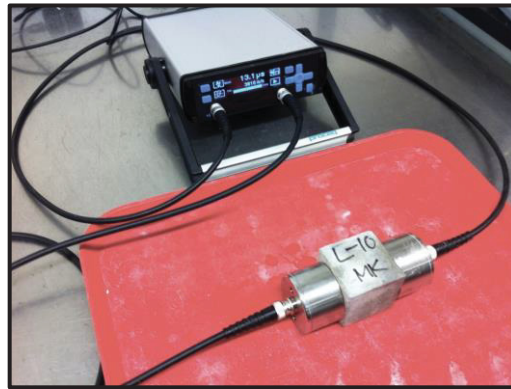
Fig. 3-4: Ultrasonic pulse velocity test on cubic mortar samples

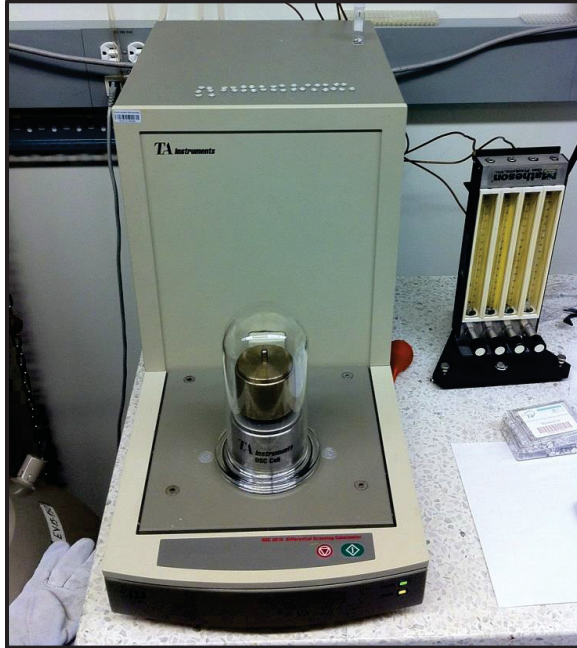
Fig. 3-5: TA Instruments-2010 DSC apparatus

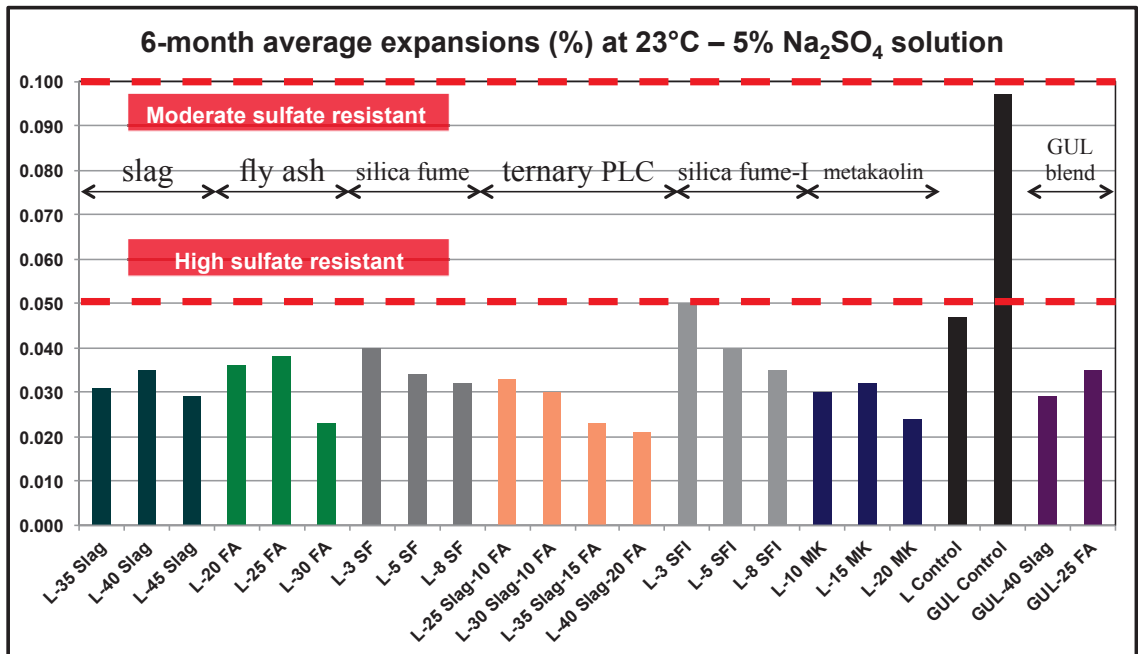
Fig. 4-1: Average expansion of CSA A3004-A mortar bars – 6-month ESA

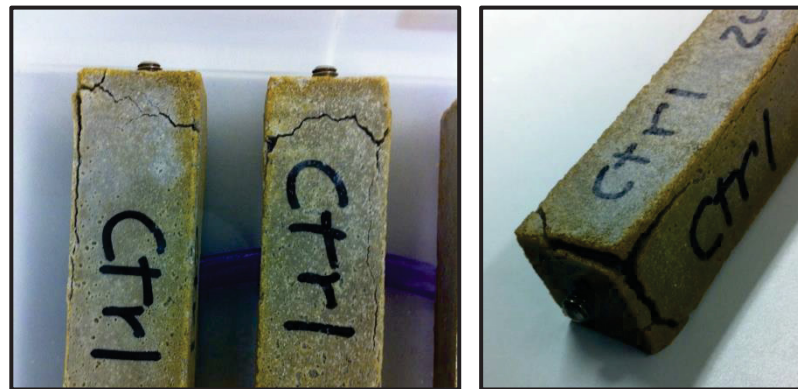
Fig. 4-5: Formation of cracks on the edges and at the end of the control mortar bars due to ESA

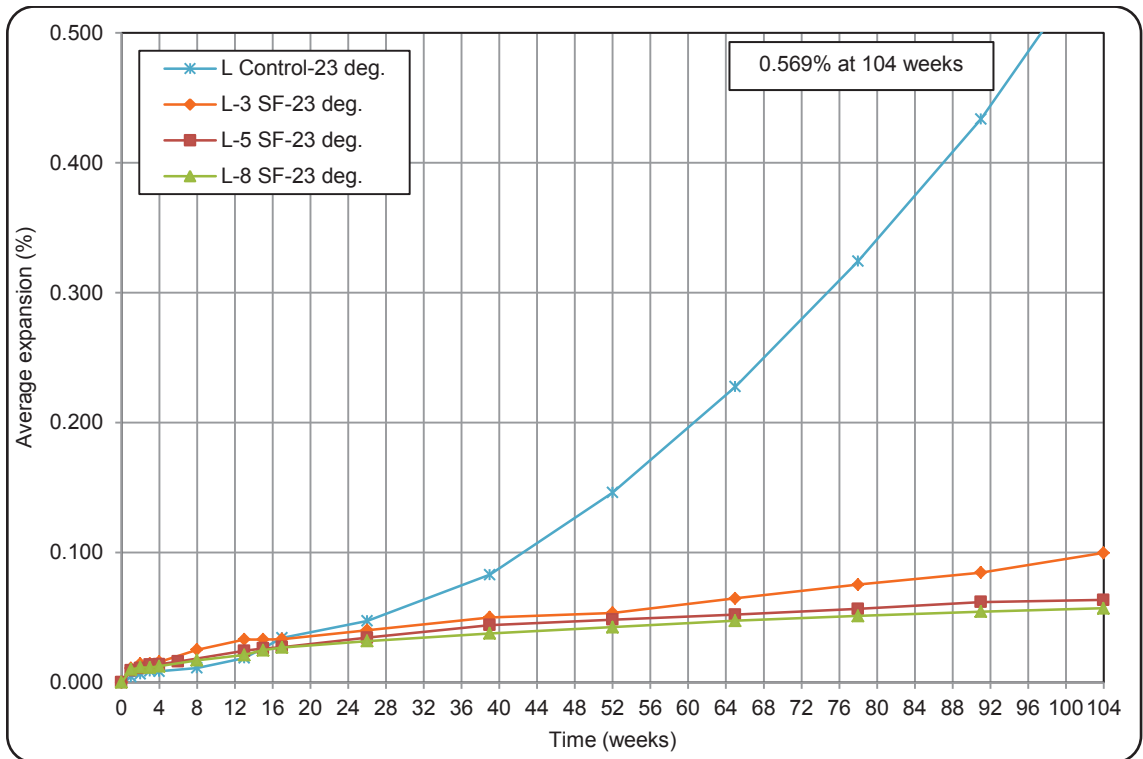
Fig. 5-4: Expansion of CSA A3004-C8-A mortar bars in a 2-year ESA – Silica fume blends
