Field Study of Wind Driven Rain Penetration into Vinyl Sidings and Stucco-Clad Wood-Frame
Wall Systems at Window Sill

A Thesis

Building, Civil and Environmental Engineering

September 2015

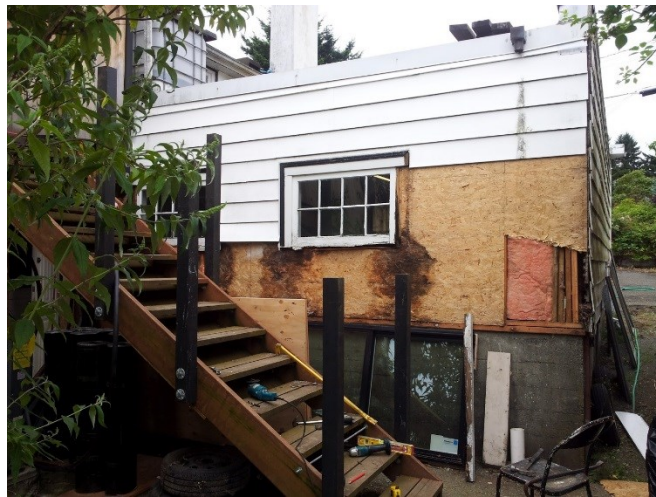
Figure 1. Sheathing board damage observed on the window sills of a wood frame wall of a garage structure in BC. Photo courtesy of David Croft (2012).

In the late 1990s, major durability problems were found at the building envelopes of many wood-framed multi-unit residential buildings in the coastal climate region of British Columbia, Canada. The building envelope failures were premature on the 1980-1990s-built, low-rise wood-framed residential buildings of up to four storeys high and required more than \$10,000 in moisture damage related repair costs. These extensive water ingress issues affected the financial well-being of the homeowner and the construction industry, and were commonly referred to as the leaky-condo crisis. In response, a survey was conducted on 37 problem buildings and 9 control buildings with no moisture problems to identify the cause of the problems (Morrison Hershfield, 1996). The survey found that the moisture problems were due to exterior water penetration, in particular at interface details, such as windows, balconies, wall penetrations for wiring, vents, and structural connections of handrails and other exterior elements. Lack of protection by roof overhangs above the walls was also found to be a contributing factor to the problems. Figure 1 is an example of moisture damaged wood framing around windows at sill corners. Many of these problems were found on face sealed stucco clad walls, and although at fewer numbers, also on wood and vinyl sidings walls.

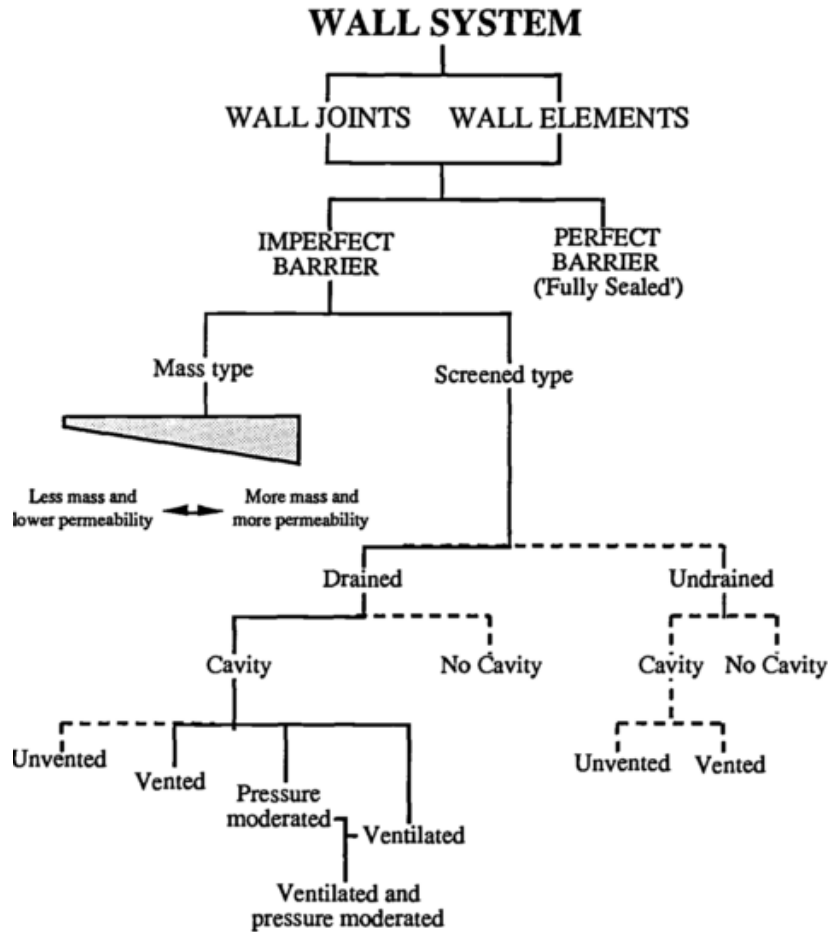
Figure 2. Classifications of wall based on the wall's performance in managing wind driven rain (Straube & Burnett, 1998).

Based on a wall's performance on managing wind driven rainwater, different wall assemblies are generally classified into the categorization as shown in Figure 2.

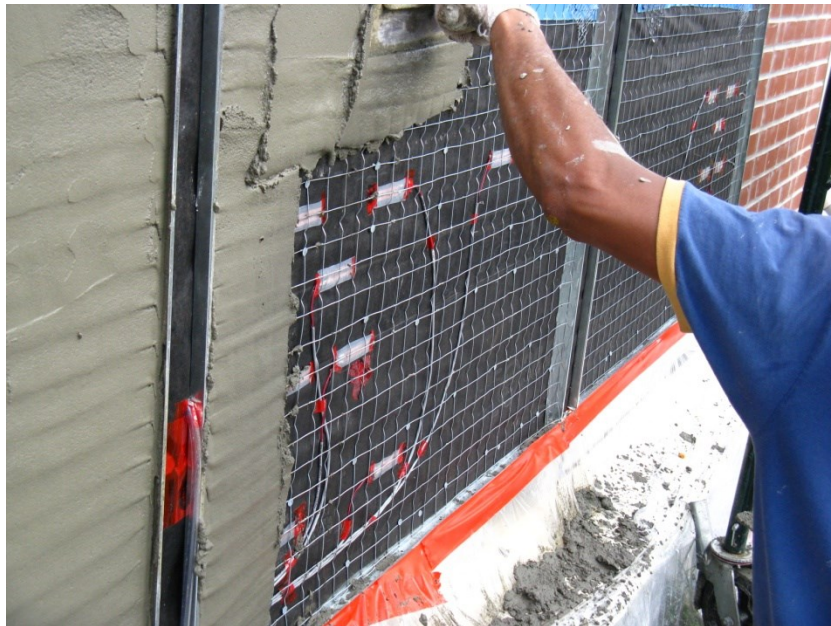
Figure 10. The application of stucco scratch coat over the metal lath on W7 panel.

The stucco cladding consists of 1 inch x1 inch chicken wire type metal lath, ¼ inch thick scratch coat, ½ inch thick brown coat to build up to the thickness of the ¾ inch casing beads, and completed with grey, smooth-texture acrylic finish coat, most commonly used in BC. In addition to the standard lime, sand, cement and water as the ingredients for the stucco cladding, fibers and plasticizer additives were added to the stucco mixtures as commonly applied. Galvanized roofing nails of 1.5 inch length were used to fasten the metal lath onto the wall framing. Figure 10 shows the stucco scratch coat layer and the metal lath.

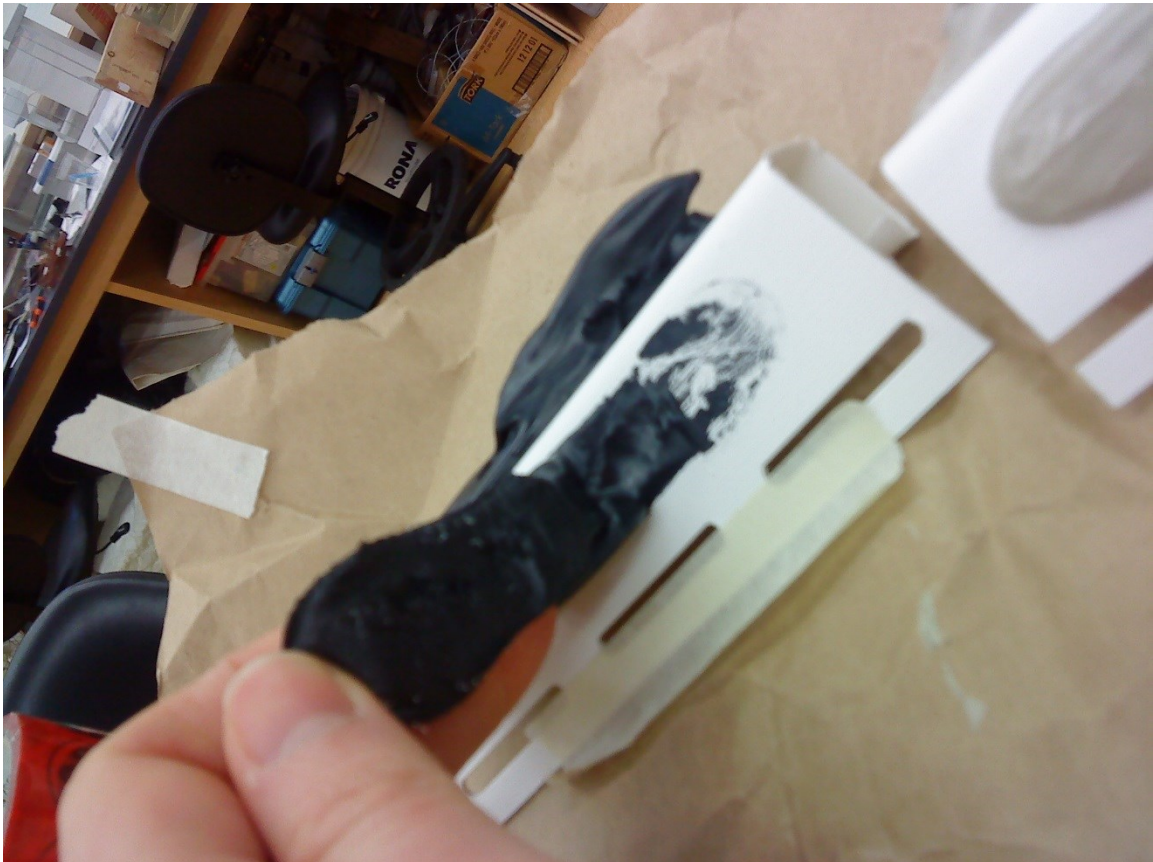
Figure 11. LePage Quad Advanced Formula exterior sealant passed the adhesion pull test on a vinyl siding J-trim as the sealant showed cohesive failure, instead of adhesive failure when pulled away from the substrate.

The exterior sealant used around the perimeter of the window between the window frame and the stucco and vinyl siding trims is the Quad Advanced formula exterior sealant by LePage, which was selected because it passed the adhesion pull test on a vinyl siding J-trim among multiple sealants tested, as shown in Figure 11. The interior window perimeter sealant used between the window frame and the self-adhered membrane on the wood framing is the Sonolastic NP1 polyurethane sealant, which is a commonly used sealant to seal air leakage.

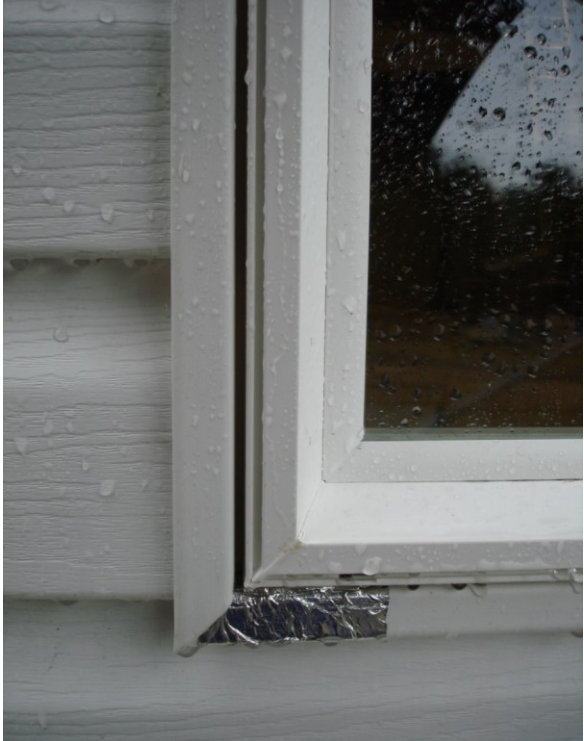
Panel No.	Photo of Wall Panel	Features, Intent & Sensor / Equipment
W1

<ul style="list-style-type: none"> • Vinyl siding • Typical construction with no head flashing • Water collection wall at the sill corner • Leakage gauge • MDT as control sensors.

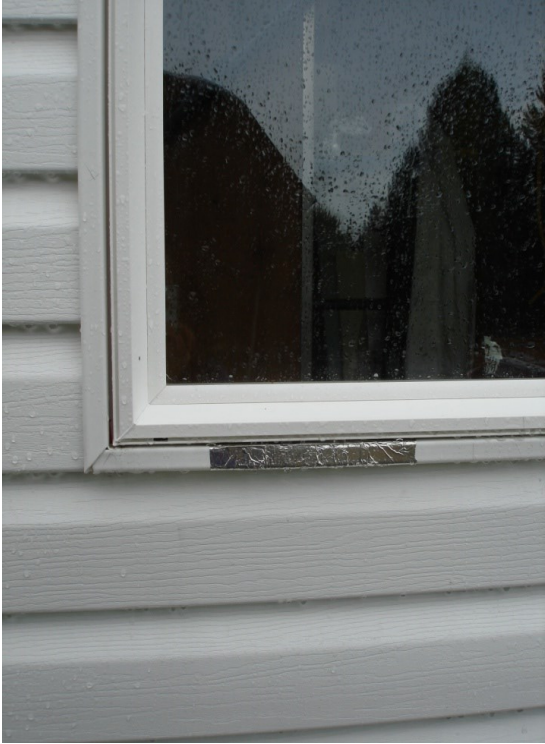
Panel No.	Photo of Wall Panel	Features, Intent & Sensor / Equipment
W2

<ul style="list-style-type: none"> • Vinyl siding • Typical construction with no head flashing • As a comparison to W1, W2 collects water at the quarter point of the window along the sill J-trim • Leakage gauge • MDT as control sensors.
W3

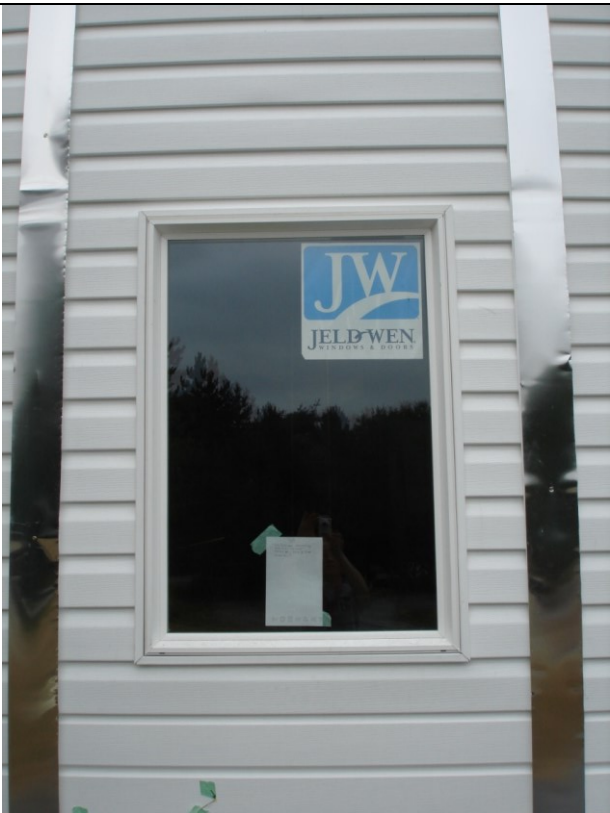
<ul style="list-style-type: none"> • Vinyl siding • Typical construction with no head flashing • A control wall for long-term performance monitoring • Thermocouples, moisture pins, RHT sensors, and moisture detection tapes • Bottom-of-wall trough and collection bottles.

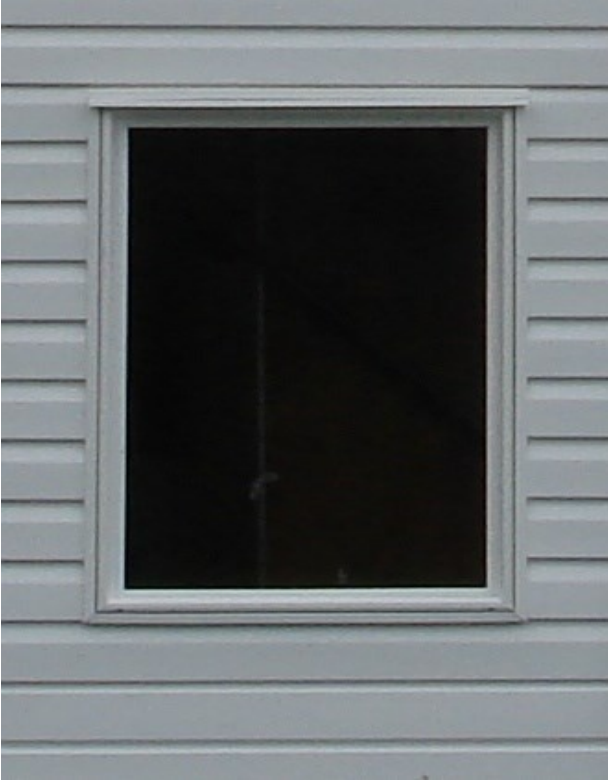
Panel No.	Photo of Wall Panel	Features, Intent & Sensor / Equipment
W4

<ul style="list-style-type: none"> • Vinyl siding • Vinyl drip cap was installed above the head of the window • For investigation of the effect of a head flashing • Thermocouples, moisture pins, RHT sensors, and moisture detection tapes • Bottom-of-wall trough and collection bottles.
W5

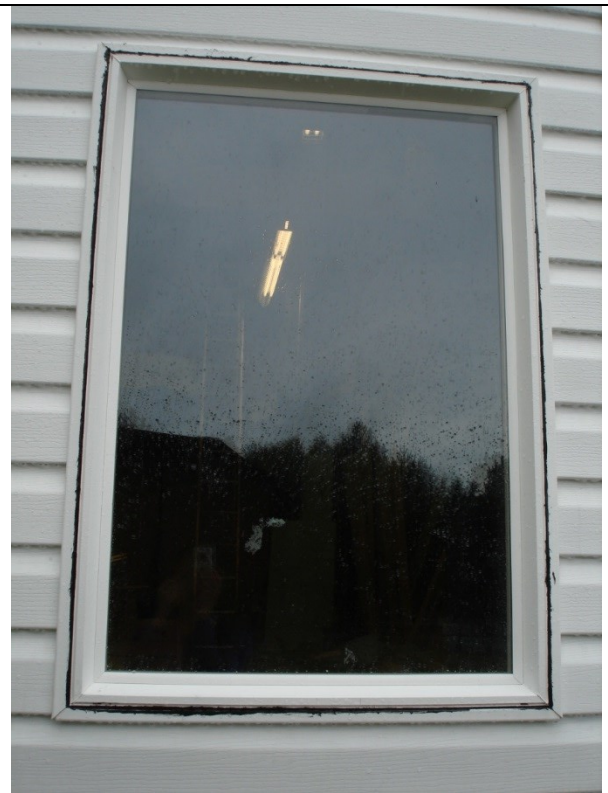
<ul style="list-style-type: none"> • Vinyl siding • No head flashing • Sealant applied between the vinyl head, jambs and sill J-trims and the window frames • For investigation of the effect of sealing the gap between the J-trims and the window frames, such that no direct WDR enters the gap, and no run-off water exits from the gap. • Thermocouples, moisture pins, RHT sensors, and moisture detection tapes • Bottom-of-wall trough and collection bottles.

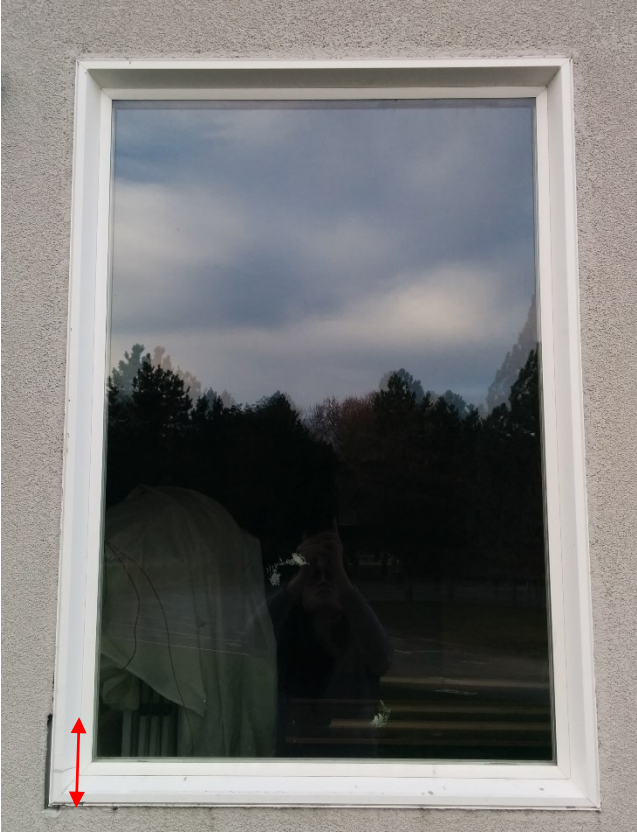
Panel No.	Photo of Wall Panel	Features, Intent & Sensor / Equipment
W7

<ul style="list-style-type: none"> • Stucco • Typical construction with no head flashing, sealant at gap between window frame and head, jamb, and sill casing beads • Replicates W6 corner missing sealant defect and monitors the condition of the sheathing board and the framing under the window sill • Thermocouples, moisture pins, RHT sensors, and moisture detection tapes • Bottom-of-wall trough and collection bottles.
W8

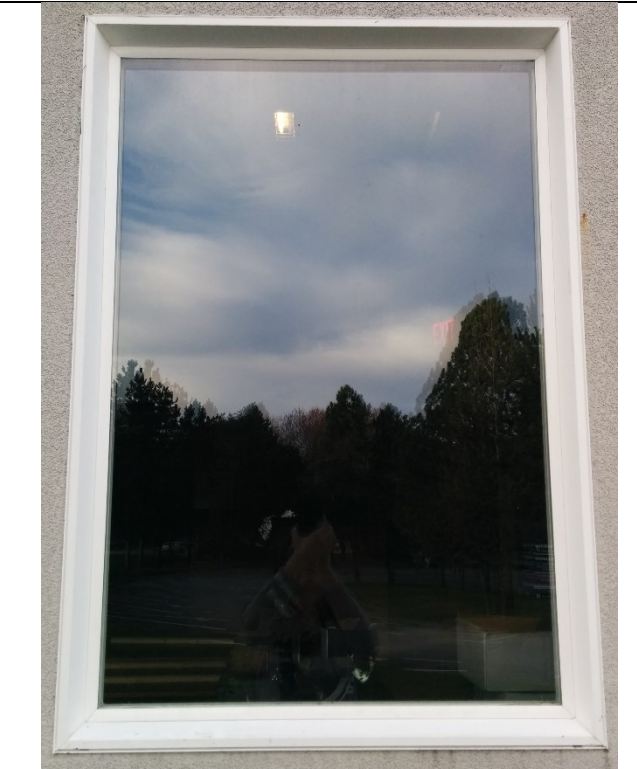
<ul style="list-style-type: none"> • Stucco • Typical construction with no head flashing, sealant at gap between window frame and head, jamb, and sill casing beads • No designed defect • Monitors the condition of the sheathing board and the framing under the window sill for comparison to W7 • Thermocouples, moisture pins, RHT sensors, and moisture detection tapes • Bottom-of-wall trough and collection bottles.

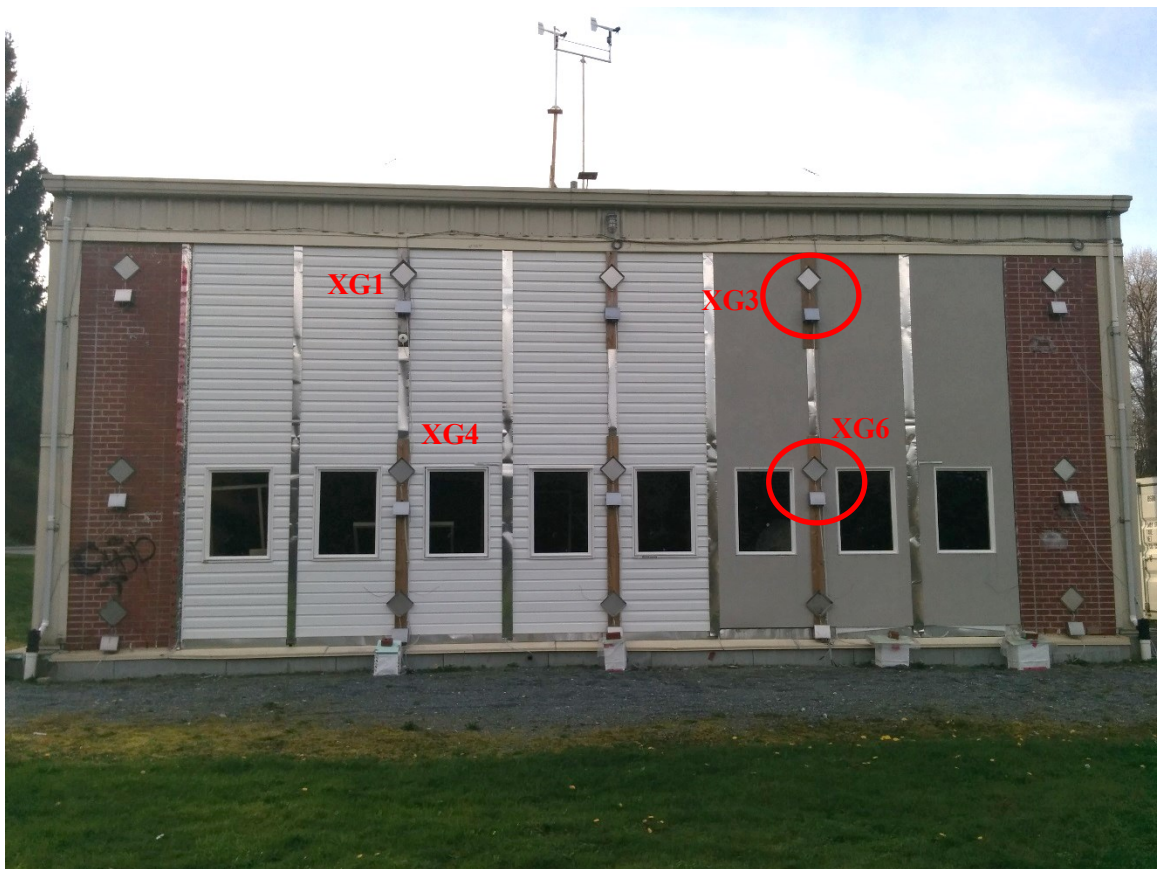
Figure 13. Locations of 15 wall rain gauges on the South East facade. In the analysis of the leakage into water collecting walls, the closest top and the middle gauges were used. For example, the circled gauges XG3 and XG6 were used for the analysis of the leakage at W6.

The wall rain gauges consist of tipping bucket rain gauge apparatus connected to receive rain from square / diamond shaped catchment metal plates. Initially, in September 2013, four existing wall gauges were placed on the brick wall panels at the North and South ends of the SE façade. In October 2013, eleven more wall gauges were added after the preliminary test in the middle area of the façade. Figure 13 shows the layout of these 15 wall gauges.

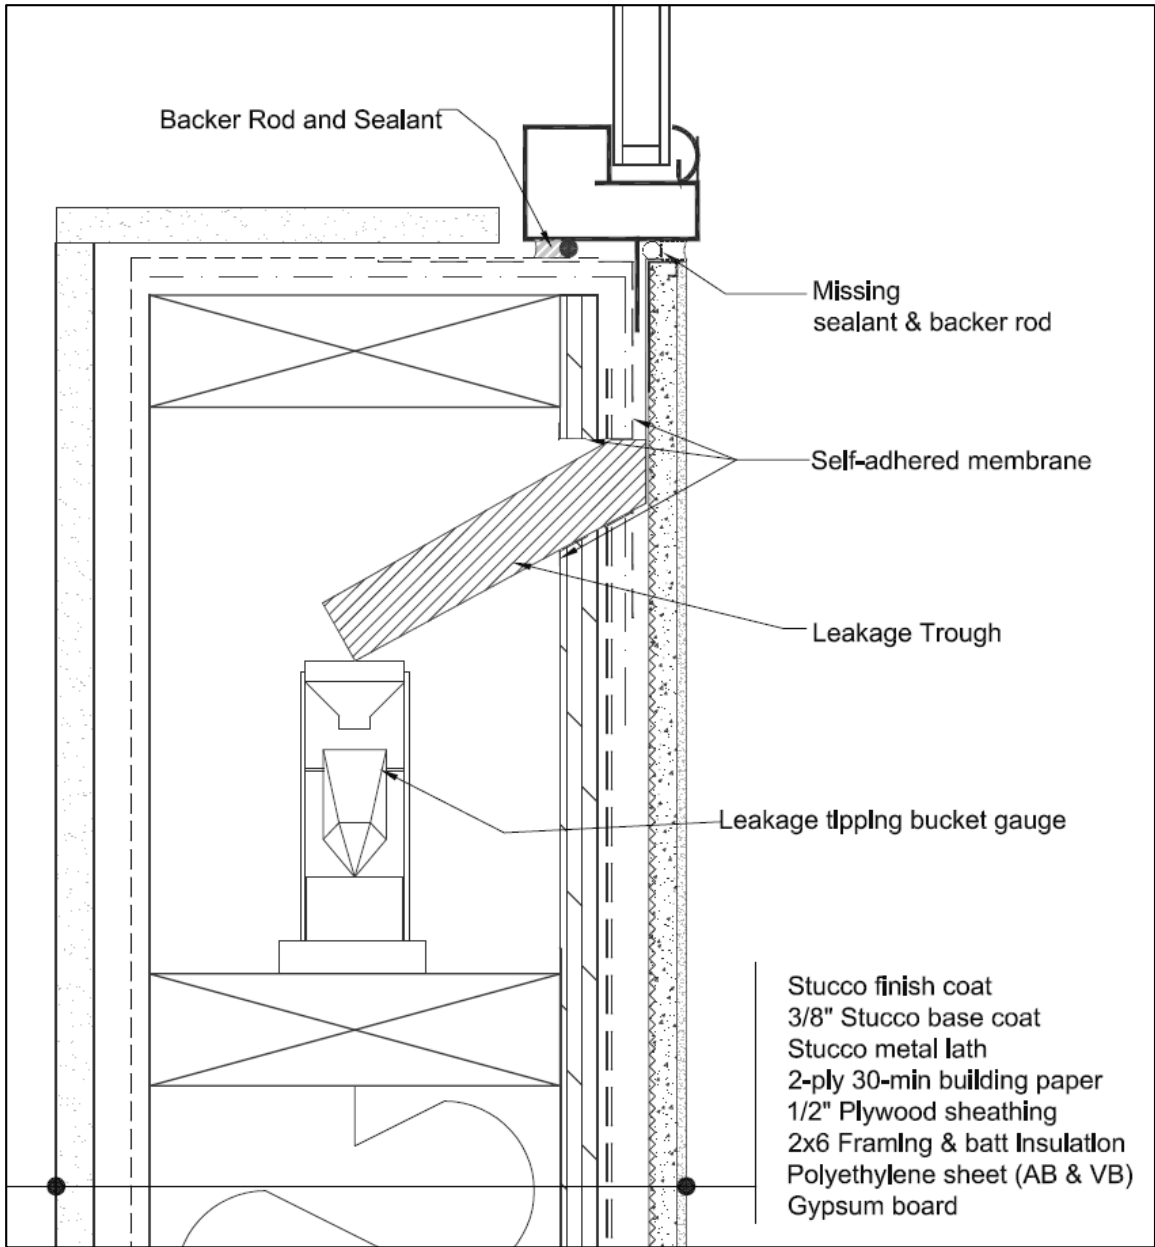
Figure 14. Detail drawing of water collection stucco wall W6 with missing sealant defect. The wall assembly cross section is typical for all stucco walls.

The framing of the water-collection walls are slightly different than that of long-term walls due to the shelves that hold the tipping bucket rain gauges as shown in Figure 14 and Figure 15. For corner water collection walls, the shelf is offset further to the panel's side. An approximately 4 or 6 inches wide by 1 inch high slots are cut through the plywood sheathing to allow aluminum troughs that direct any rainwater that can potentially infiltrate the wall assembly past the building paper water resistive barrier into the leakage gauge collection bucket. The troughs were made from paint coated, corrosion-resistant aluminum flashing sheet. Around the slot opening, self-adhesive membrane or peel-and-stick are applied as if the slot is a rough opening of a window, except that the overlapping of the membrane is to direct the water onto the triangular trough.

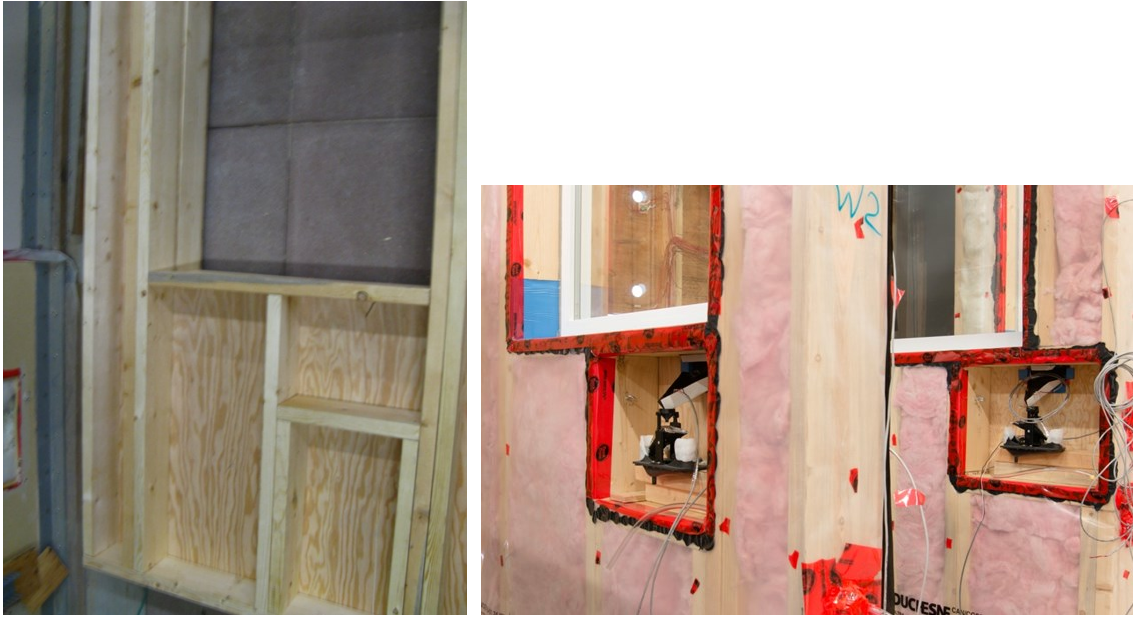
Figure 15. Left: Framing for the leakage gauge shelf of middle collection area for W2 panel. Right: Leakage gauges placed in assembled W2 and W1 panels; note the offset shelf in W1.

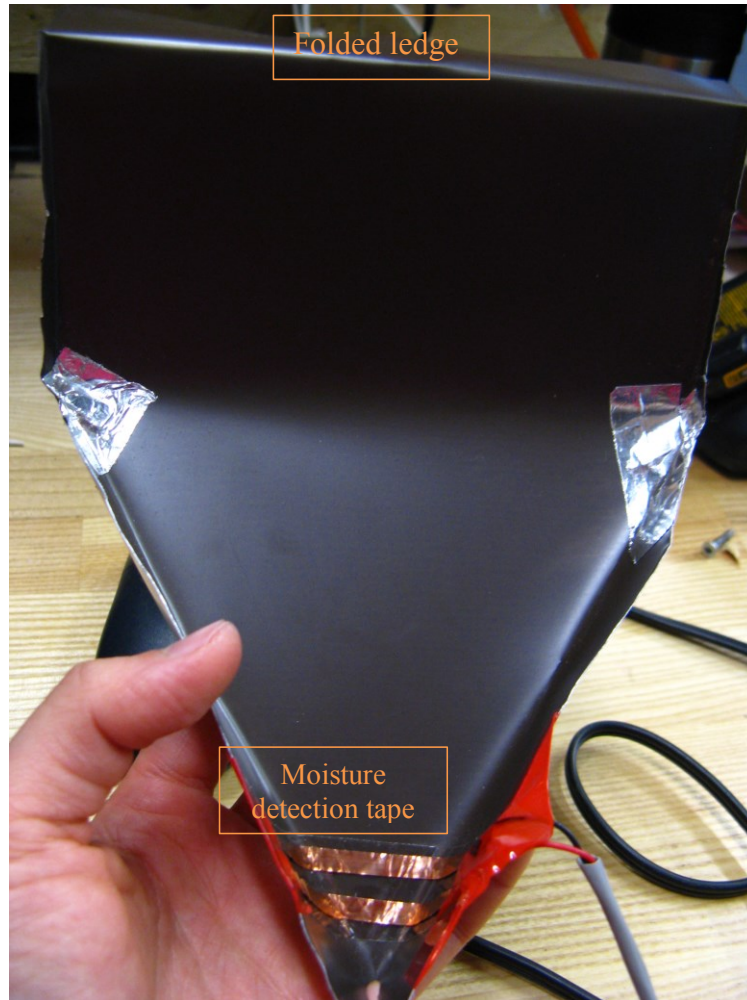
Figure 17. A typical triangular aluminum trough with a moisture detection tape labelled as W1GtMdR, W2GtMdC, W6GtMdR, and W6GtMdC for the water collection troughs at W1, W2, W6 sill corner and W6 middle locations respectively.

As shown in Figure 17, the triangular aluminum trough extends vertically up and its top edge folded to form a ledge. This folded ledge is later set to sit on top of the window sill stucco stop / casing bead or vinyl J-trim.

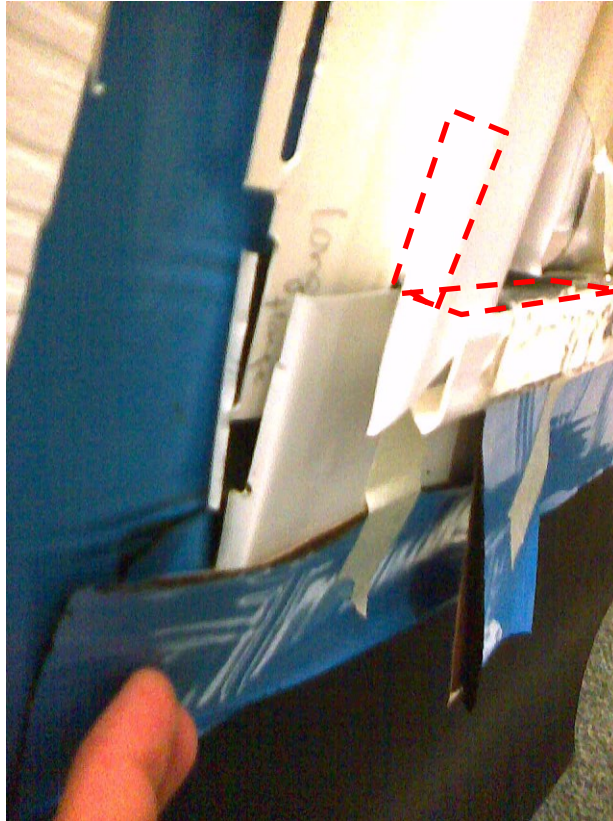
Figure 18. Sill corner collection area details for the aluminum triangular trough at W1.

The collection area and the triangular trough are offset such that the sill corner lines up to approximately the middle of the triangular trough. Therefore, at a sill corner collection area such as at W1, the horizontal flat area of the aluminum trough is partially cut and then folded up behind the depth of the jamb J-trim of that corner – as shown in Figure 18 by the dotted lines. The ends of the folded ledge are taped to the vinyl J-trim using an aluminum tape at vinyl siding walls, while at stucco wall W6, the ends of the folded ledge is held down with the moldable thermoplastics.

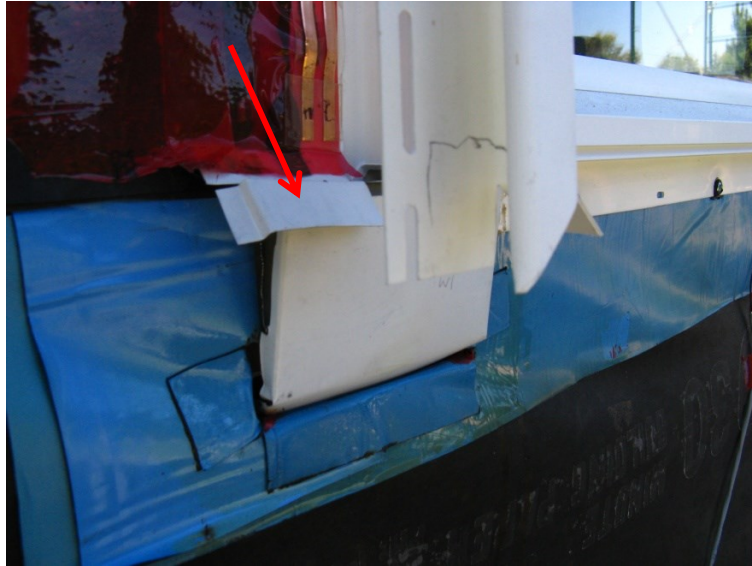
Figure 19. Additional flashing piece over the open aluminum trough at the sill corner area.

An additional flashing piece is installed over the open aluminum trough at the sill corner area – as shown in Figure 19– so that the water that runs behind the wall vinyl siding and the jamb J-trim is not directed into the leakage gauge. A short piece of moisture detection tape is then attached near the bottom tip of the aluminum trough as a control monitoring sensor to confirm whether or not water passes through the aluminum trough during a leakage event. The moisture detection tape is further discussed in section 6 of this chapter.

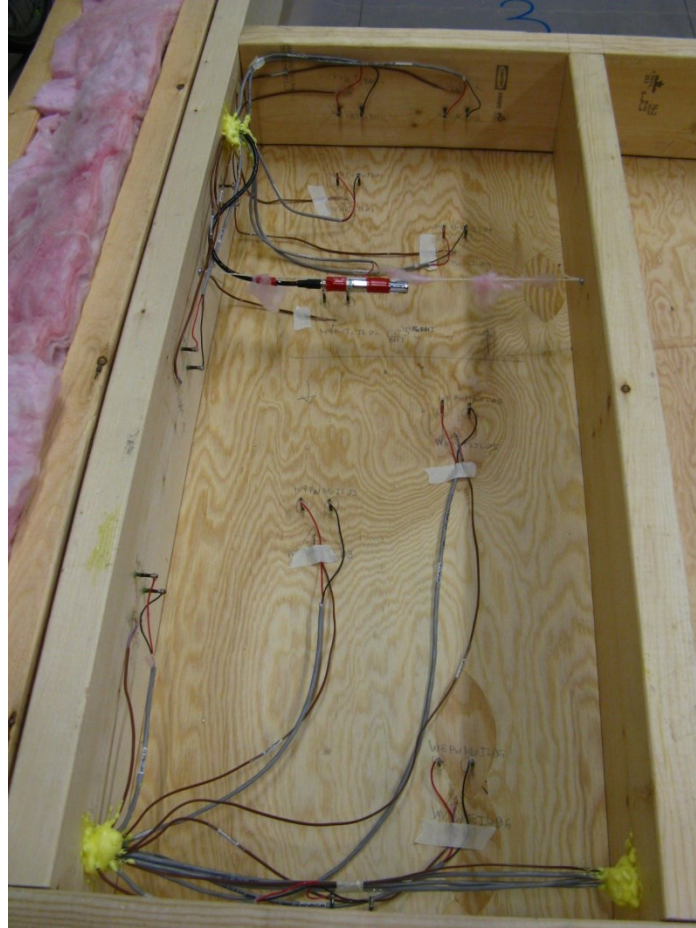
Figure 20. Typical overview of moisture pins, thermocouples, and RHT sensor installation in a wall cavity under the window sill.

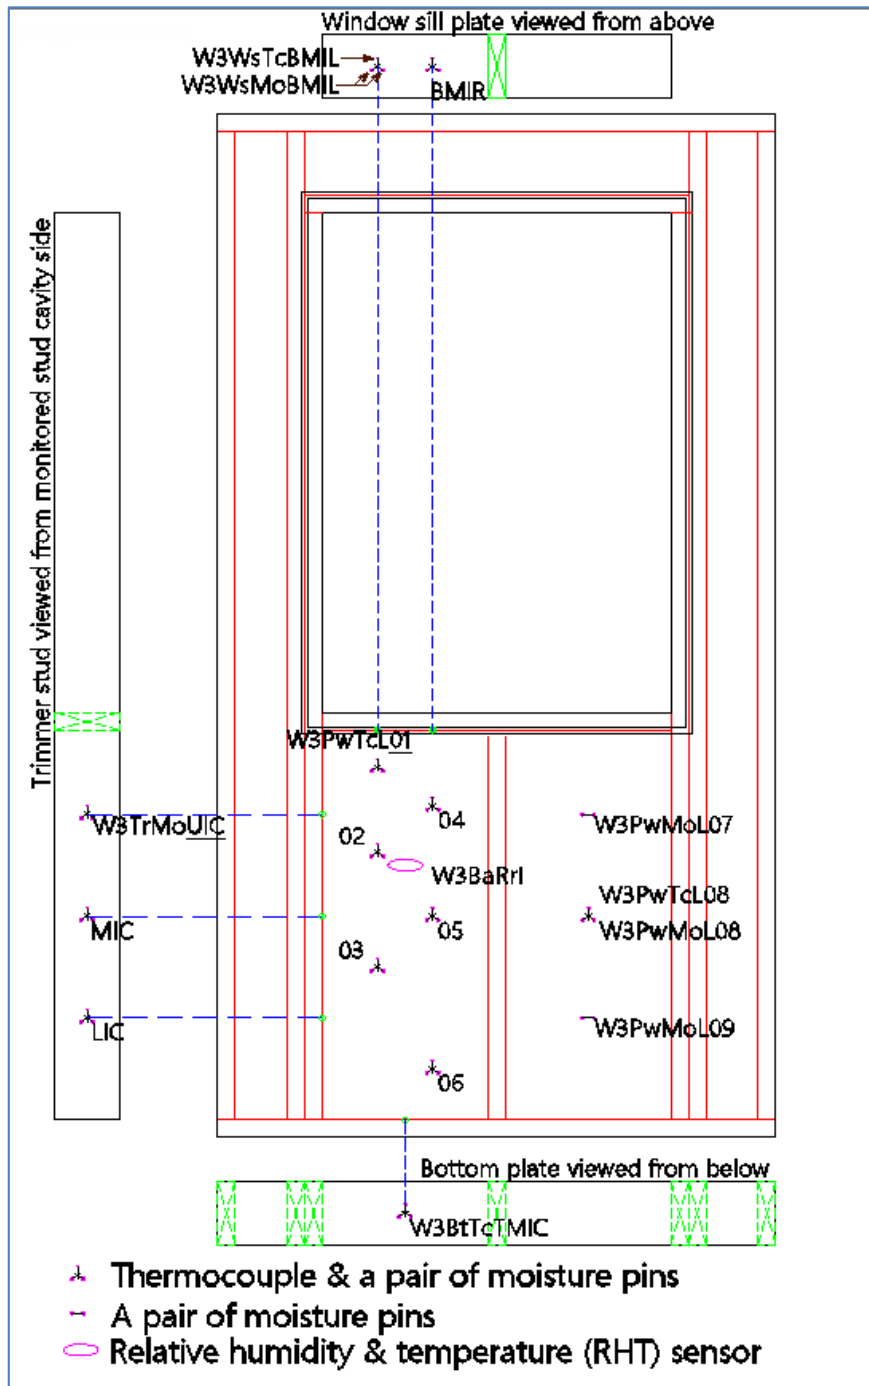
Figure 22. Locations and labelling of typical interior sensors in the wall cavity of long-term performance walls, with W3 as an example.

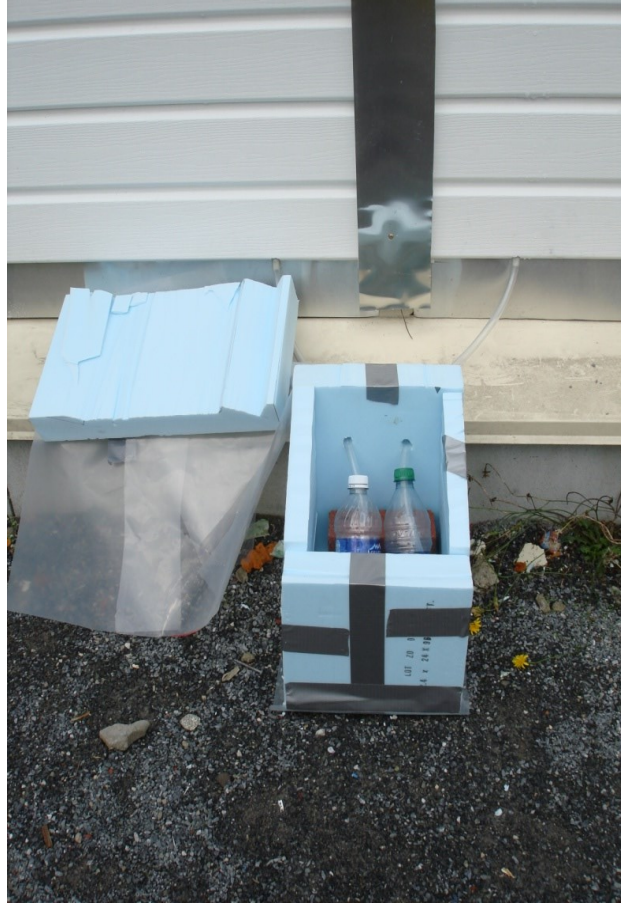
Figure 30. XPS housing for the bottles collecting drainage water from W3 and W5 vinyl siding walls.

At the bottom of the long term performance walls W3, W4, W5, W7 and W8, the amount of rain that was retained by stucco cladding, and/or was drained on the WRB behind vinyl siding or stucco cladding, was captured by a trough along the bottom of the wall claddings. The water in this trough was then directed via plastic tubes into bottles that are housed in boxes made out of extruded polystyrene insulation (XPS) as shown in Figure 30. The XPS boxes were made to minimize evaporation of the collected water from the bottles. The water collected in these bottles were periodically measured manually using 50 mL capacity graduated cylinder and 5 mL capacity graduated syringe – the type that is sold as an oral medicine dropper. Efforts were made so that the measurements of the collected water are done within 3 hours after the end of rain events during daytime, or in the early morning if the rain events ended at night. This was also to reduce the loss of collected water due to evaporation. Occasionally, intermediate measurements were also taken several times during a long period of rain, as the bottle waters were limited in sizes. At stucco walls W7 and W8, 1 L jar and bottle were used, while at vinyl siding walls, 500 mL bottles were used.

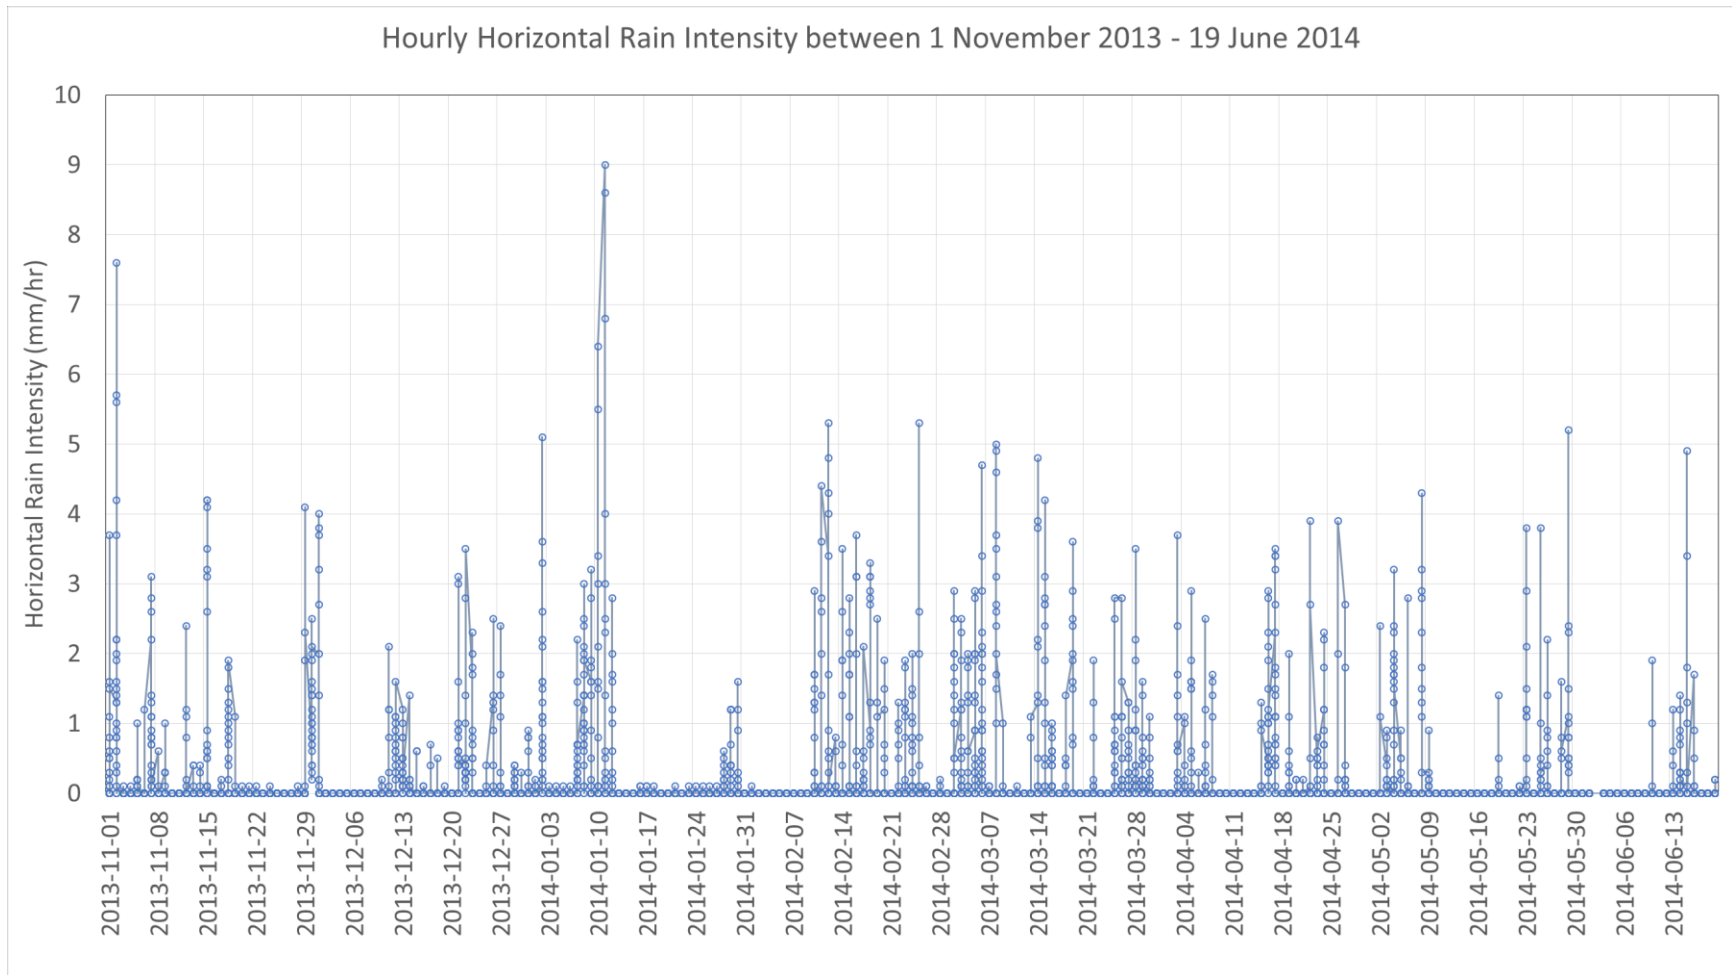
Figure 33. Horizontal rain intensity during the period of 1 November 2013 – 19 June 2014.

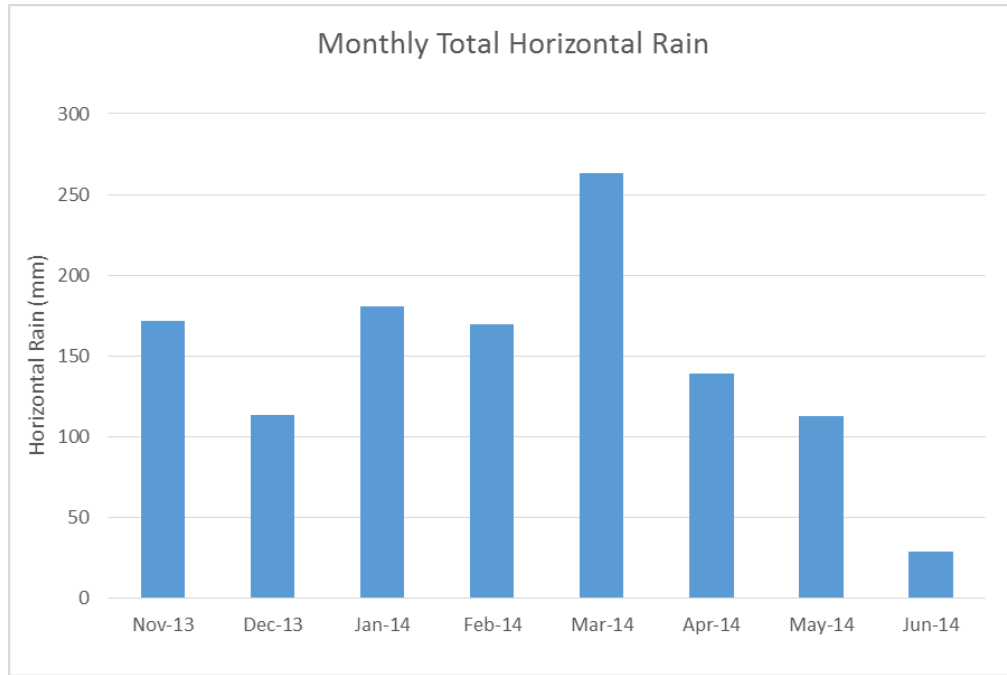
Figure 34. Horizontal rain summarized by the months.

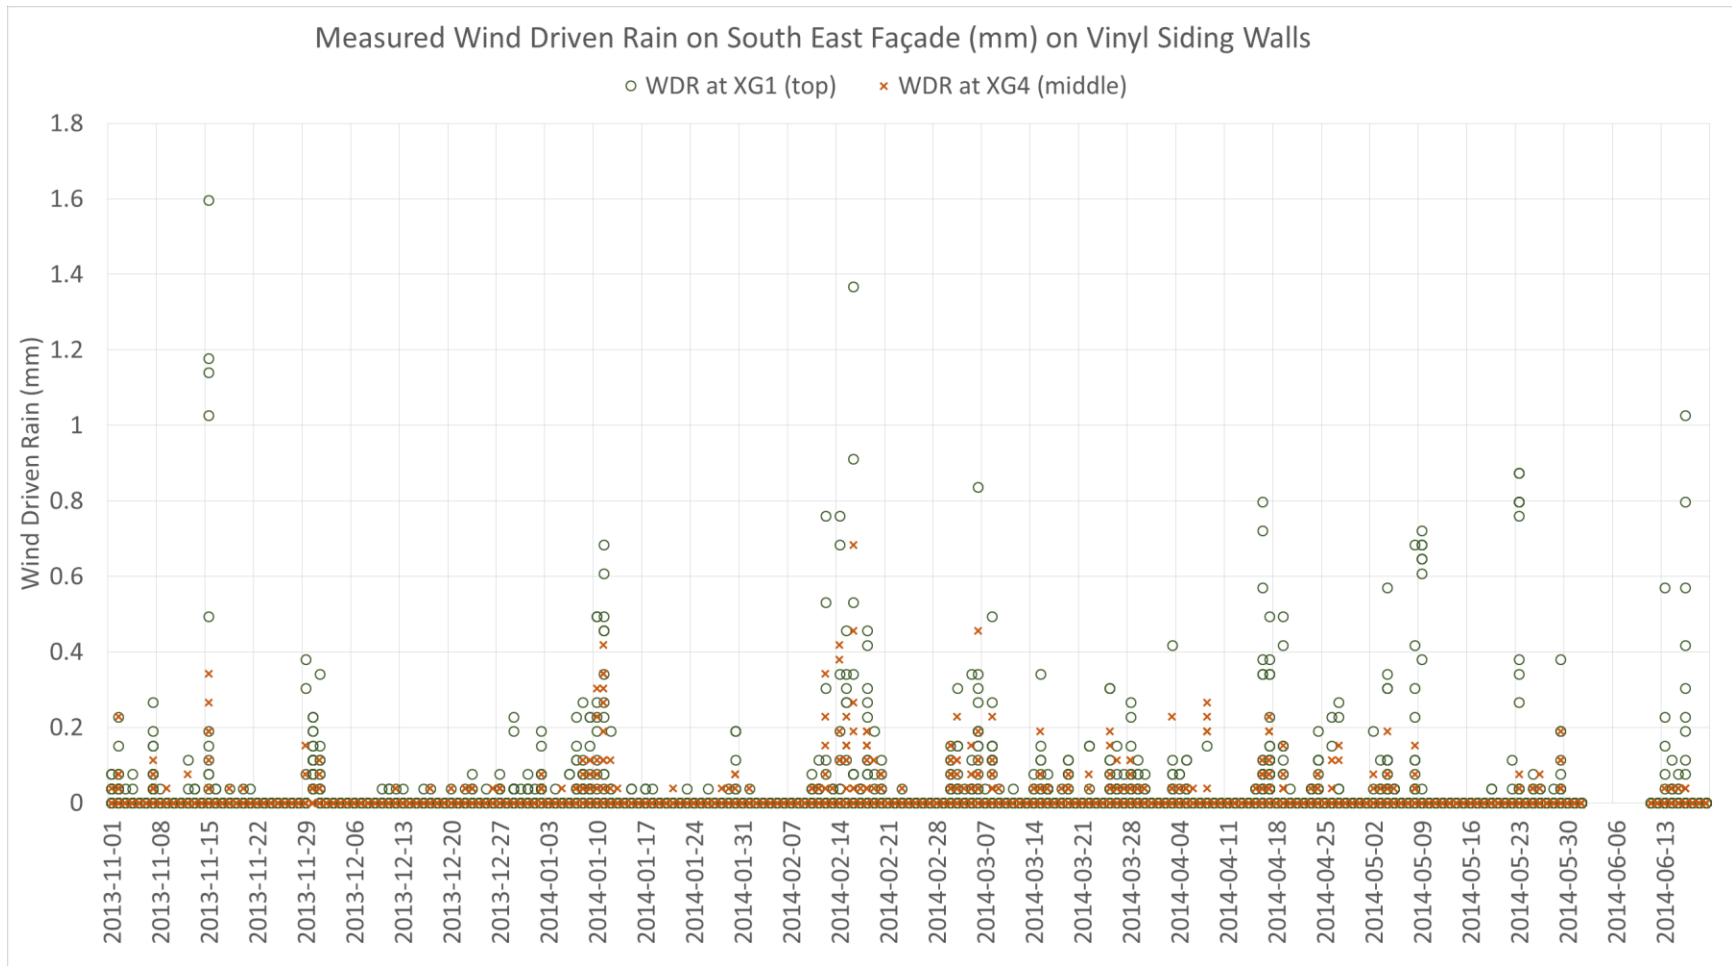
Figure 36. Measured wind driven rain amount by wall rain gauges XG1 and XG4 near vinyl siding walls during November 1, 2013 to June 19, 2014.

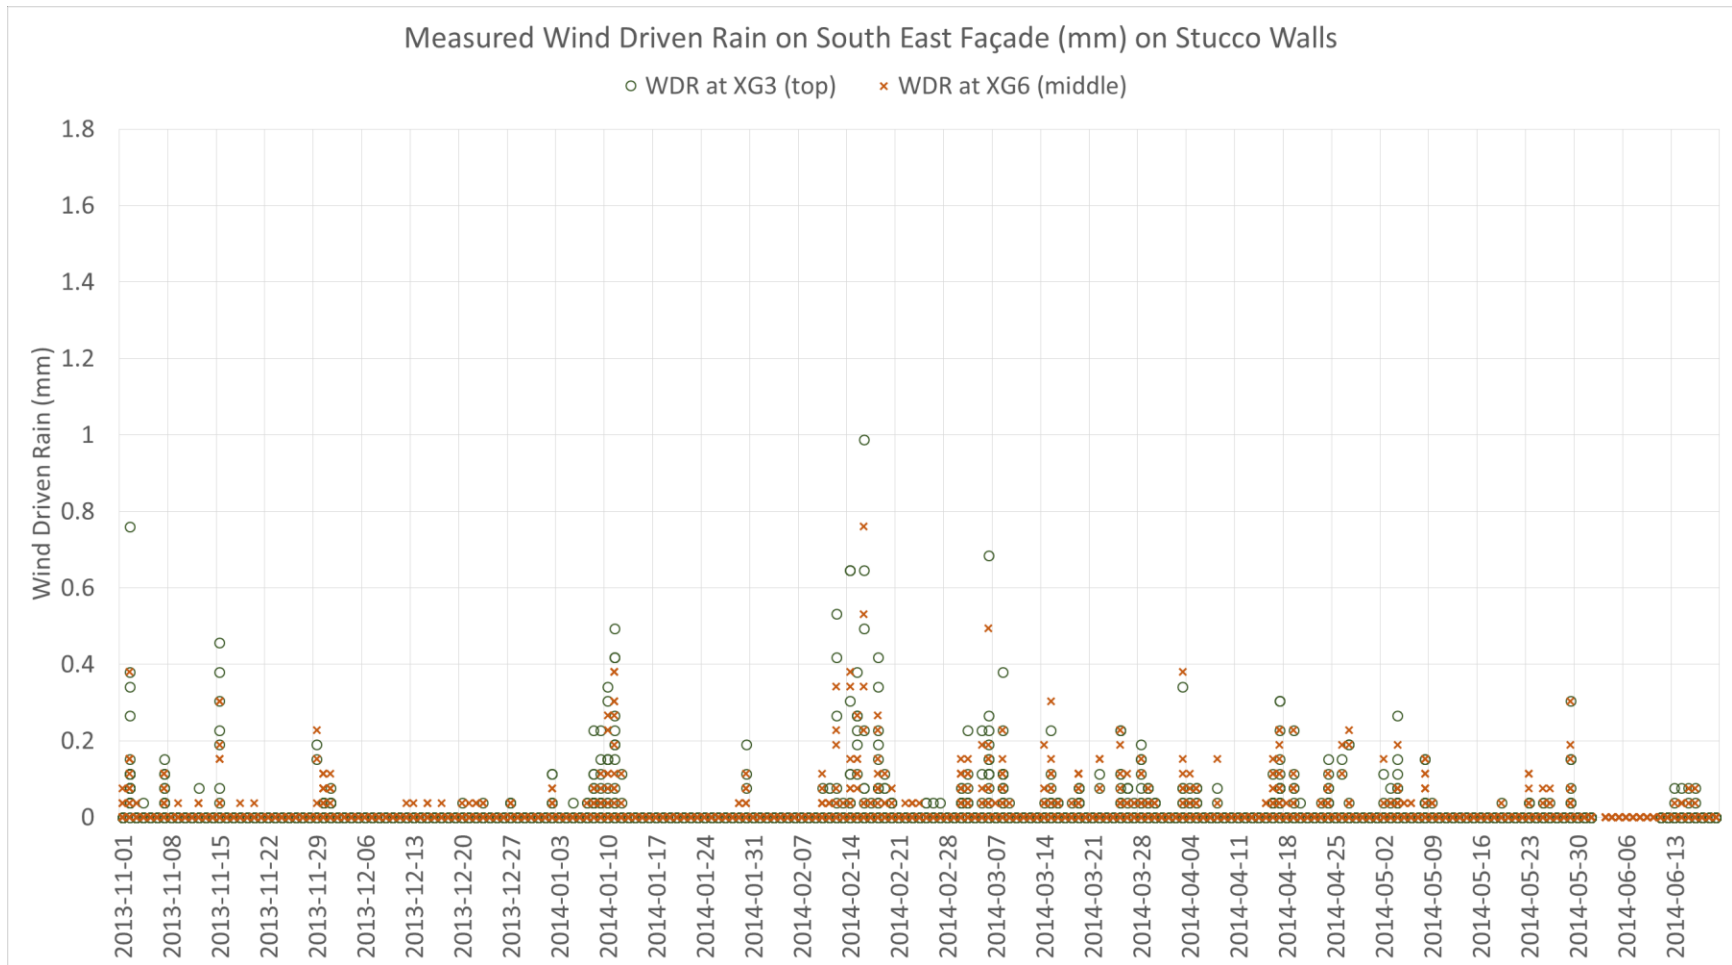
Figure 37. Measured wind driven rain amount by wall rain gauges XG3 and XG6 near stucco walls during November 1, 2013 to June 19, 2014.

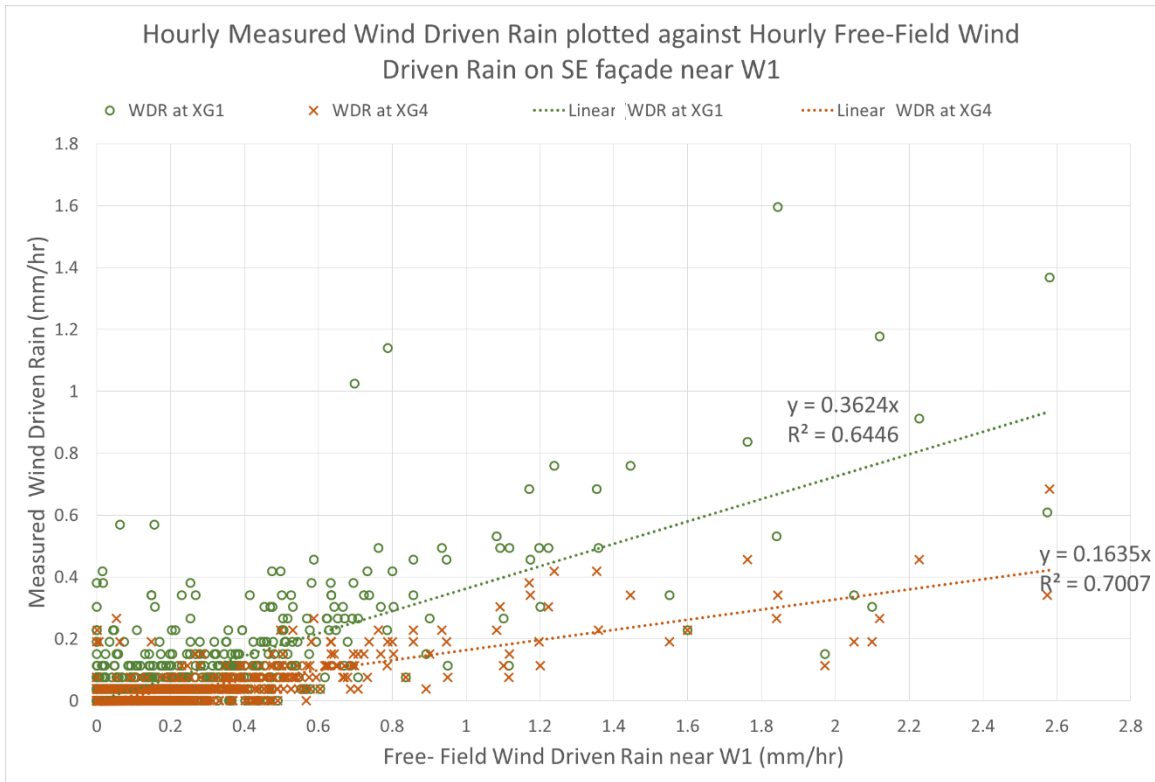
Figure 38. Hourly measured wind driven rain plotted against the free-field wind driven rain near W1. The slope of the regression lines reflects the Rain Admittance Factors (RAF).
