Field Study of Wind Driven Rain Penetration into Vinyl Sidings and Stucco-Clad Wood-Frame
Wall Systems at Window Sill

A Thesis

Building, Civil and Environmental Engineering

September 2015

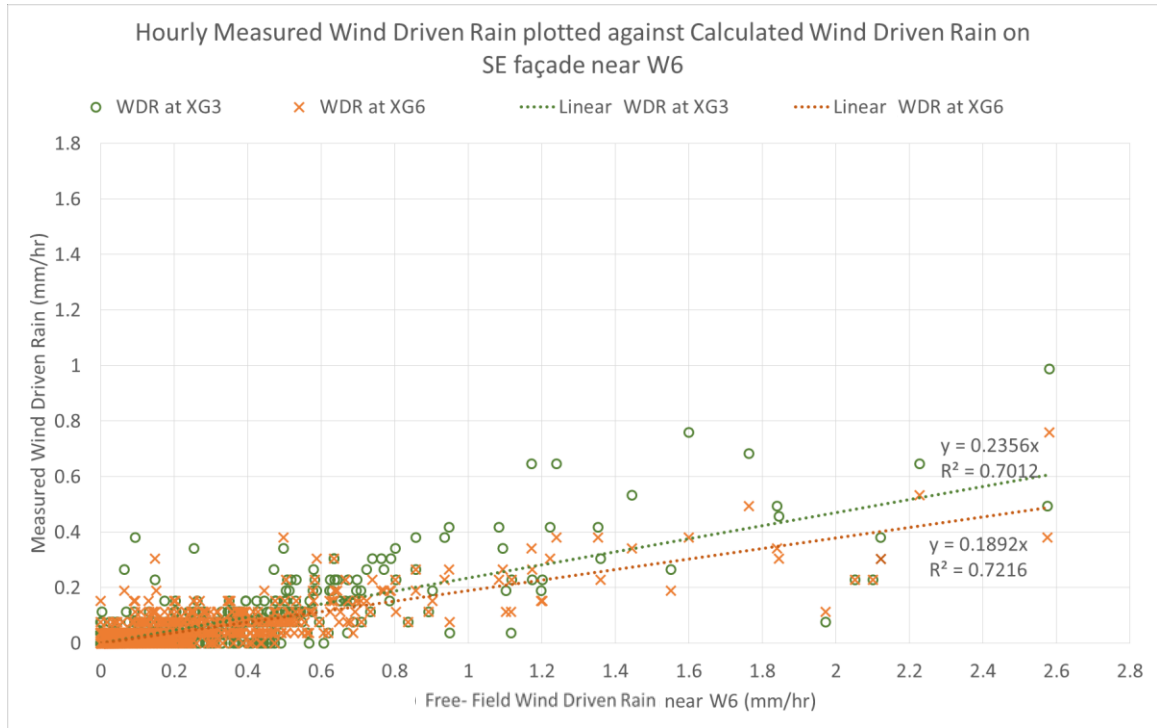
Figure 39. Hourly measured wind driven rain plotted against the free-field wind driven rain near W6. The slope of the regression lines reflects the Rain Admittance Factors (RAF).

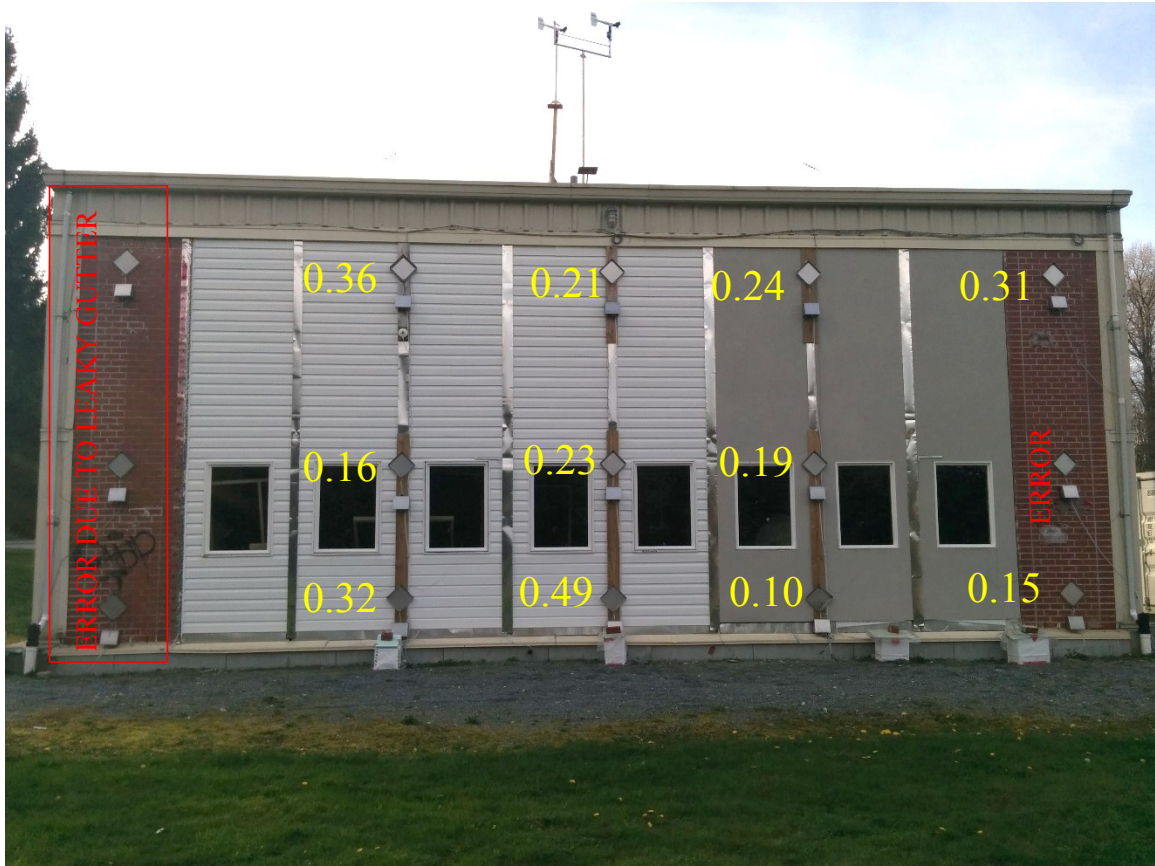
Figure 40. Rain Admittance Factors (numbers in yellow) calculated based on the measured WDR at the respective wall rain gauges and the free-field WDR as calculated following the Straube and Burnett’s method.

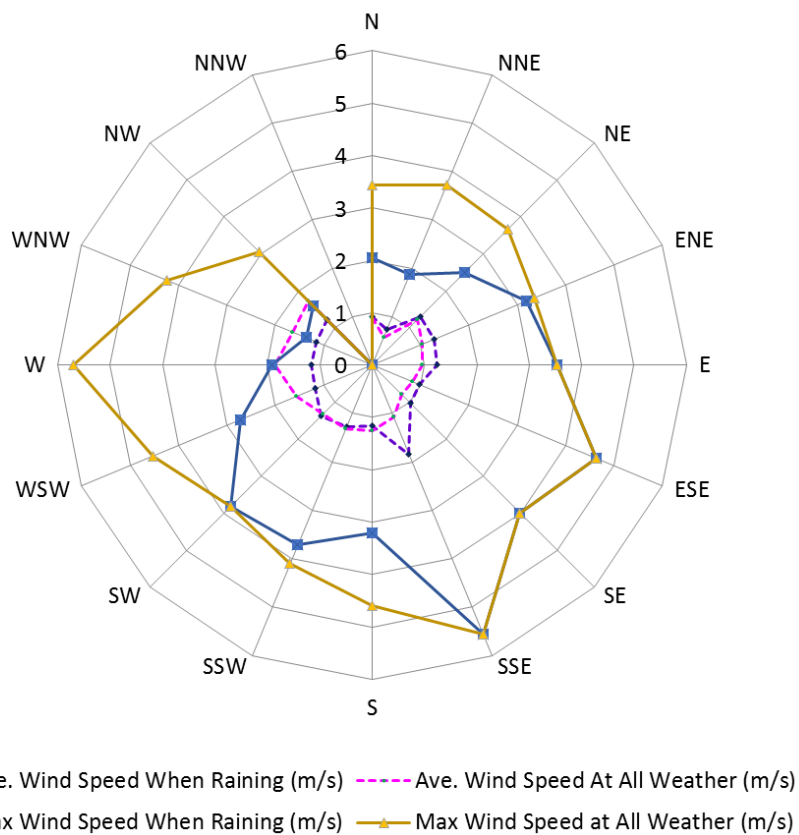
Figure 42. Hourly averages and maximums of minute records of wind speed at each wind directions during rain and at all weather conditions for BCIT Burnaby in November 2013 – June 2014.

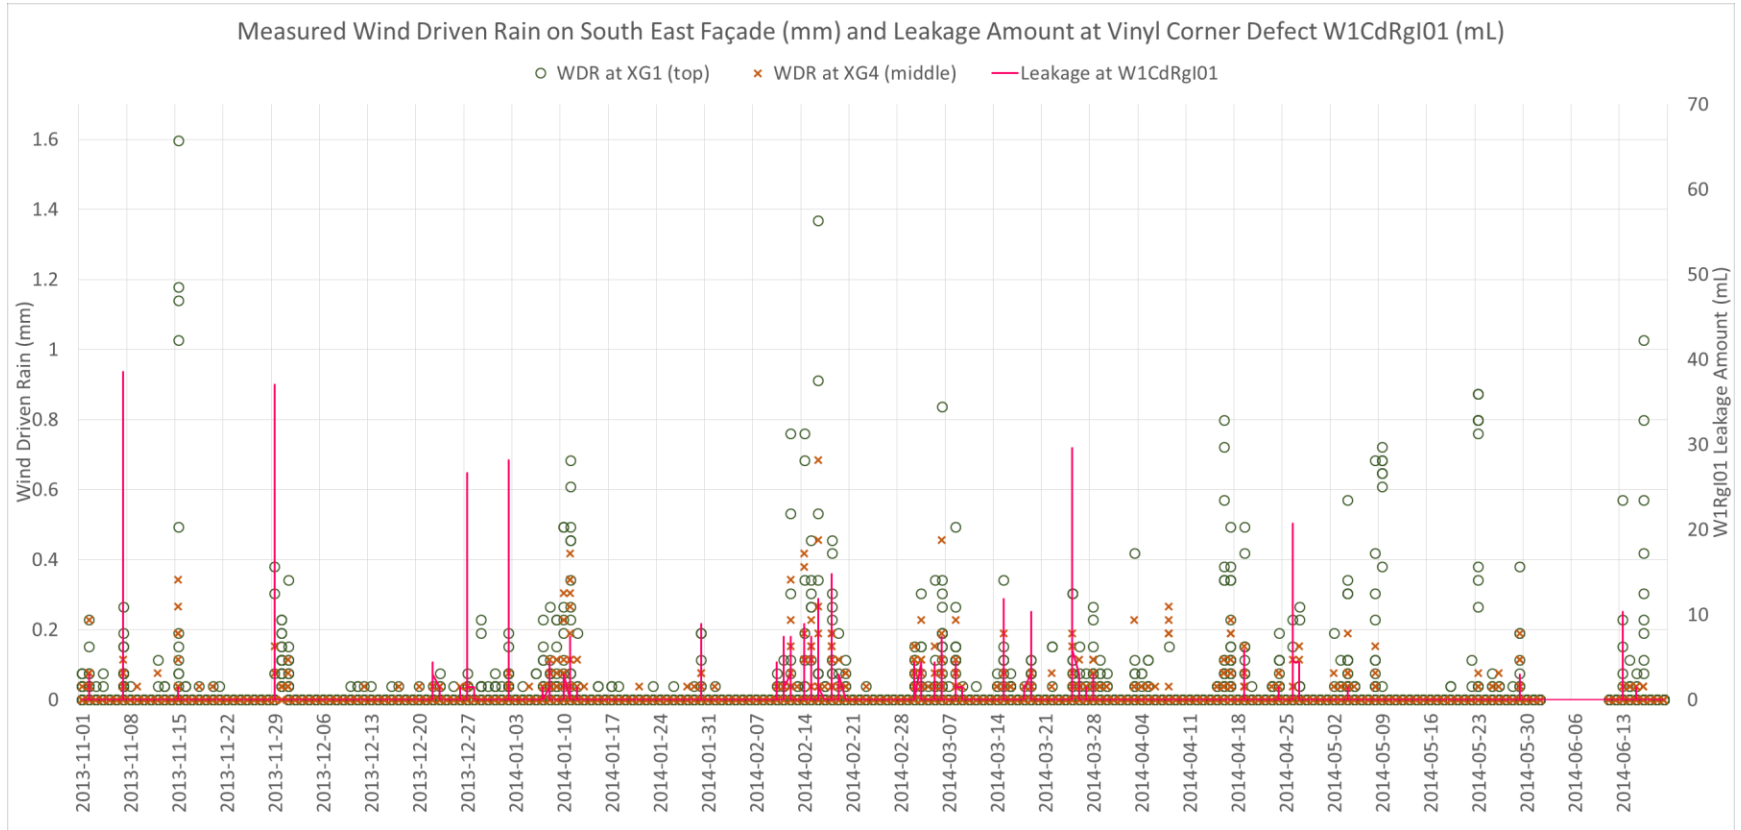
Figure 43. Measured hourly wind driven rain intensity on South East Façade in November 1, 2013 – June 19, 2014, overlapped with the leakage amount at W1 (window sill corner collection of the vinyl siding wall).

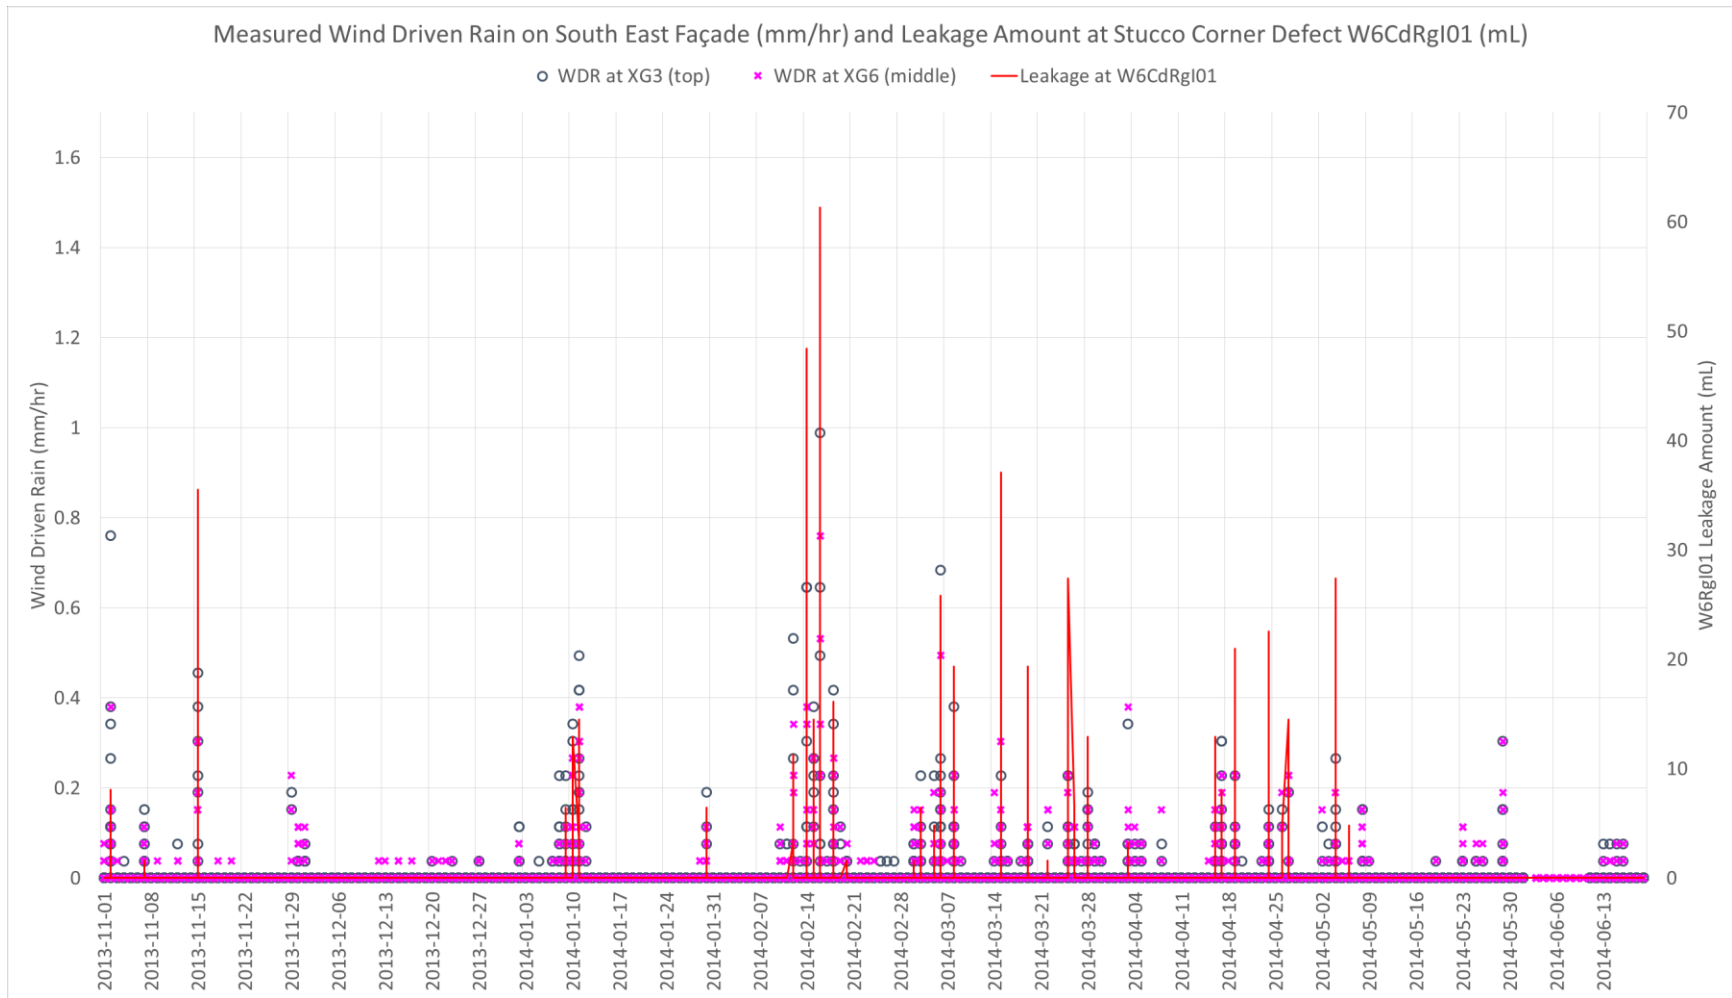
Figure 44. Measured hourly wind driven rain intensity on South East Façade in November 1, 2013 – June 19, 2014, overlapped with the leakage amount at W6 (window sill corner defect at the stucco wall).

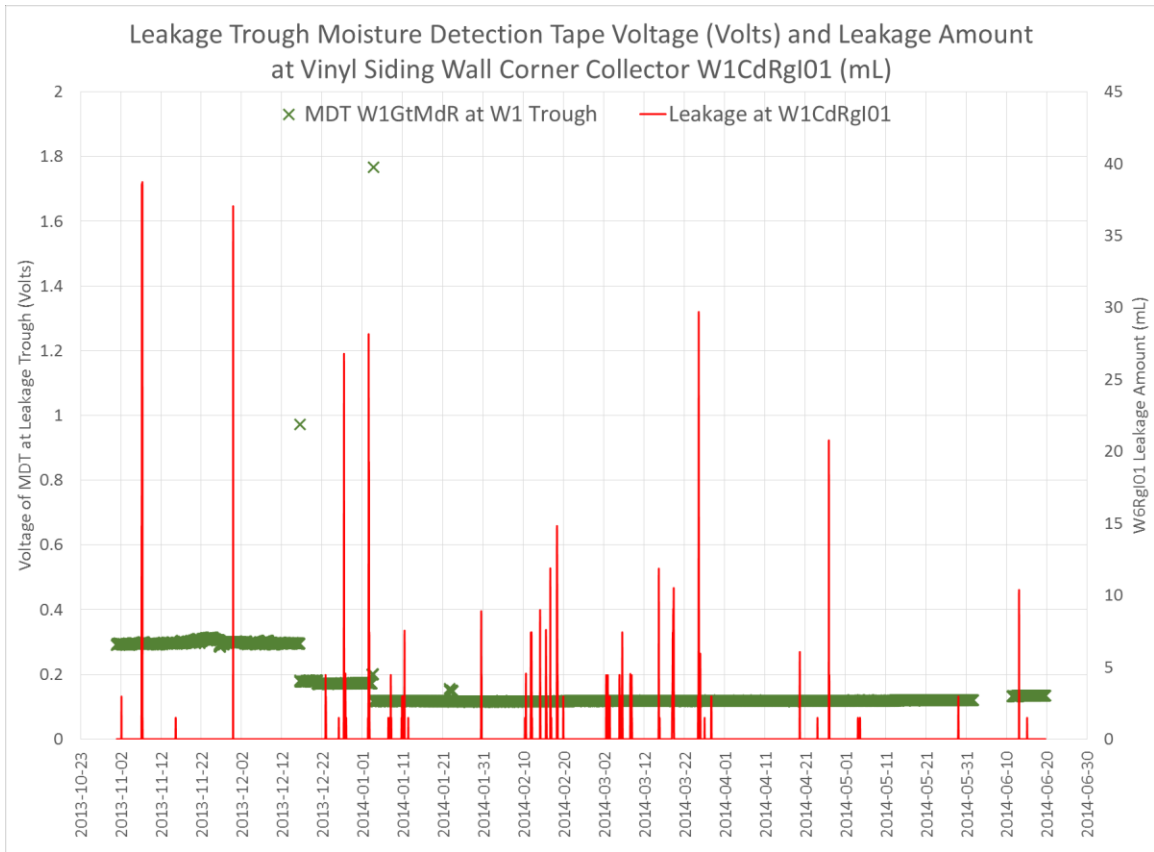
Figure 45. Leakage trough moisture detection tape voltage compared to the leakage amount at vinyl siding corner defect.

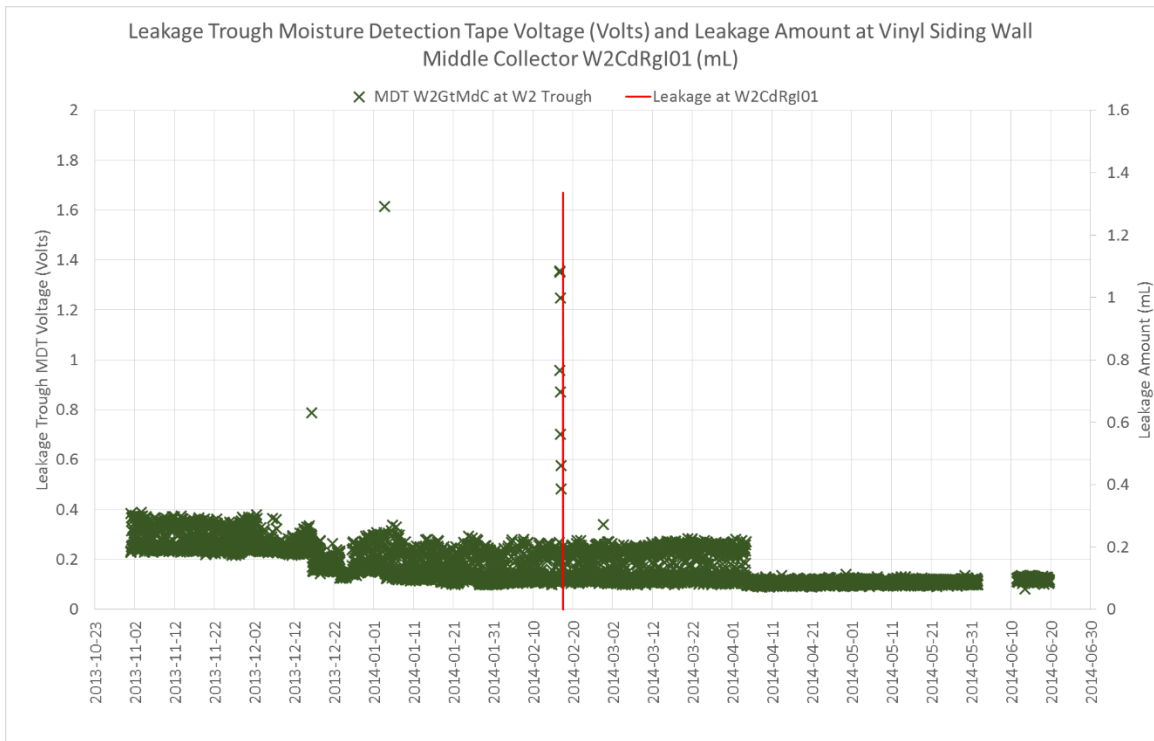
Figure 46. Leakage trough moisture detection tape voltage compared to the leakage amount at vinyl siding middle collection gauge.

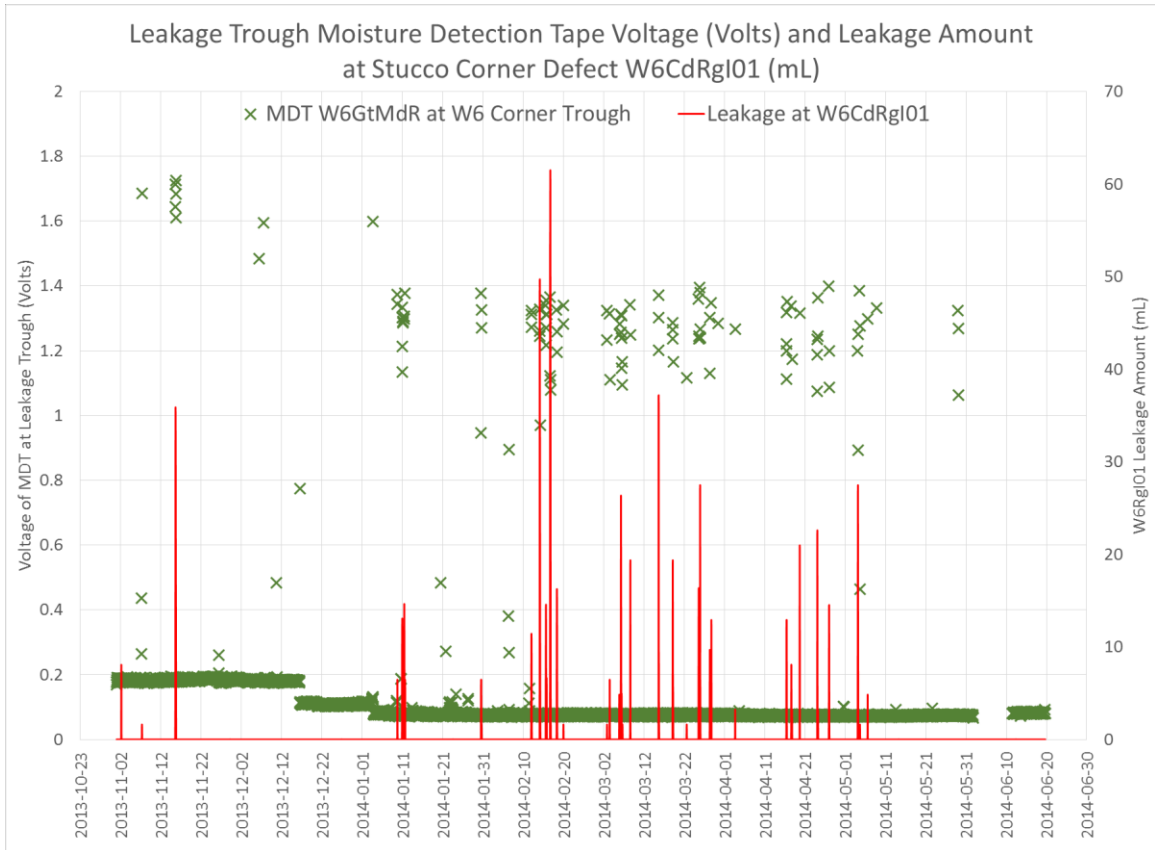
Figure 47. Leakage trough moisture detection tape voltage compared to the leakage amount at stucco wall W6 corner defect collection gauge.

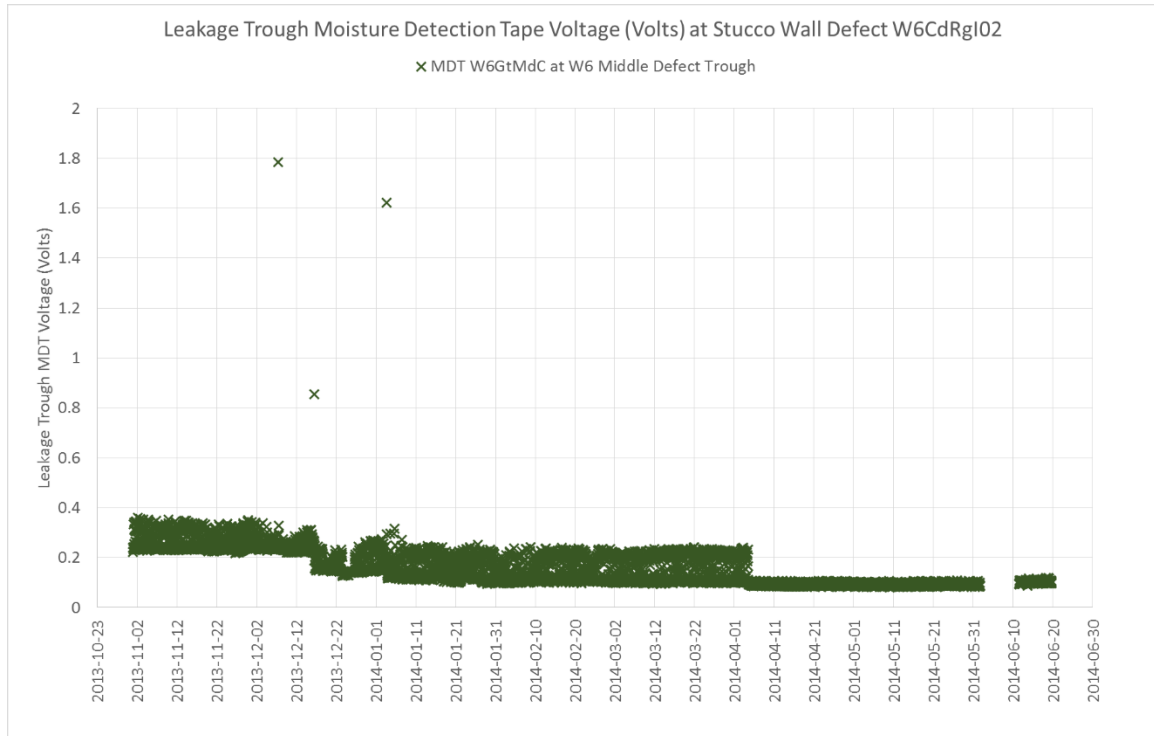
Figure 48. Leakage trough moisture detection tape voltage compared to the leakage amount at stucco wall W6 middle defect collection gauge.

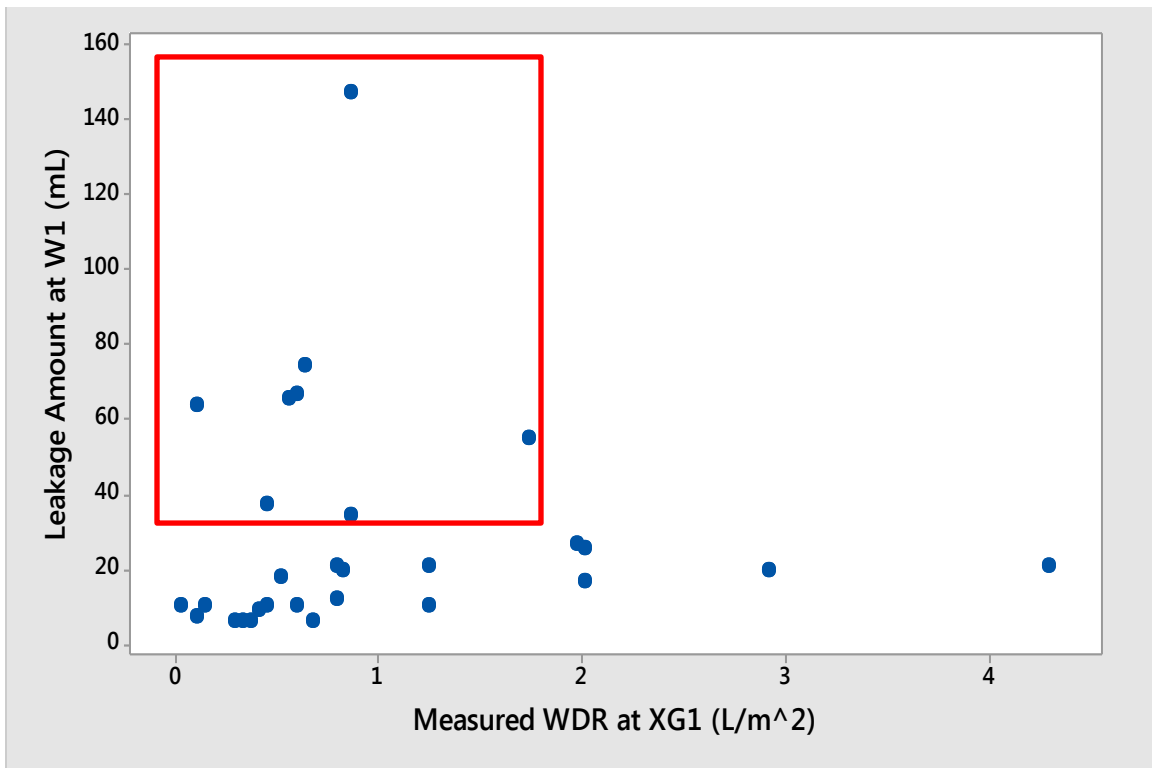
Figure 49. Plot of leakage amount at W1 leakage gauge collector to measured WDR amount at wall rain gauge XG1. A red box highlights unusual leakage events, where the leakage amount is more than 30 mL but the measured WDR is less than 2 L/m².

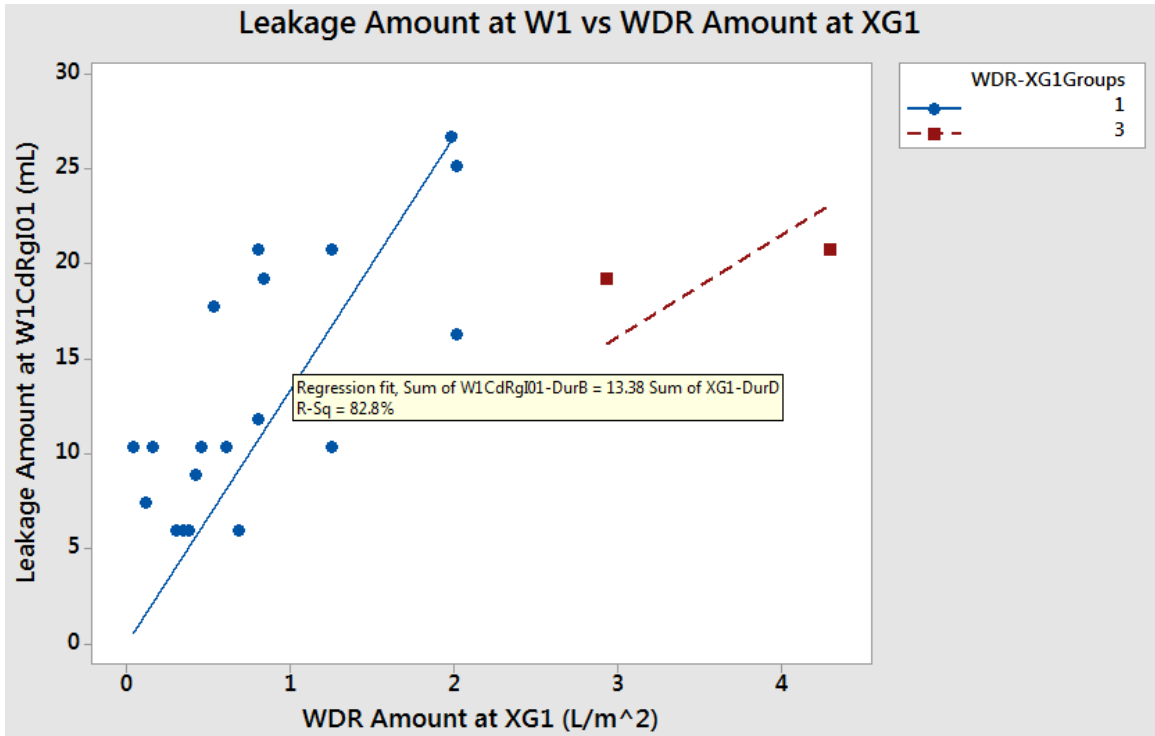
Figure 50. Scatterplot of leakage amount at W1 vinyl siding wall against wind driven rain amount at XG1, after the exclusion of unusually high leakage events as outliers and leakage events with 2 tips or less.

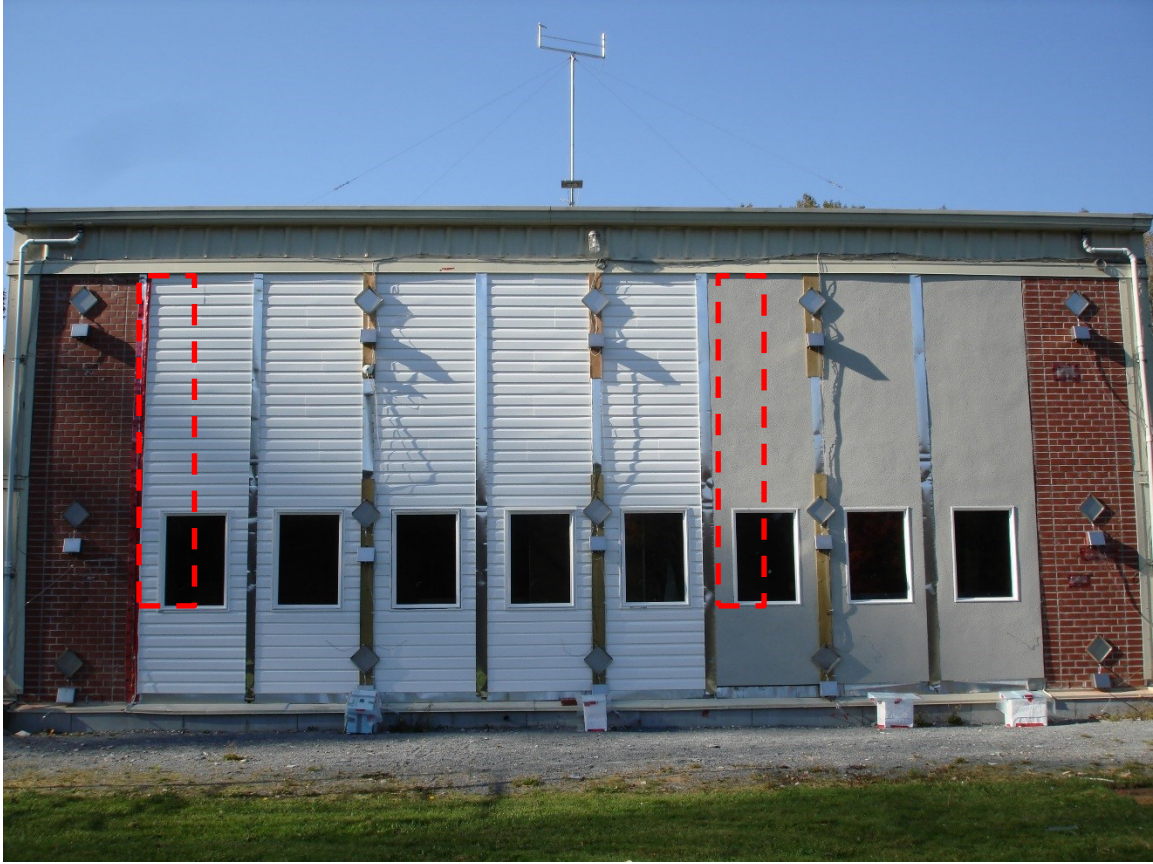
Figure 51. Areas of 2.42 m² each above the windows of W1 and W6, assumed to be catchment area of the WDR contributing to the leakage amount at the sill corners leakage collection points.

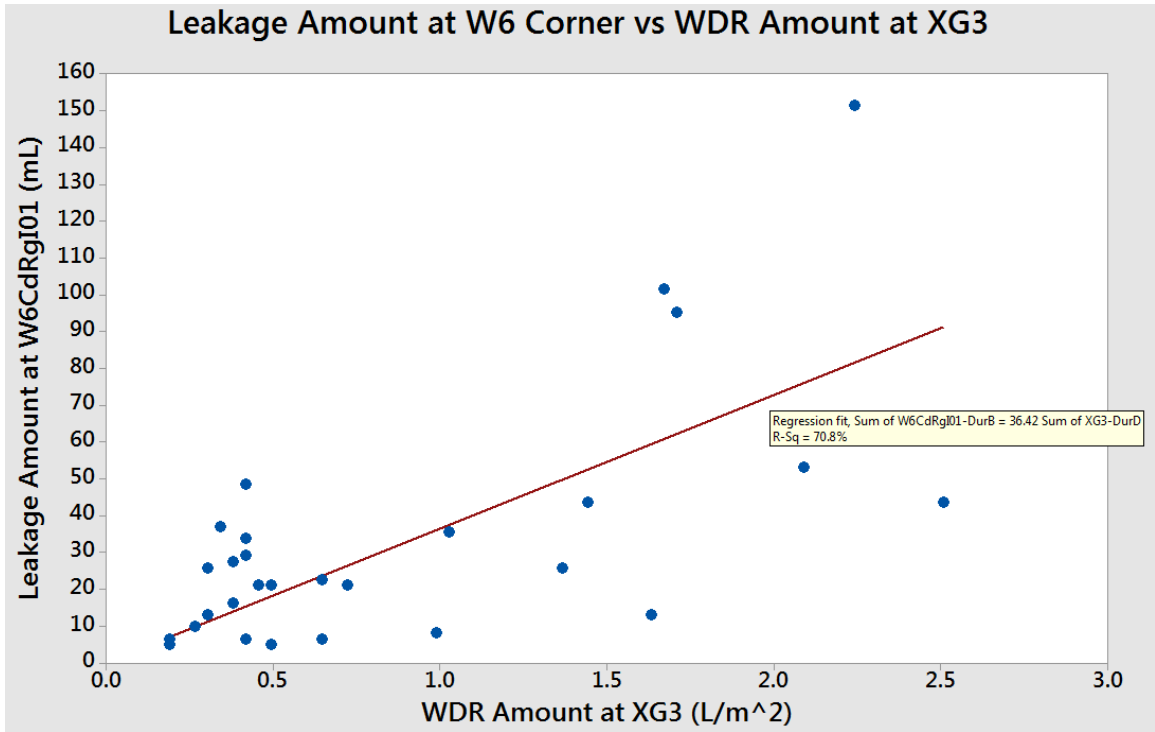
Figure 52. Plot of leakage amount at W6 corner leakage gauge collector to measured WDR amount at rain gauge XG3. Leakage events with 2 tips or less at the leakage gauge measurement are excluded.

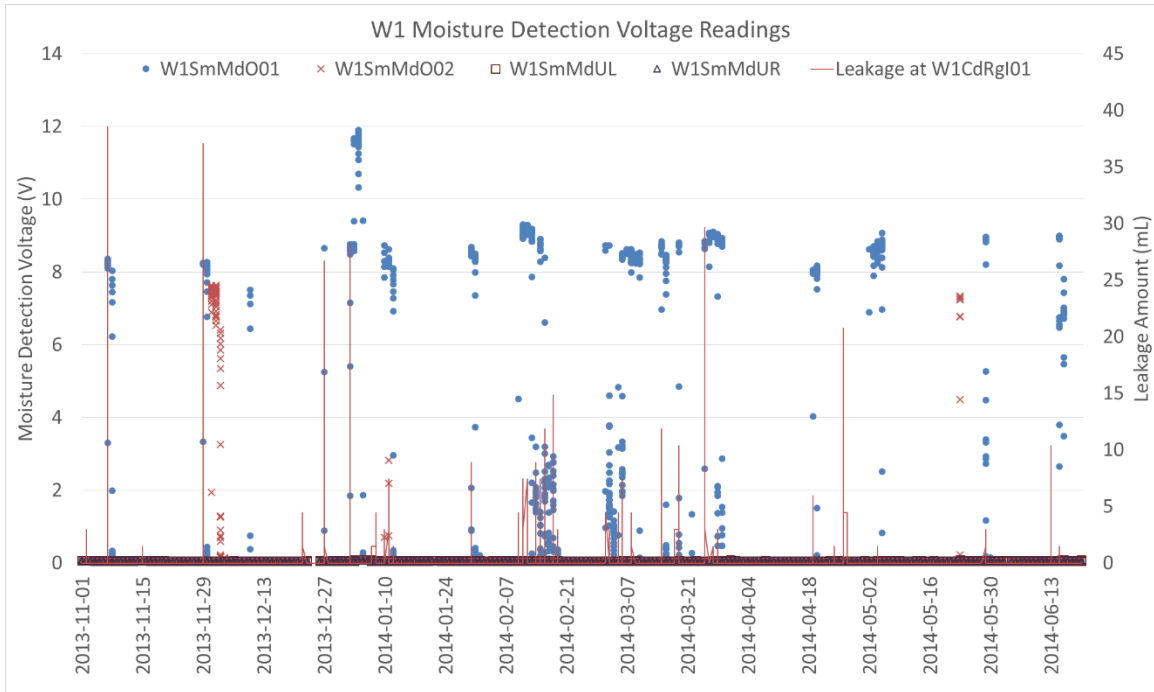
Figure 55. W1 moisture detection tape voltage readings from November 2013 – mid June 2014 compared to the measurements at leakage gauge W1.

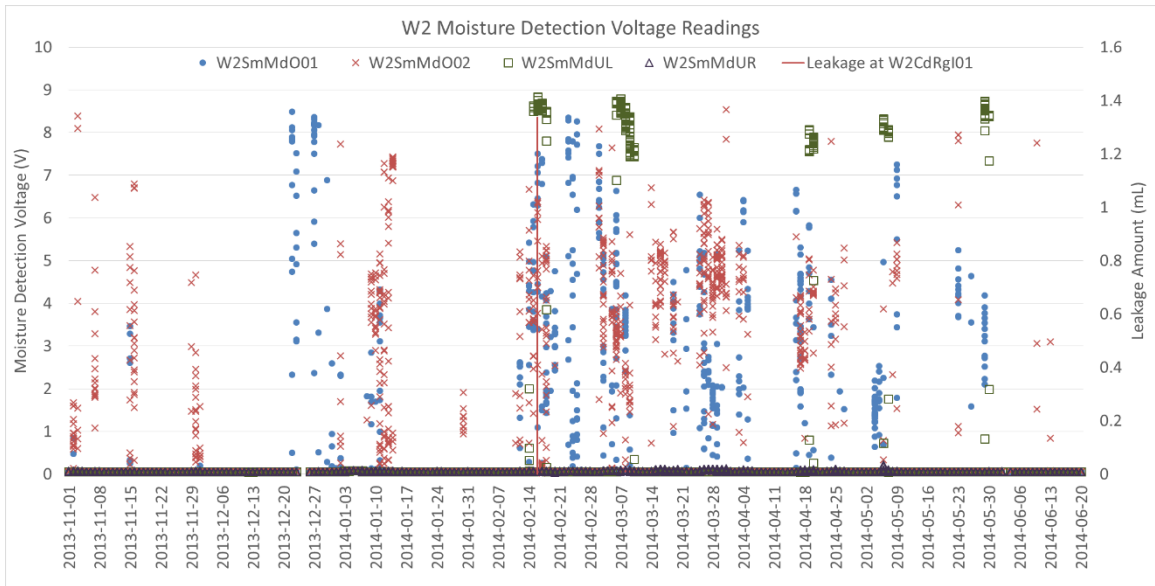
Figure 56. W2 moisture detection tape voltage readings from November 2013 – mid June 2014 compared to the measurements at leakage gauge W2.

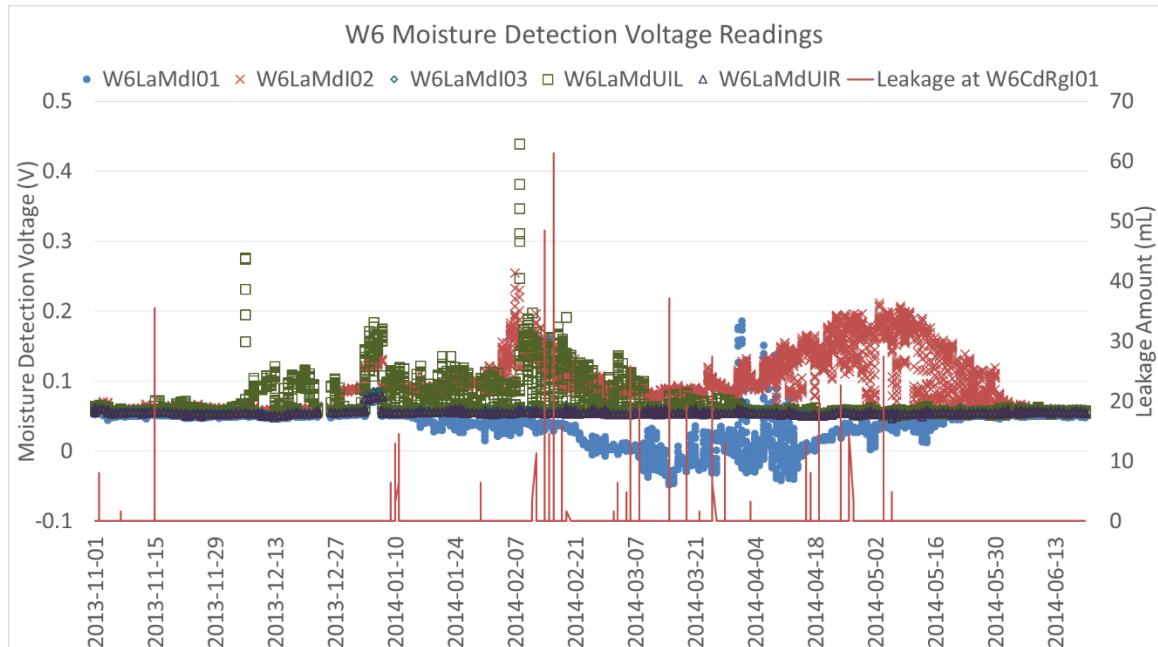
Figure 57. W6 moisture detection tape voltage readings from November 2013 – mid June 2014 compared to the measurements at leakage gauge W6 corner.

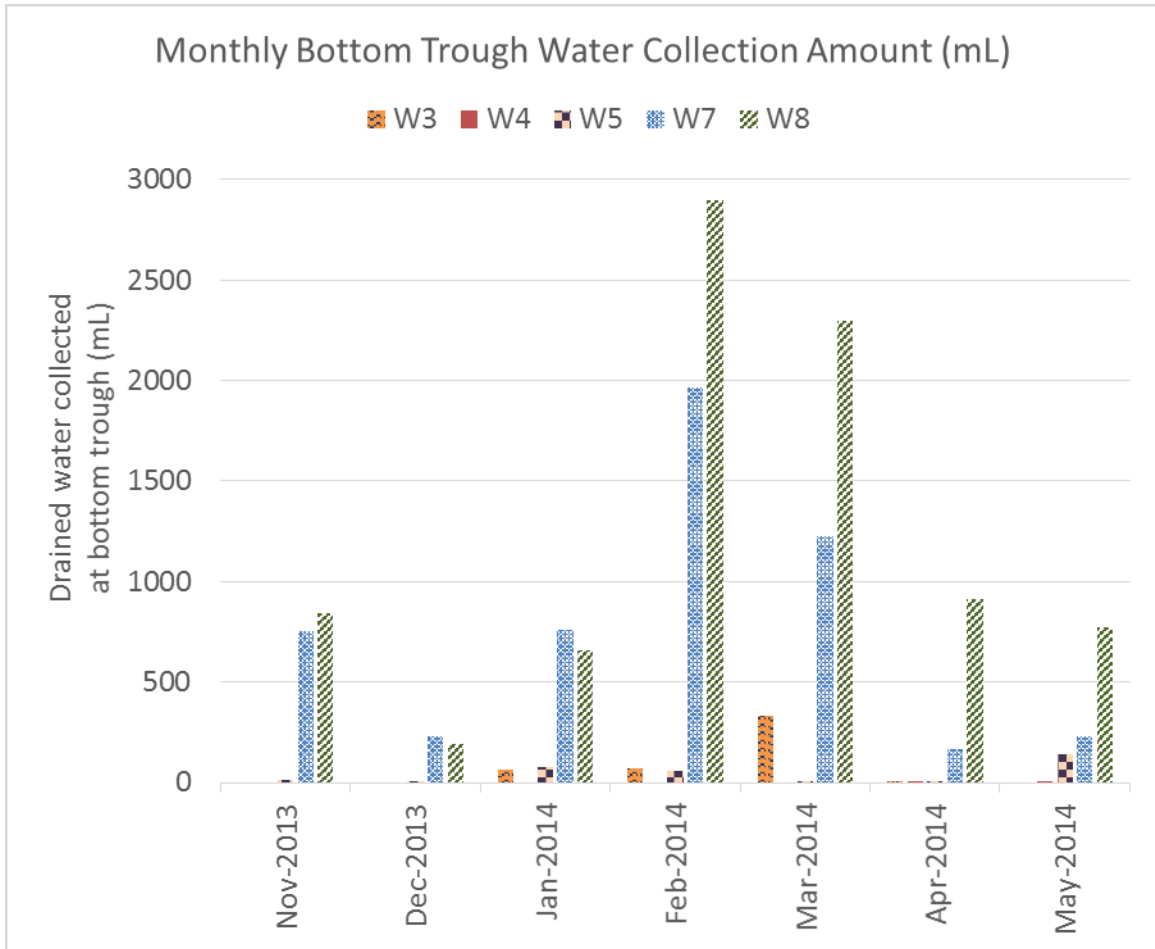
Figure 59. Monthly drainage water collection amount collected by bottom trough at the five long term performance walls.

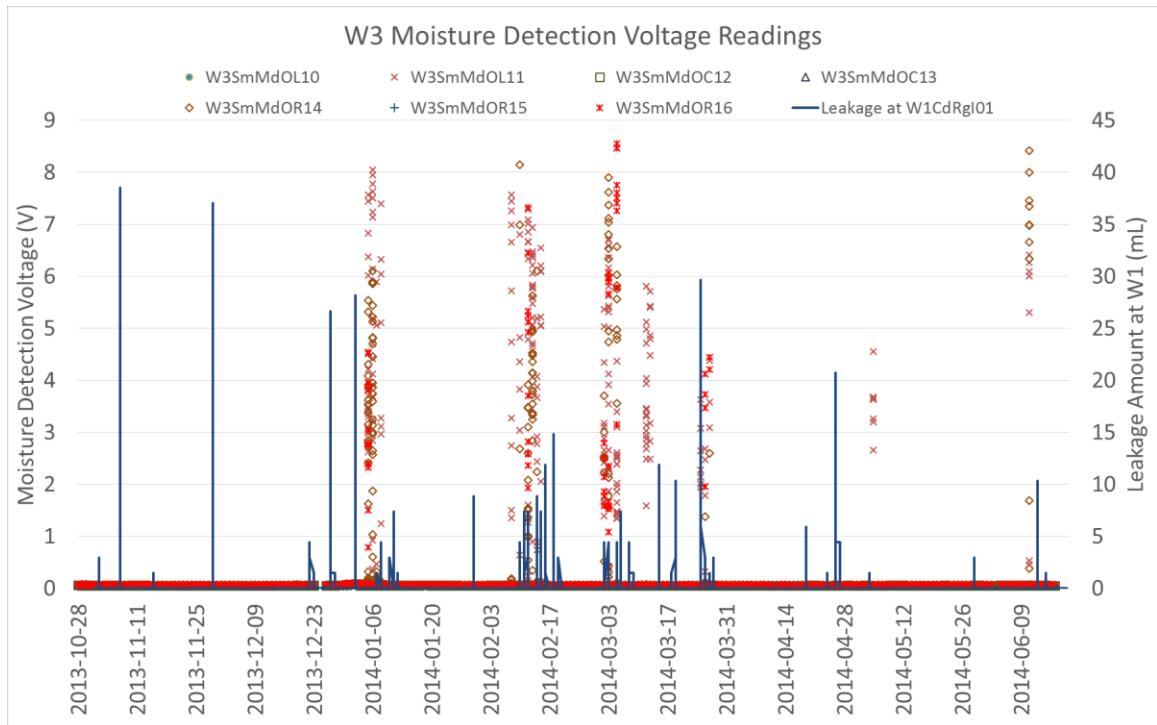
Figure 60. W3 moisture detection tape voltage readings from November 2013 – mid June 2014.

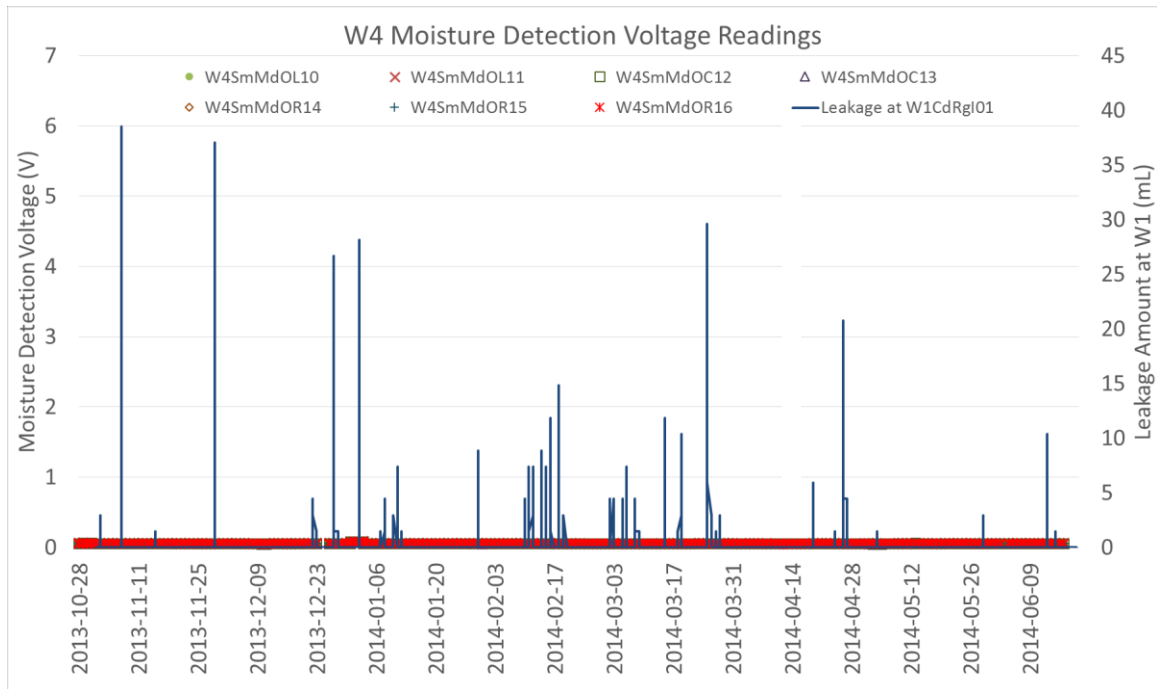
Figure 61. No significant moisture detection voltage readings were observed at W4.

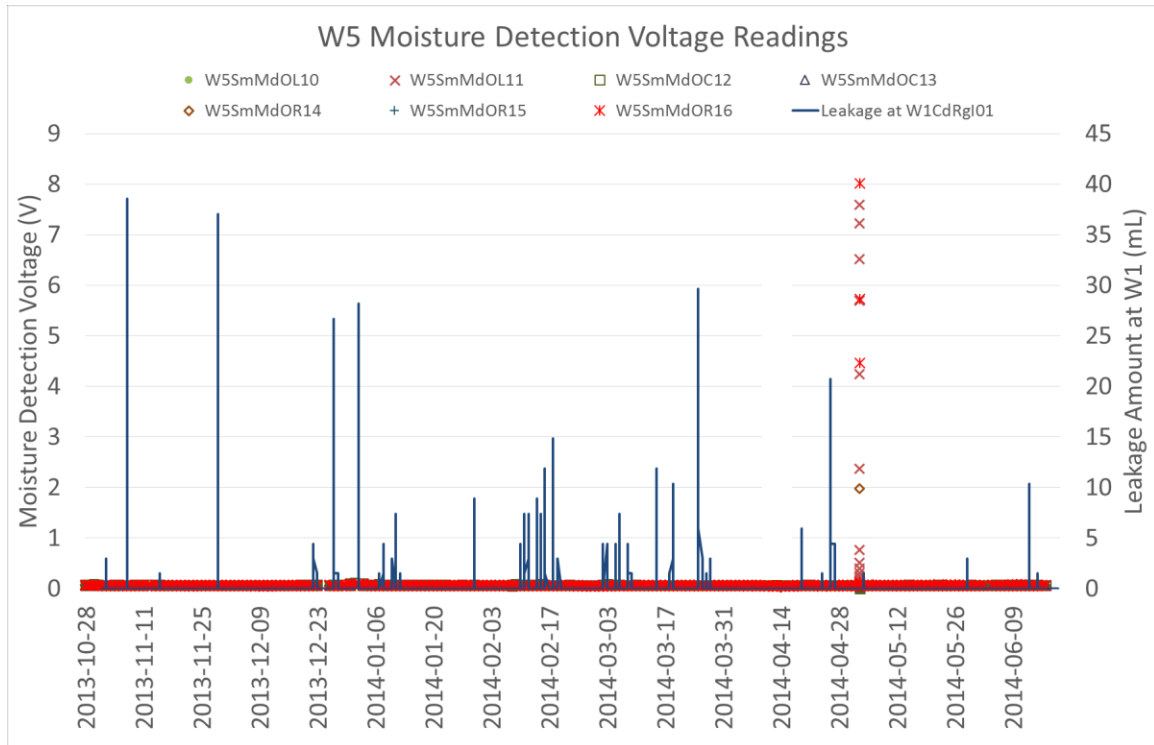
Figure 62. W5 moisture detection tape voltage readings from November 2013 – mid June 2014.

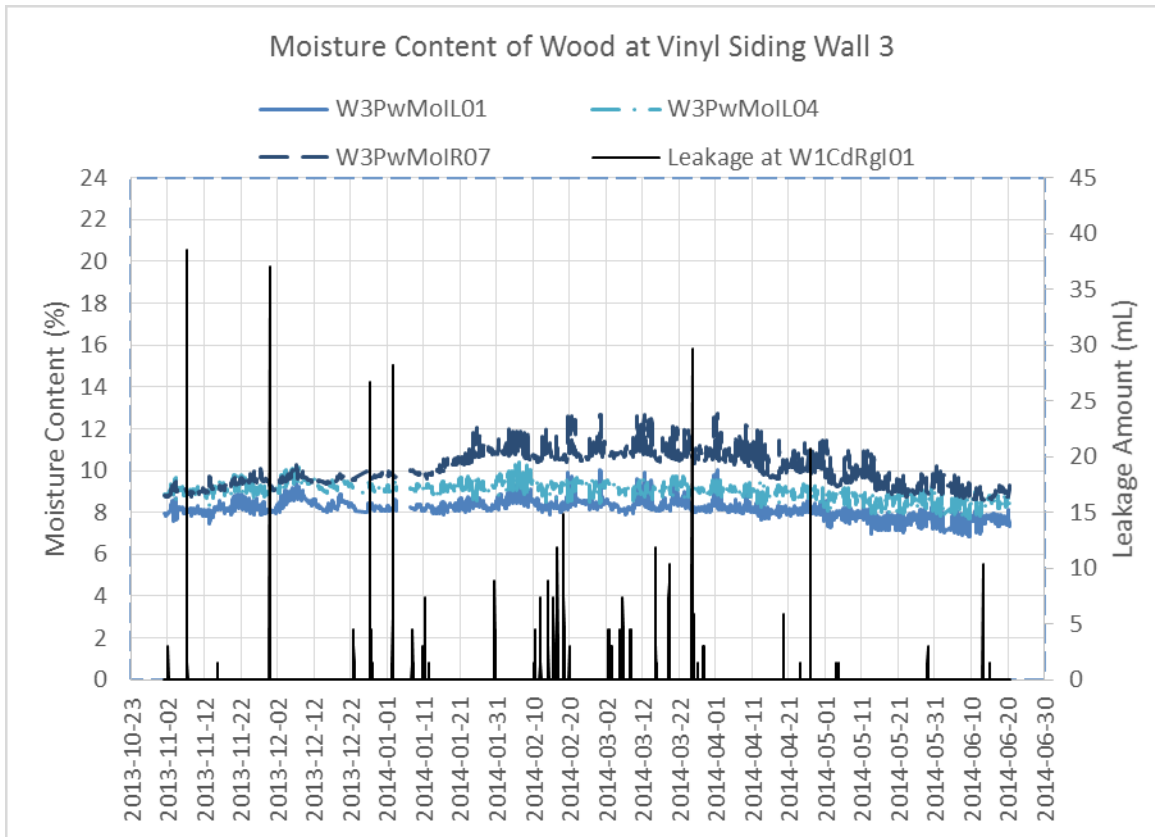
Figure 63. W3 Moisture content of plywood at upper moisture pin locations L01, L04, and R07, compared to the leakage amount at W1 as a reference to leakage events.

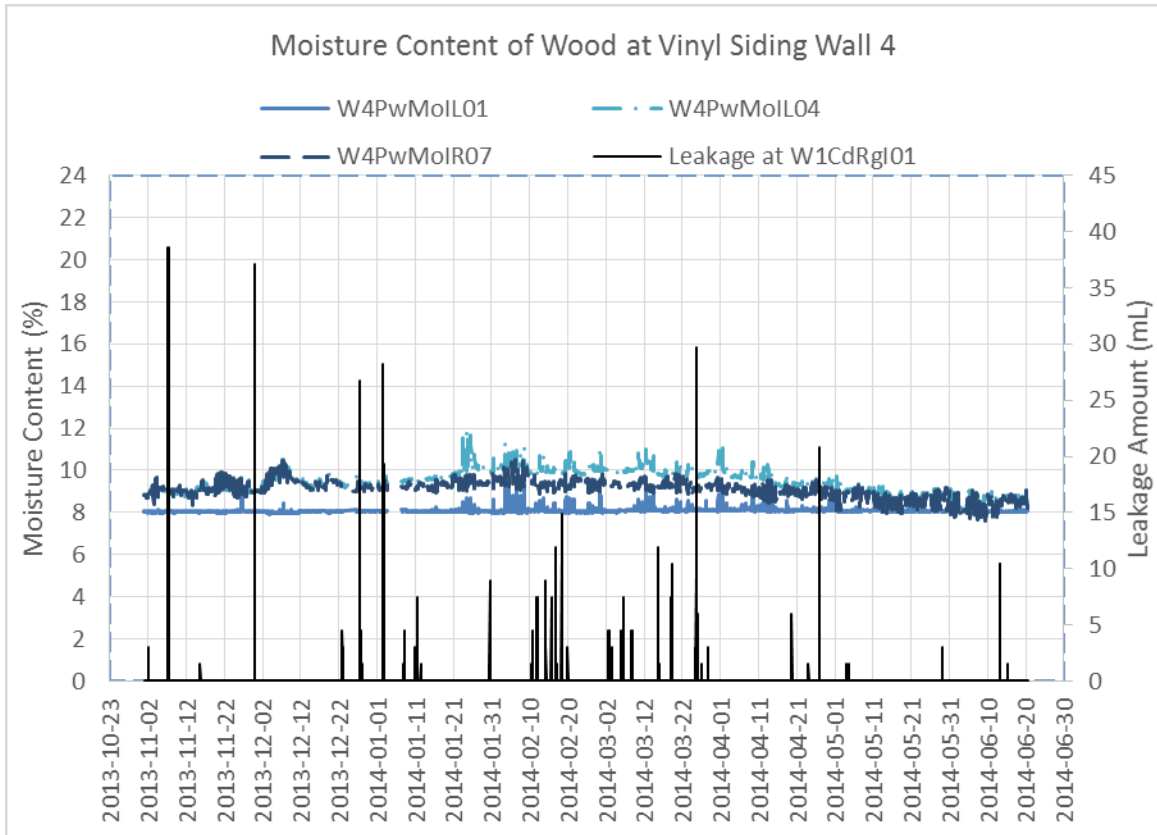
Figure 64. W4 Moisture content of plywood at upper moisture pin locations L01, L04, and R07, compared to the leakage amount at W1 as a reference to leakage events.

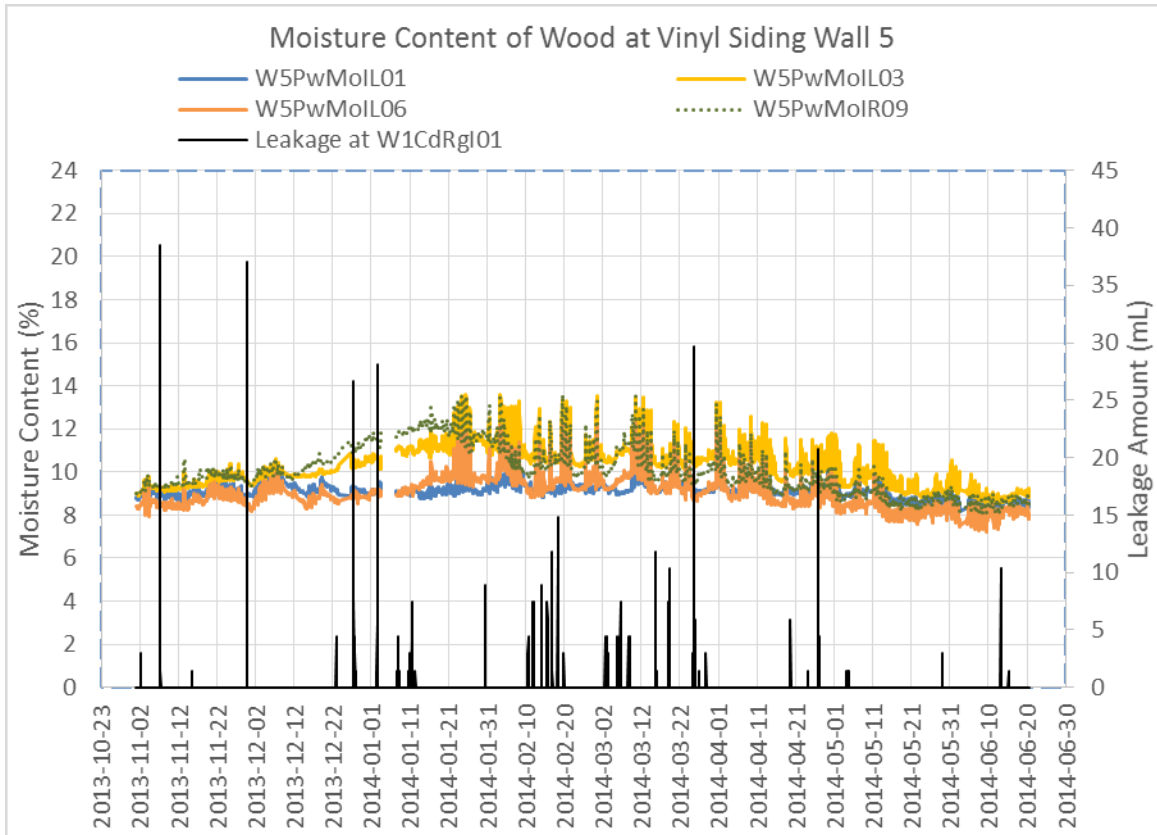
Figure 65. W5 Moisture content of plywood at moisture pin locations L01, L03, L06 and R09, compared to the leakage amount at W1 as a reference to leakage events.
