Field Study of Wind Driven Rain Penetration into Vinyl Sidings and Stucco-Clad Wood-Frame
Wall Systems at Window Sill

A Thesis

Building, Civil and Environmental Engineering

September 2015

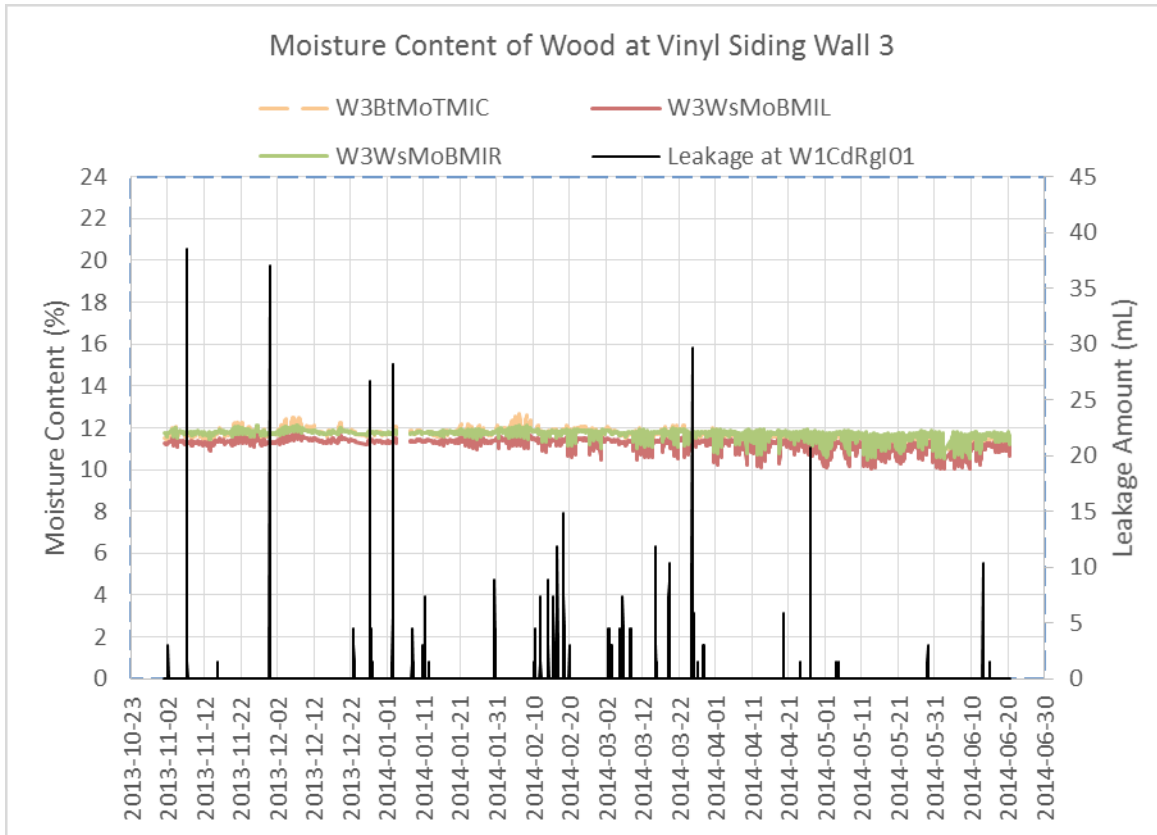
Figure 66. W3 Moisture content of window sill plate (locations BMIL and BMIR) and bottom plate (location TMIC), compared to the leakage amount at W1 as a reference to leakage events.

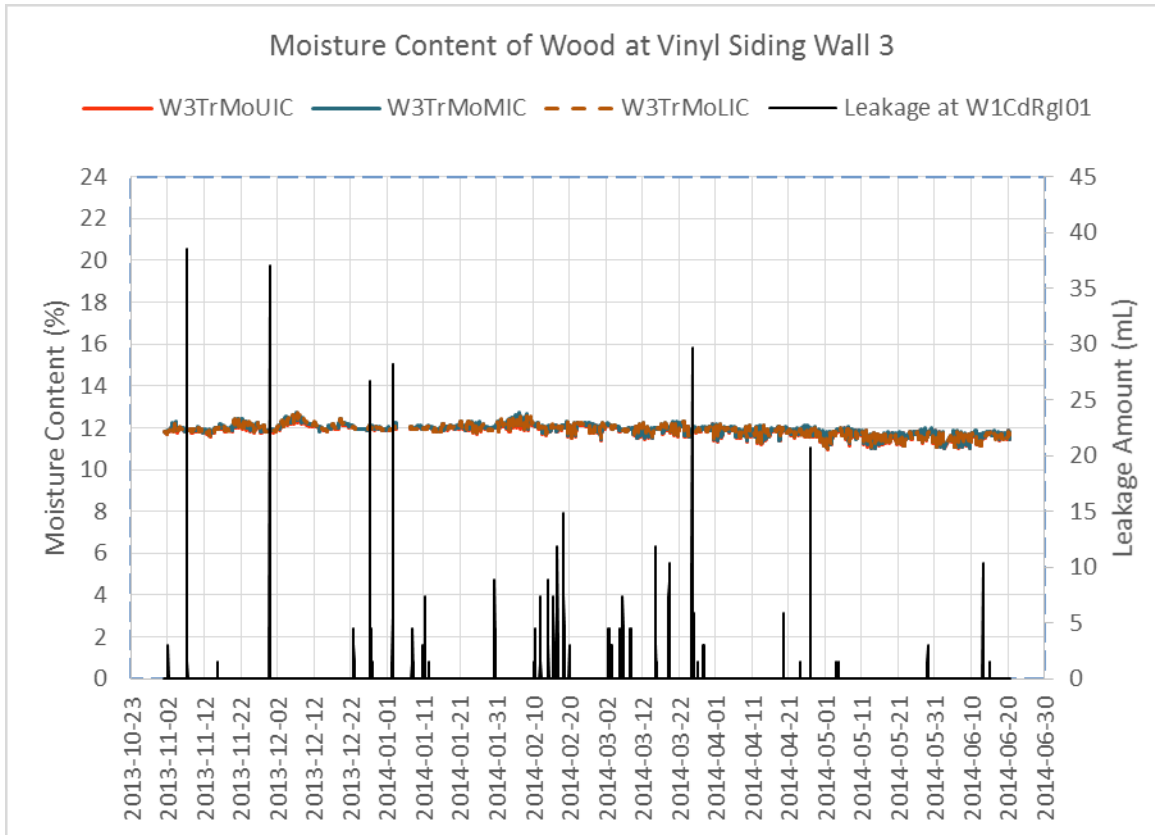
Figure 67. W3 Moisture content of stud next to wall cavity (locations UIC, MIC, and LIC), compared to the leakage amount at W1 as a reference to leakage events.

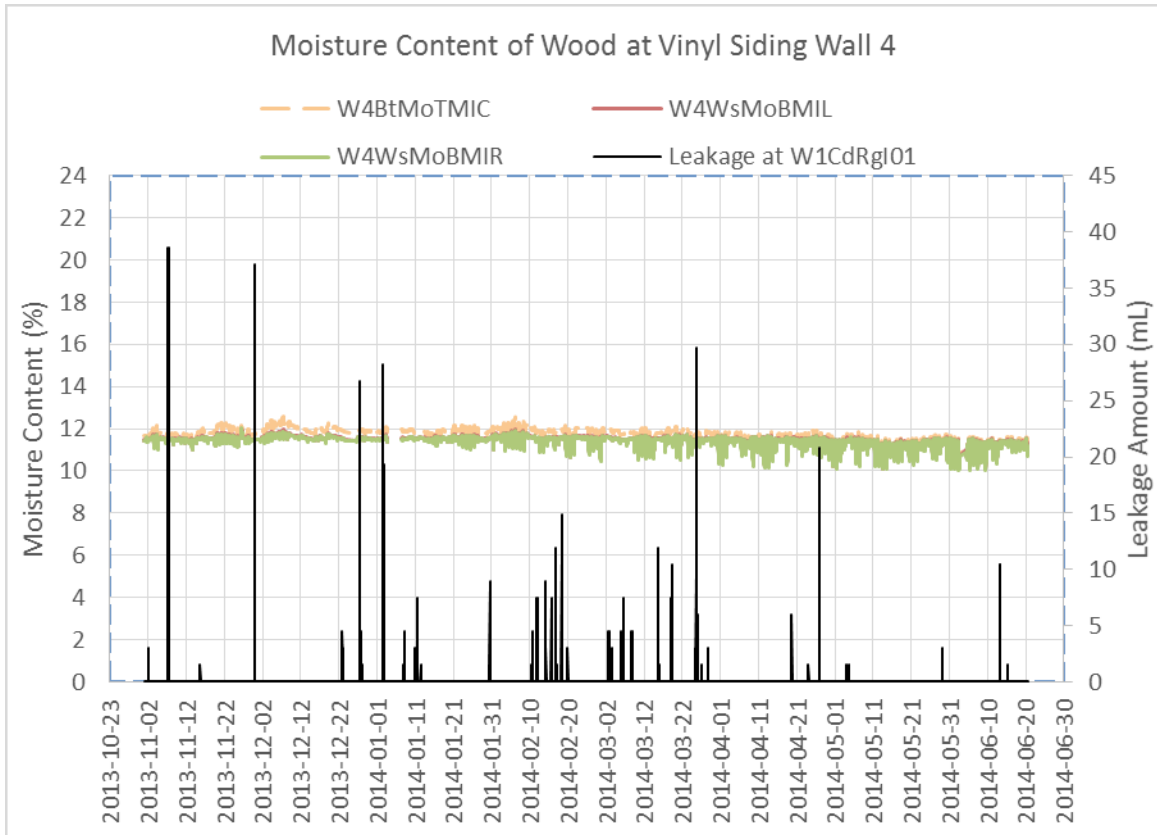
Figure 68. W4 Moisture content of window sill plate (locations BMIL and BMIR) and bottom plate (location TMIC), compared to the leakage amount at W1 as a reference to leakage events.

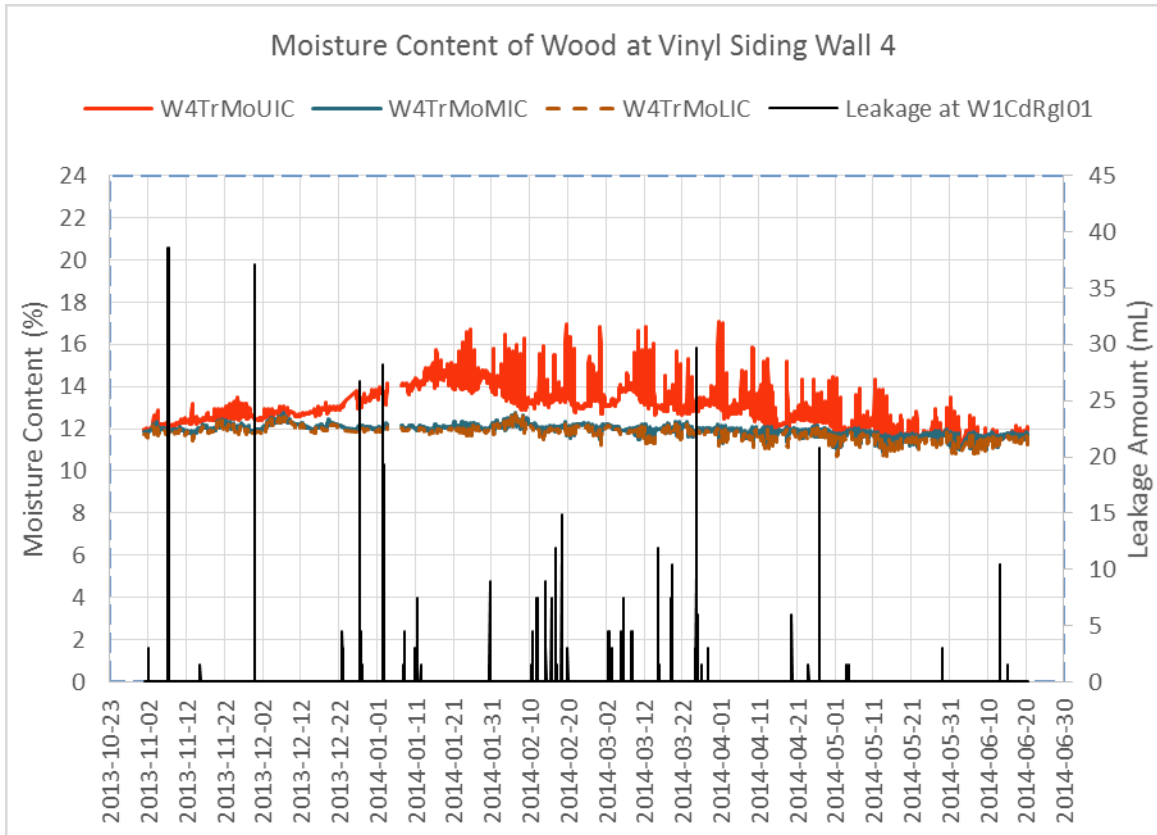
Figure 69. W4 Moisture content of stud next to wall cavity (locations UIC, MIC, and LIC), compared to the leakage amount at W1 as a reference to leakage events.

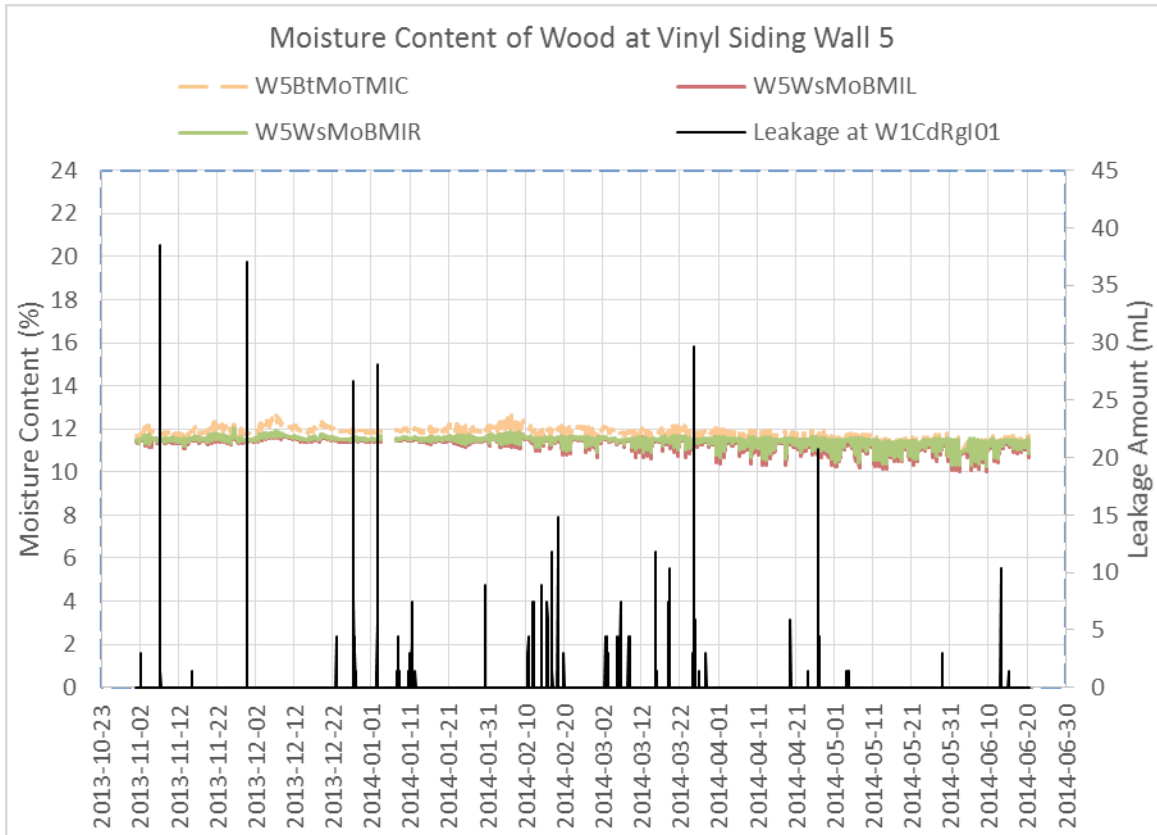
Figure 70. W5 Moisture content of window sill plate (locations BMIL and BMIR) and bottom plate (location TMIC), compared to the leakage amount at W1 as a reference to leakage events.

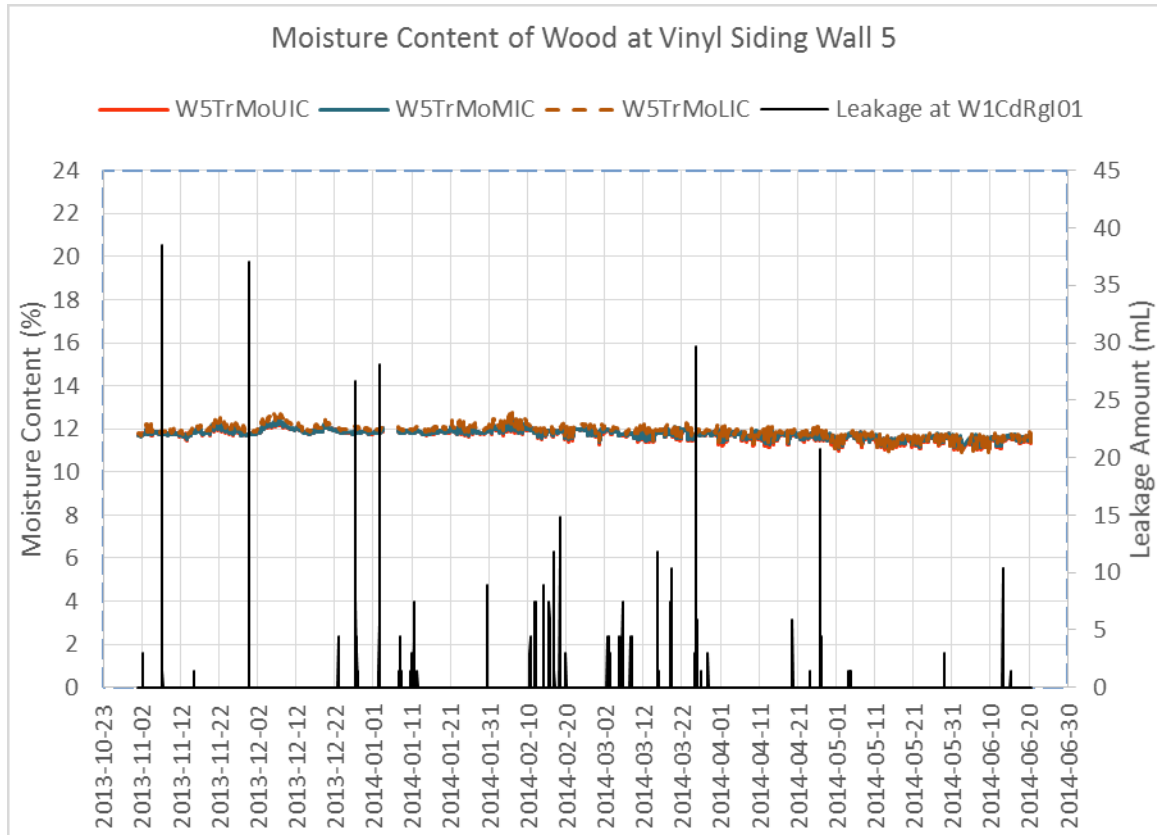
Figure 71. W5 Moisture content of stud next to wall cavity (locations UIC, MIC, and LIC), compared to the leakage amount at W1 as a reference to leakage events.

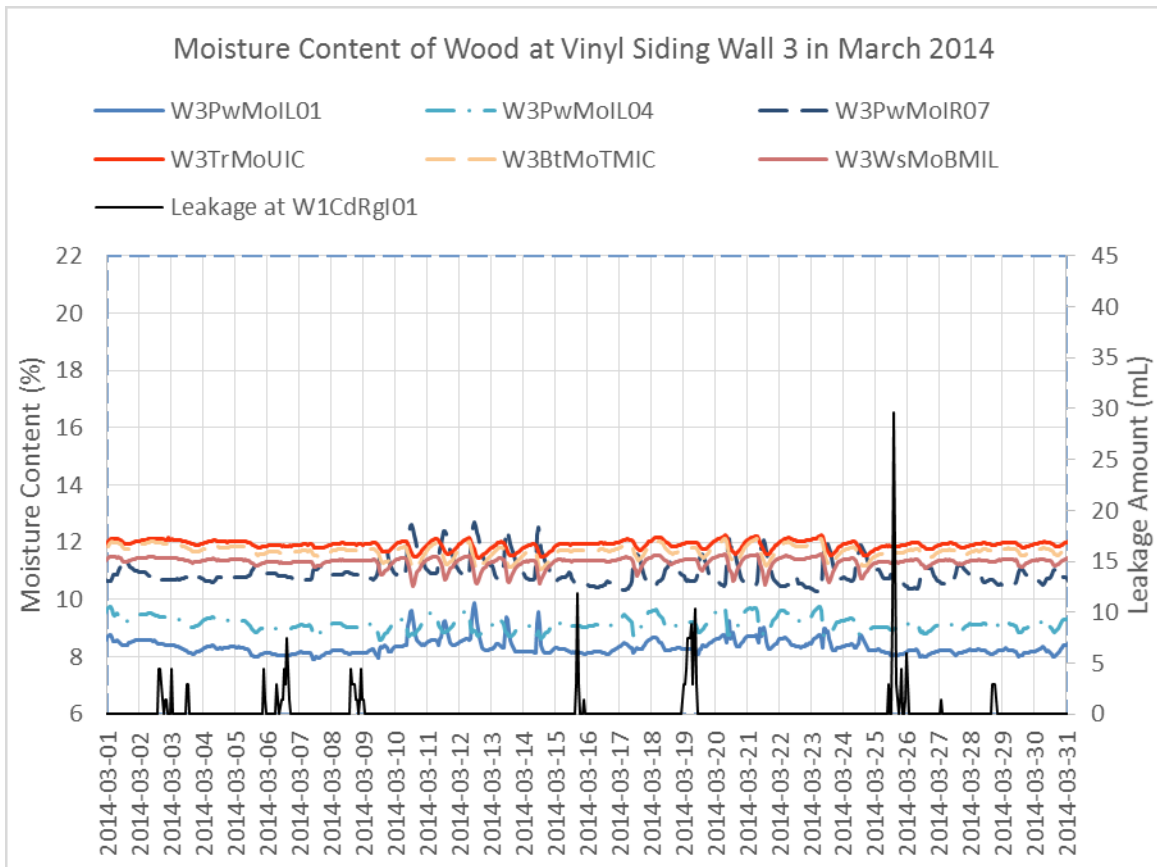
Figure 72. Close-up view of moisture content of plywood and wood framing at W3 in March 2014.

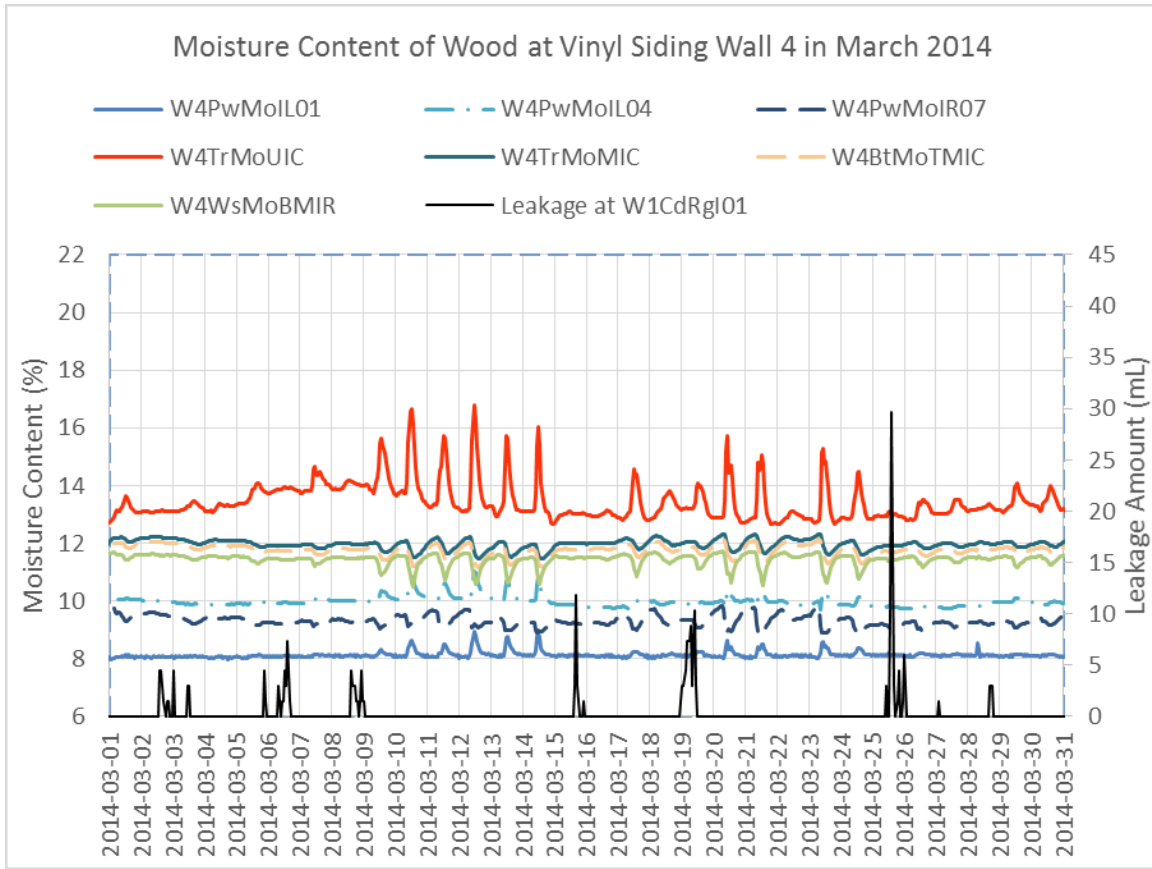
Figure 73. Close-up view of moisture content of plywood and wood framing at W4 in March 2014.

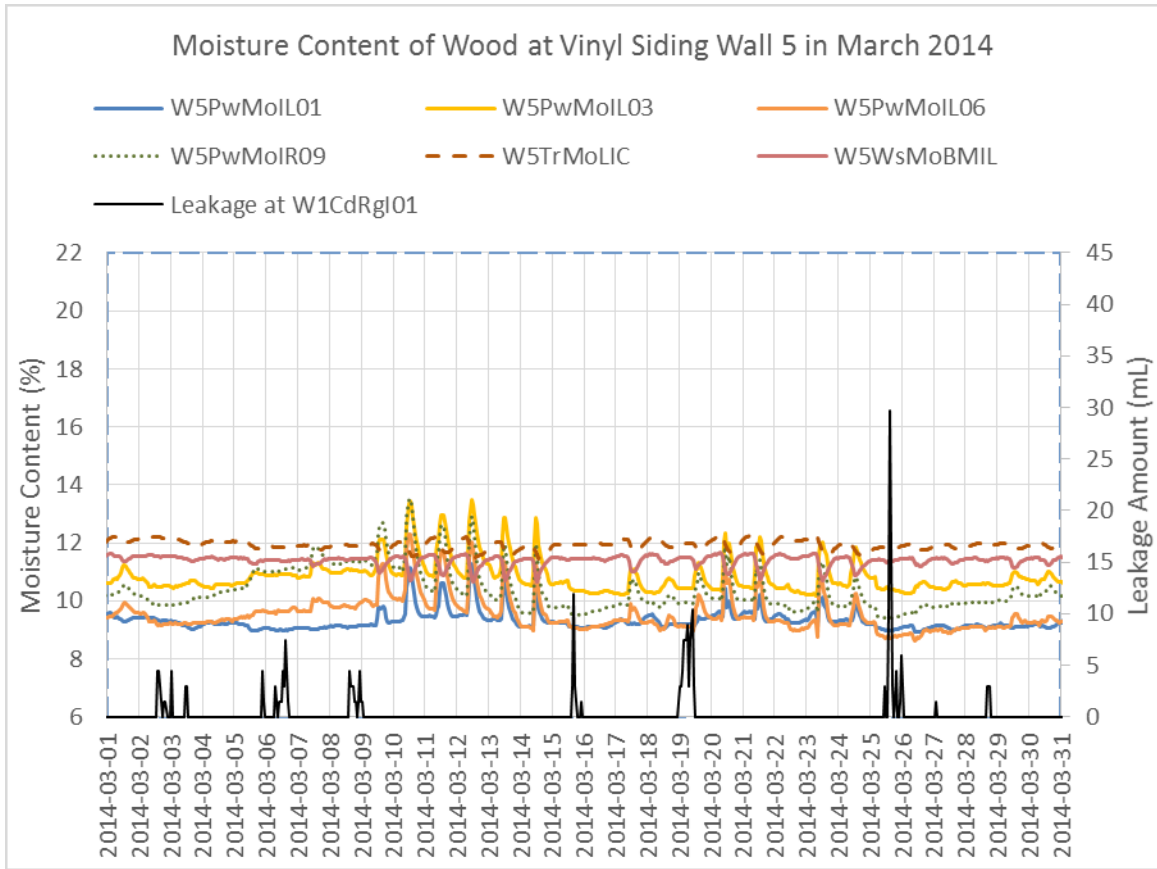
Figure 74. Close-up view of moisture content of plywood and wood framing at W5 in March 2014.

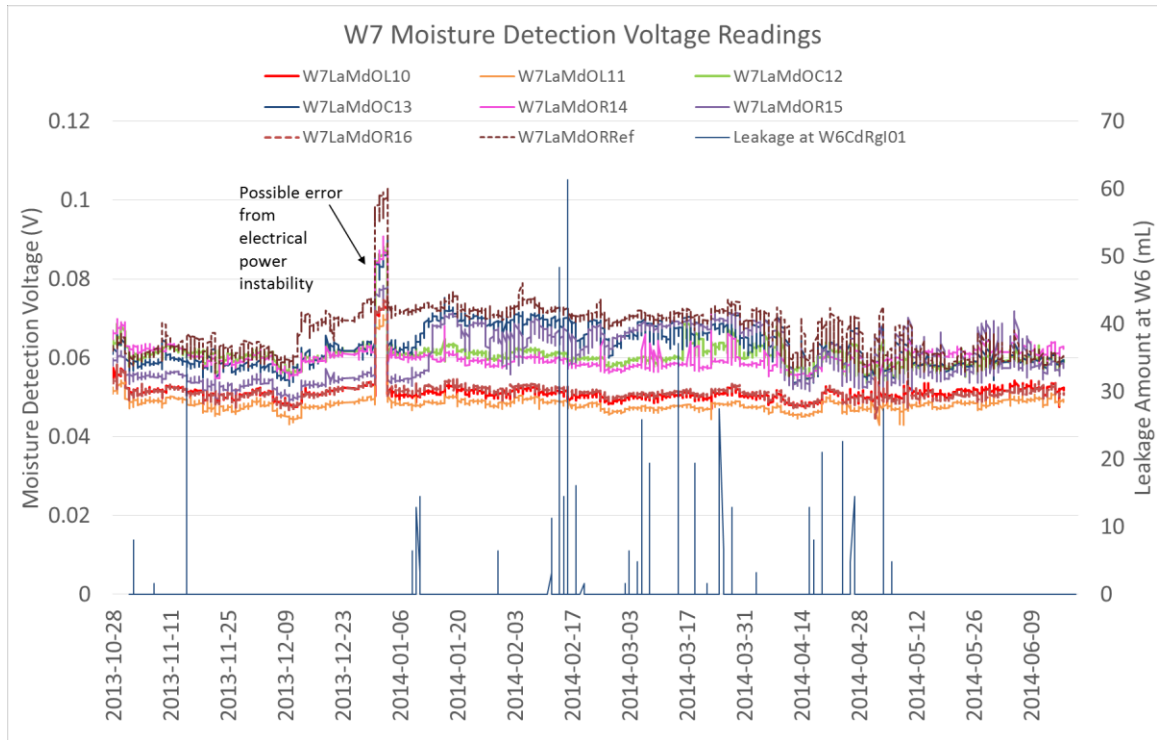
Figure 75. W7 moisture detection tape voltage readings from November 2013 – mid June 2014.

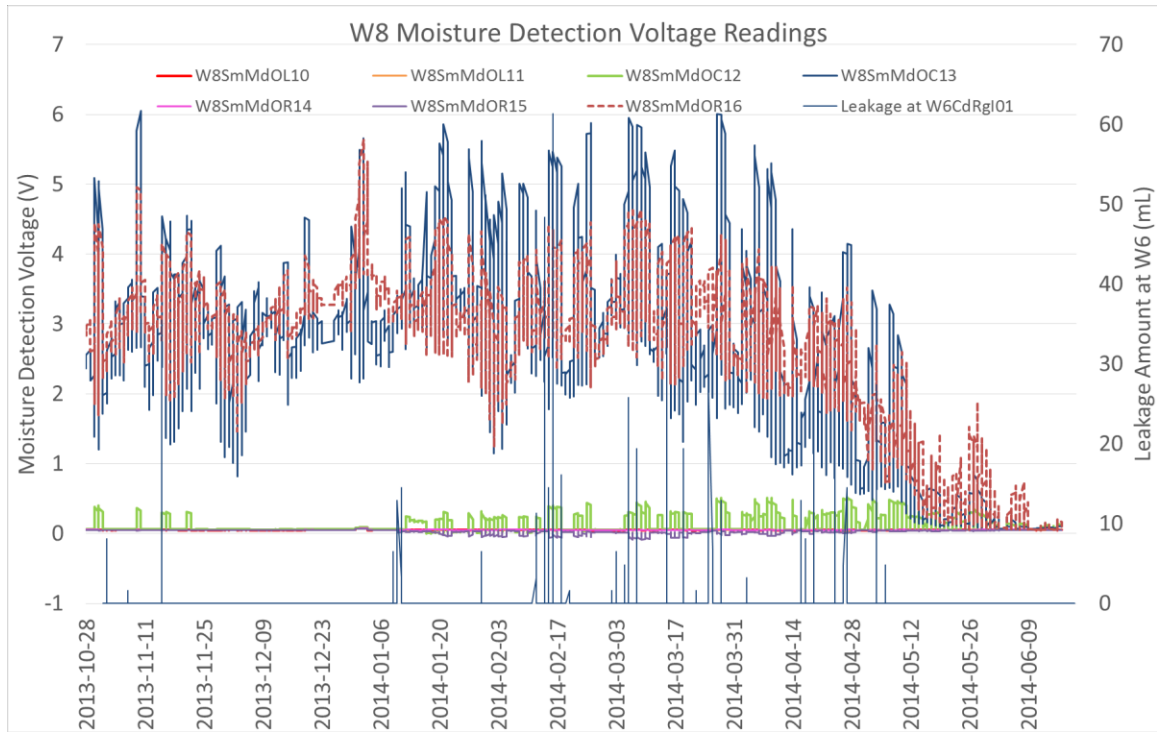
Figure 76. W8 moisture detection tape voltage readings from November 2013 – mid June 2014. Only W8SmMdOR13 and W8SmMdOR16 showed significant voltage readings.

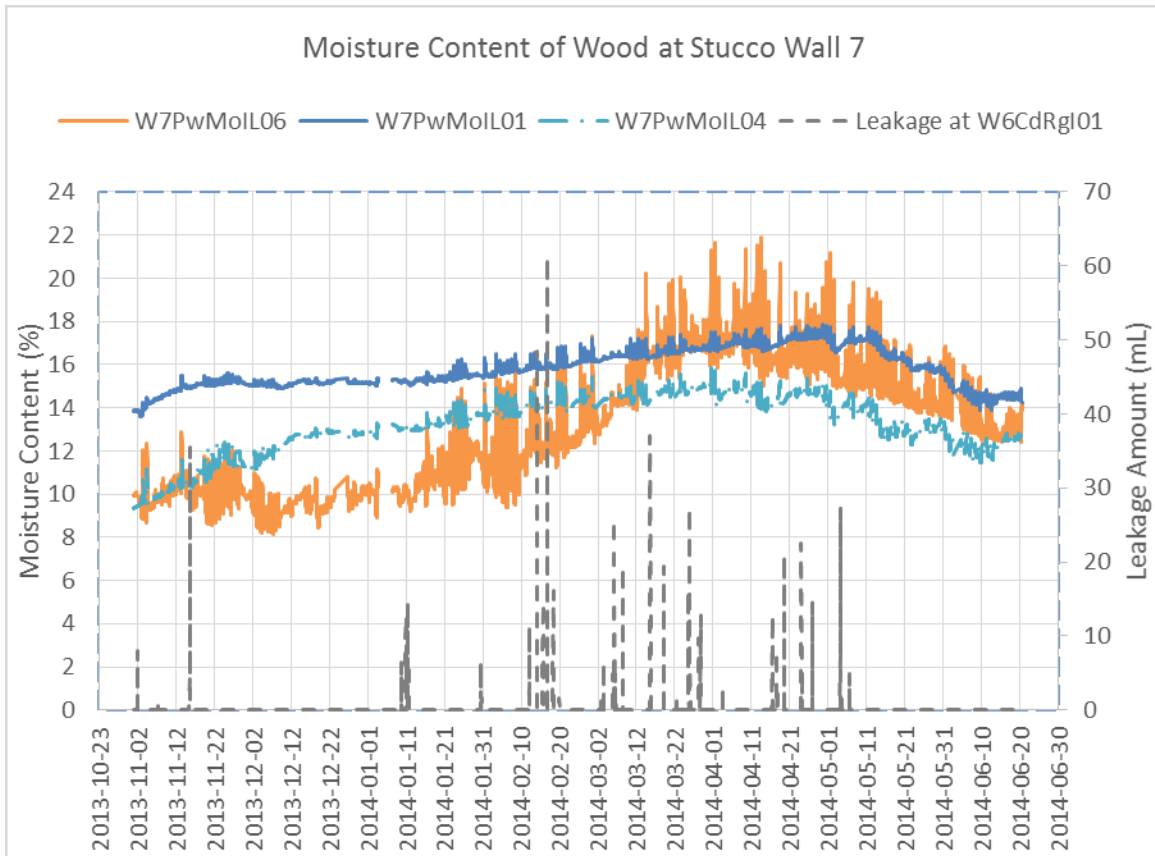
Figure 77. Moisture content of W7 plywood at moisture pin locations L01, L04, and L06, compared to the leakage amount at W6 as a reference to leakage events.

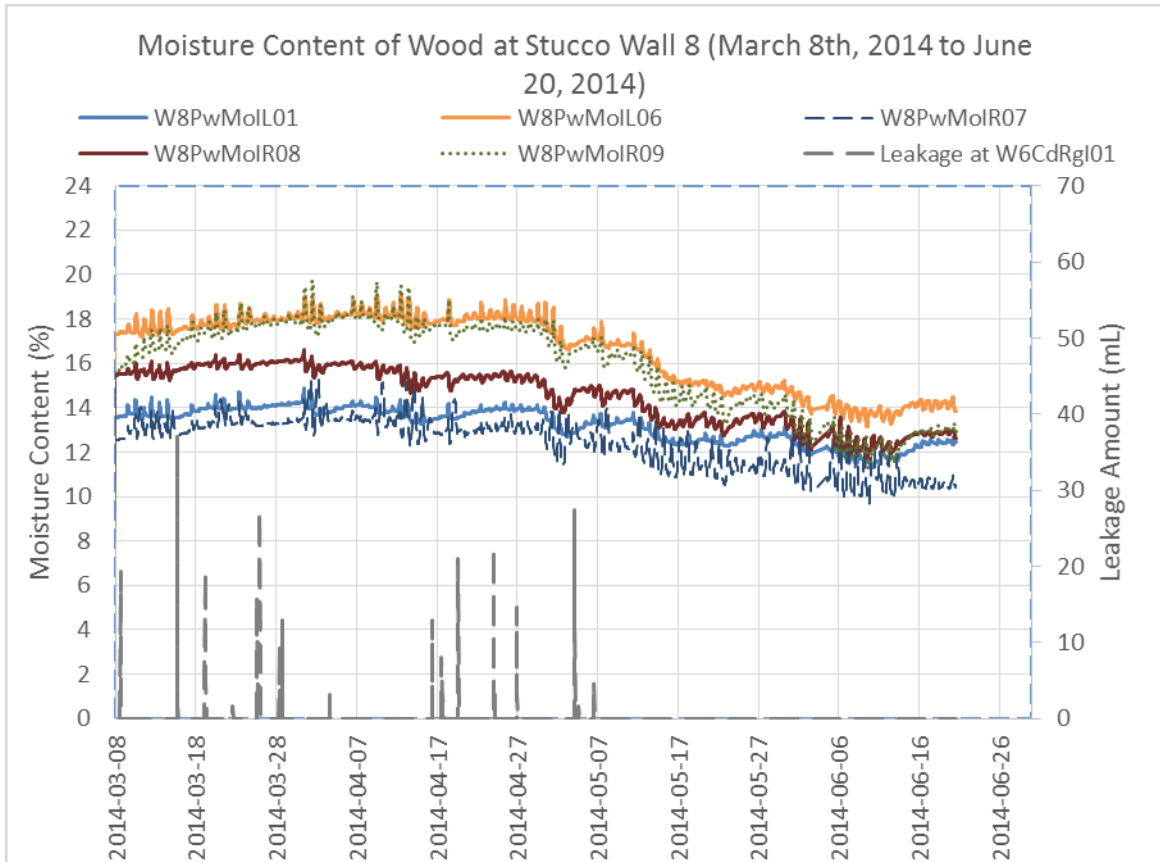
Figure 78. Moisture content of W8 plywood at upper moisture pin locations L01, L06, and L07, compared to the leakage amount at W6 as a reference to leakage events.

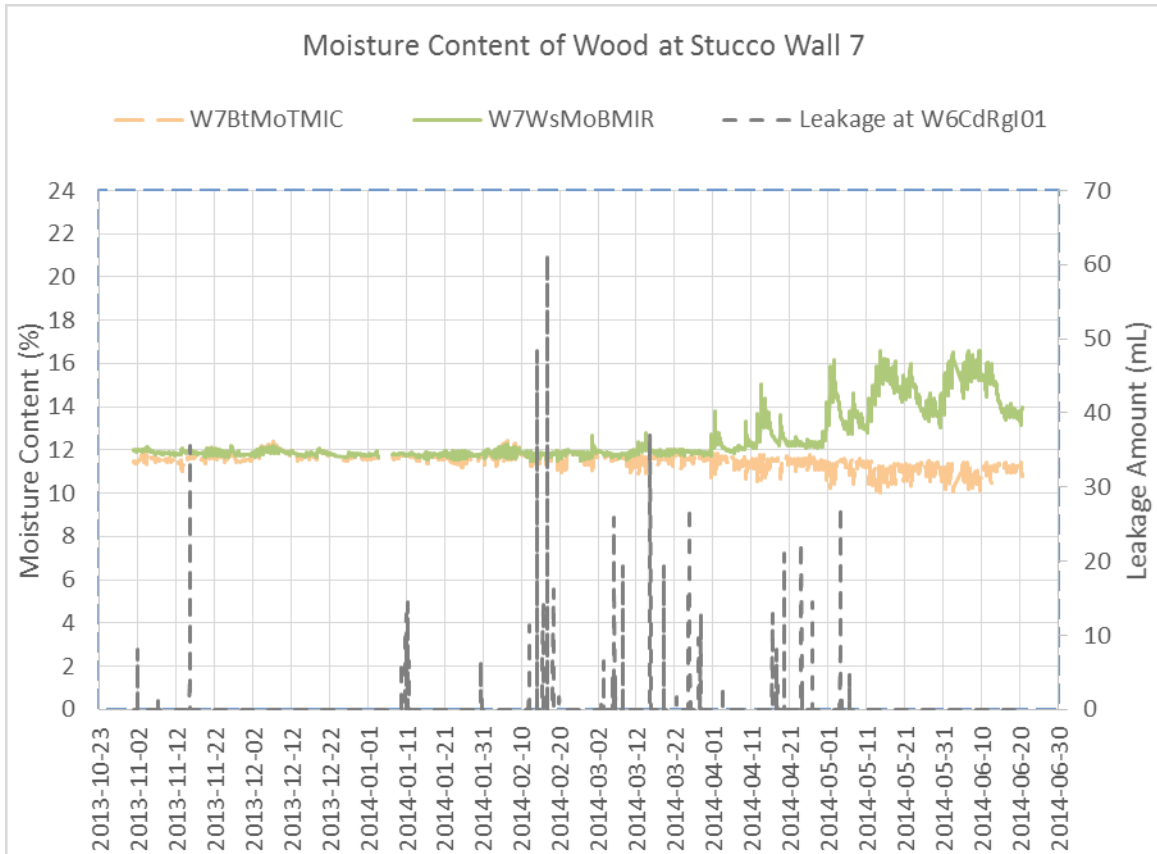
Figure 79. Moisture content of W7 window sill plate (location BMIR) and bottom plate (location TMIC), compared to the leakage amount at W6 as a reference to leakage events.

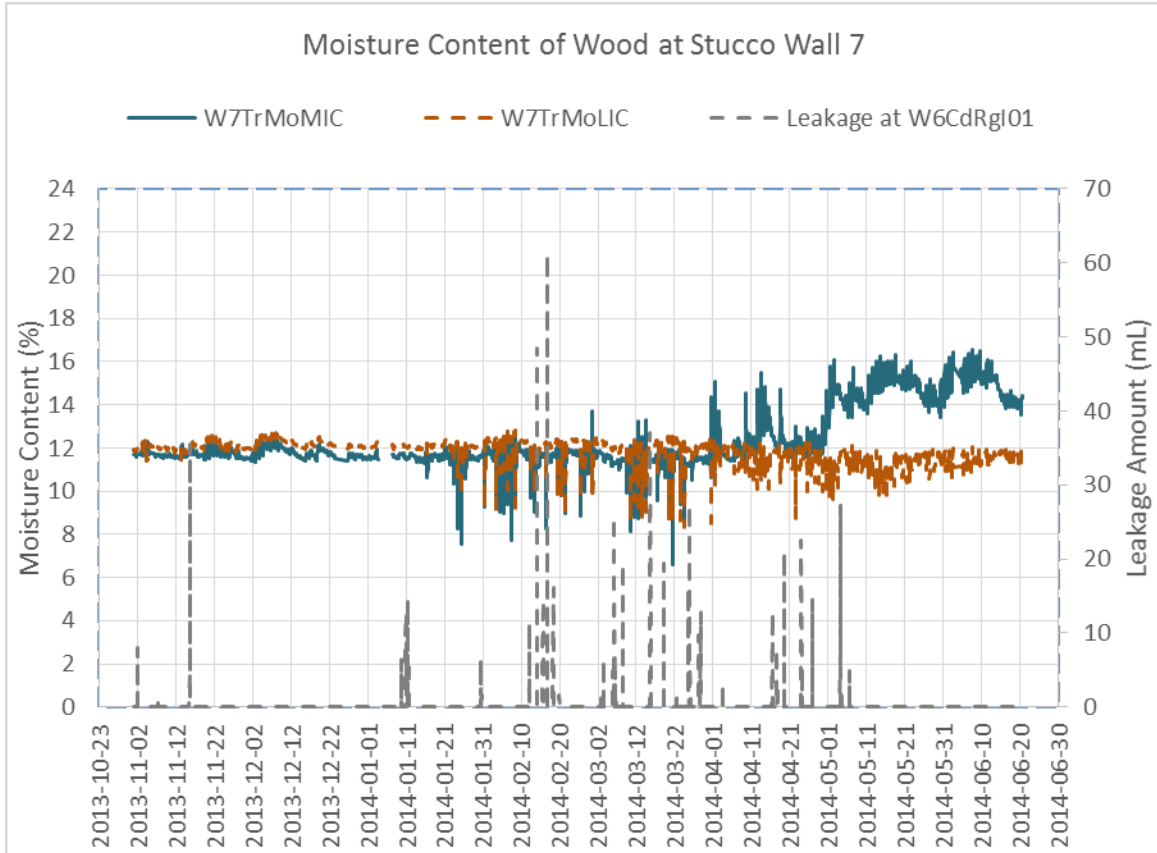
Figure 80. Moisture content of the W7 stud next to wall cavity (locations MIC and LIC), compared to the leakage amount at W6 as a reference to leakage events.

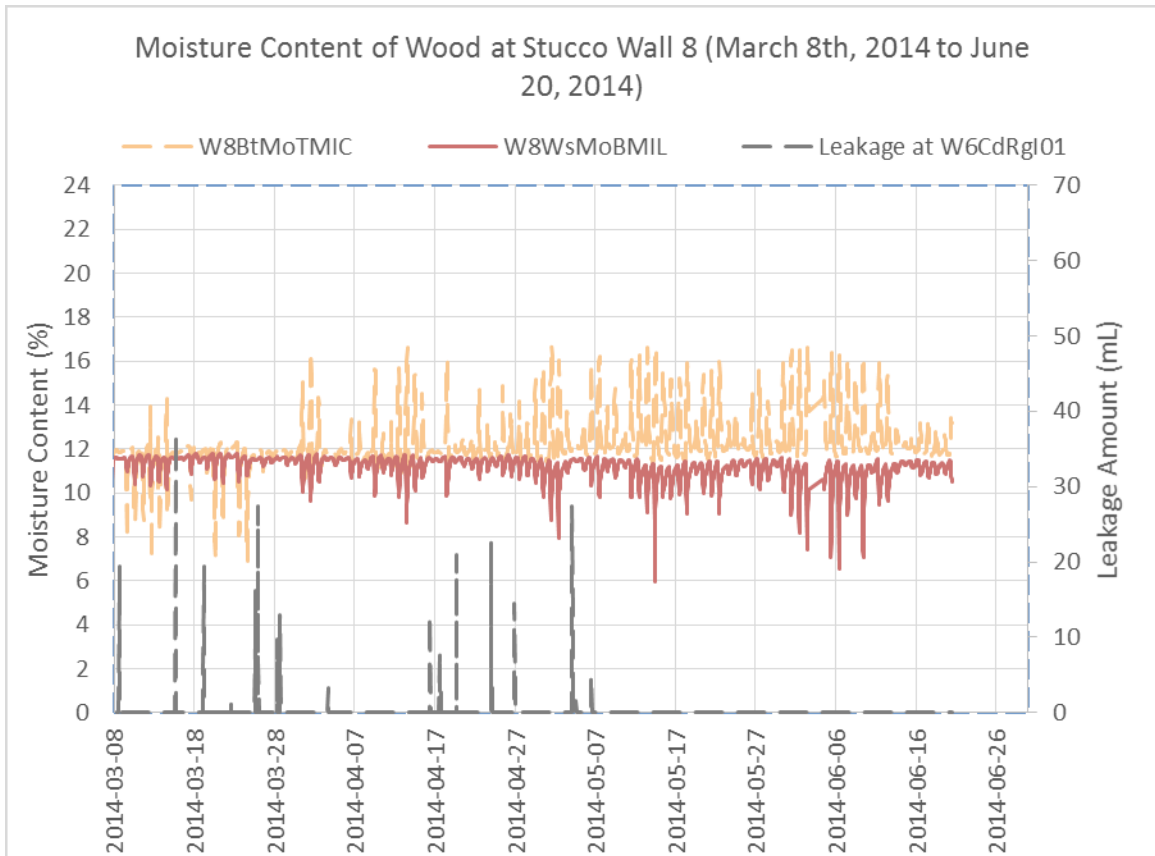
Figure 81. Moisture content of W8 window sill plate (locations BMIL) and bottom plate (location TMIC), compared to the leakage amount at W6 as a reference to leakage events.

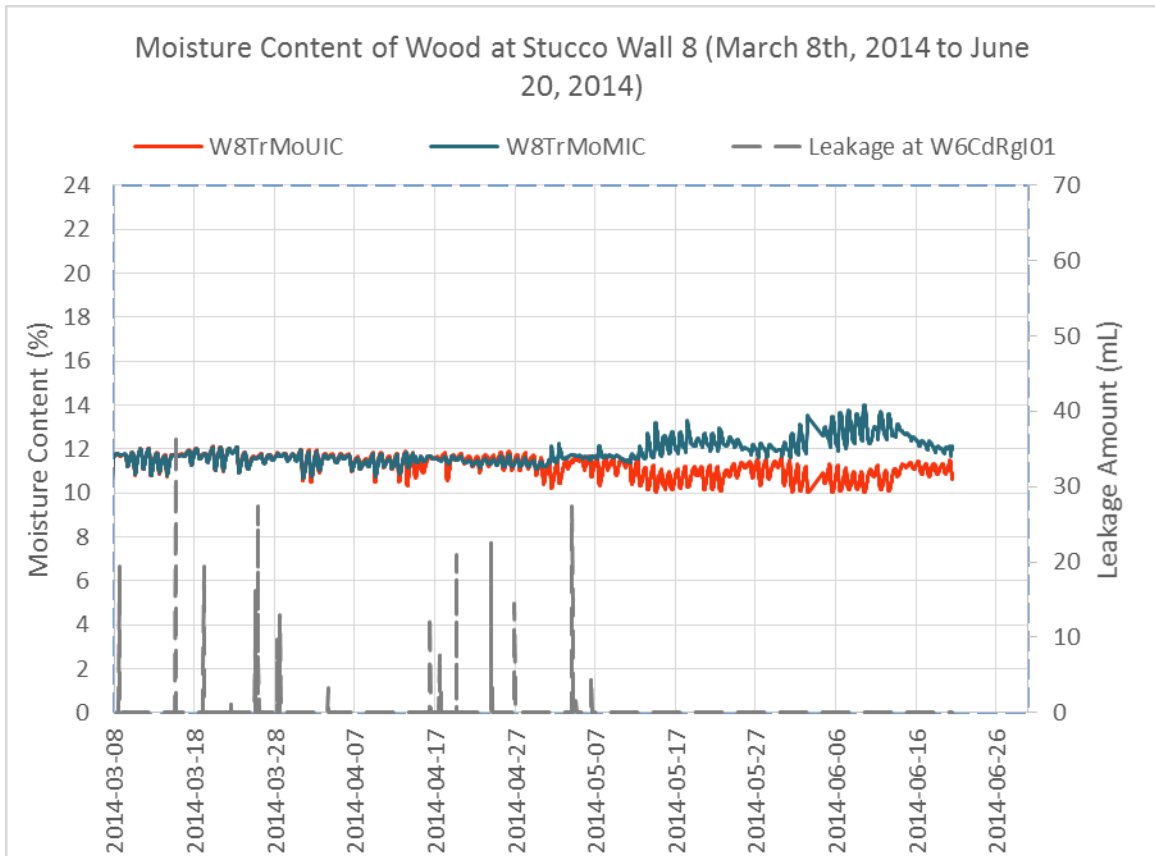
Figure 82. Moisture content of W8 stud next to wall cavity (locations UIC and MIC), compared to the leakage amount at W6 as a reference to leakage events.

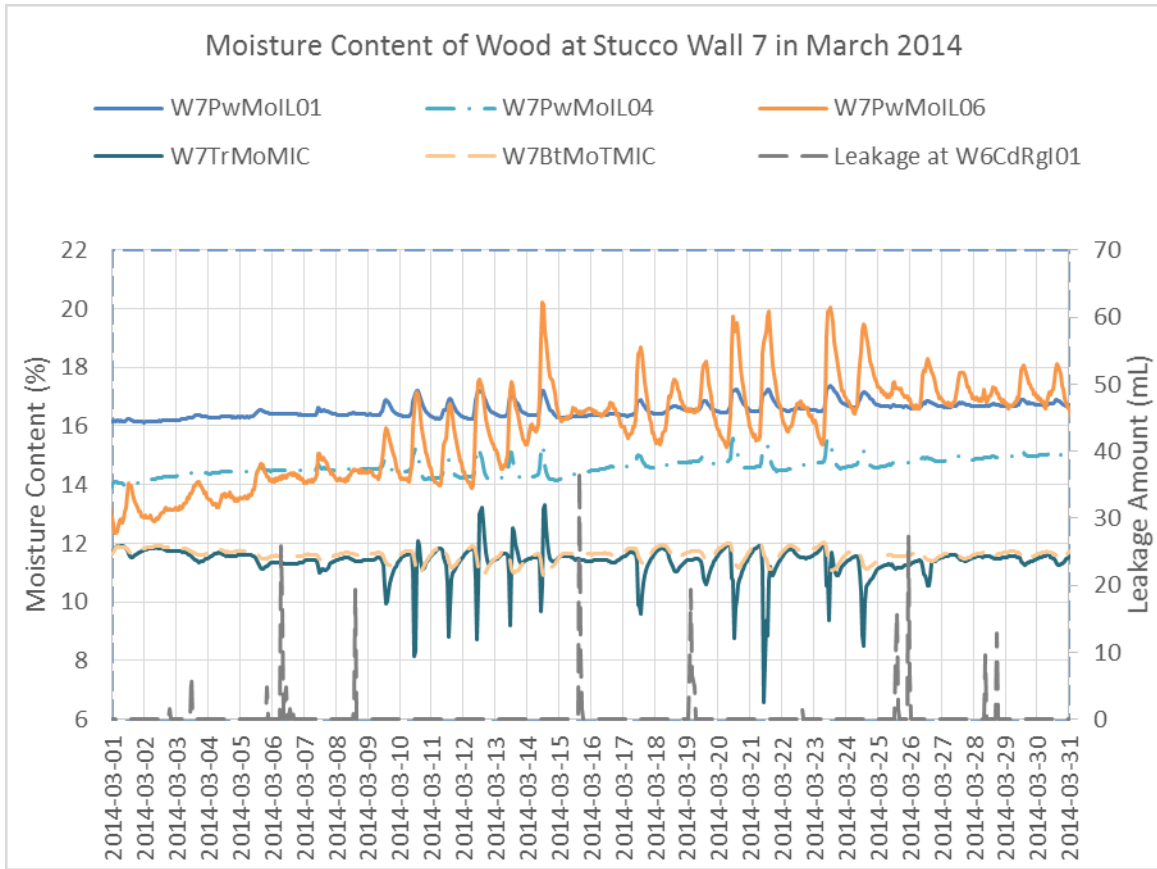
Figure 83. Close-up view of moisture content of plywood and wood framing at W7 in March 2014.

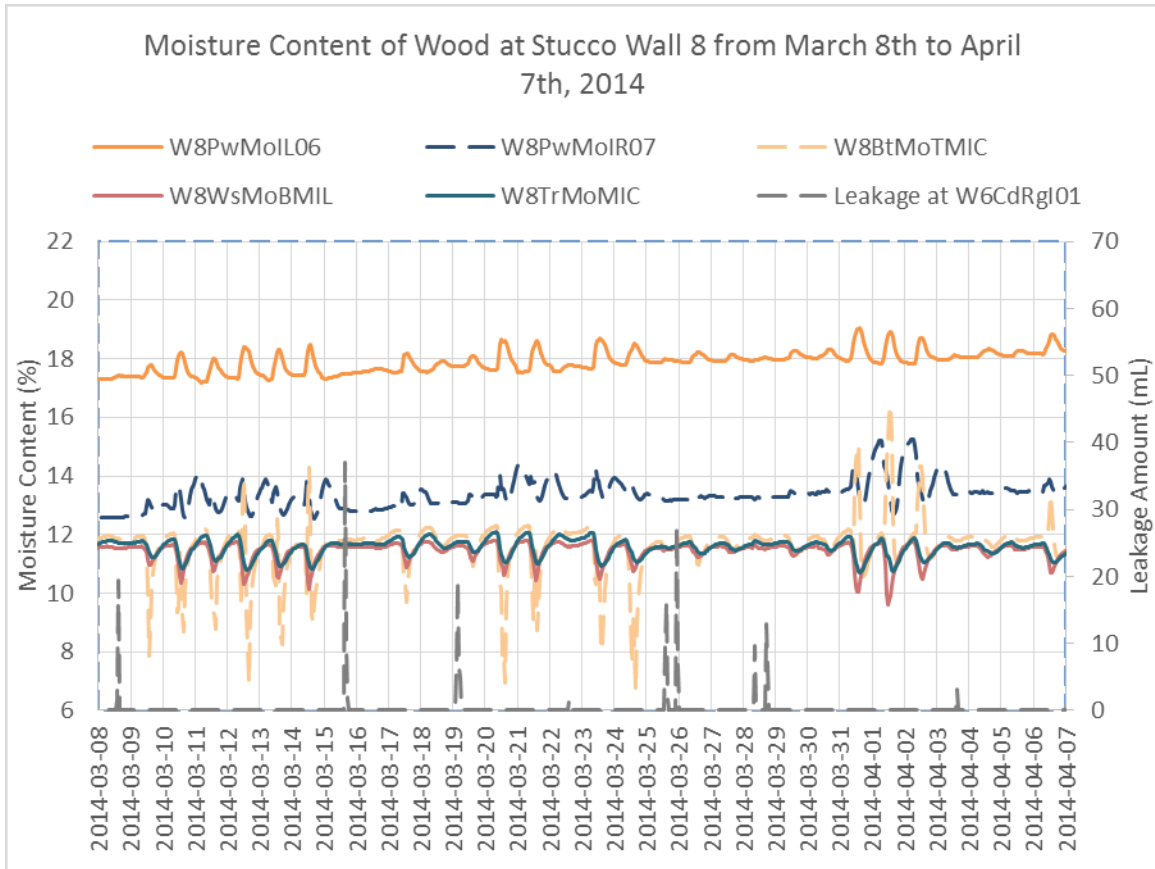
Figure 84. Close-up view of moisture content of plywood and wood framing at W8 in March 2014.

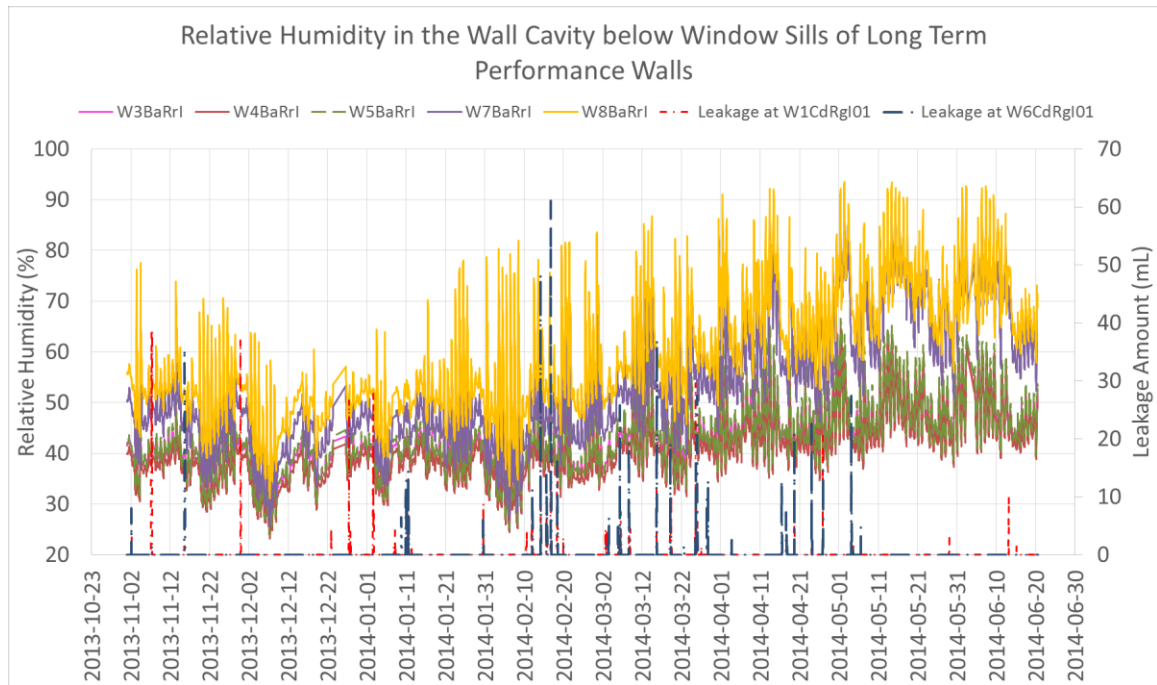
Figure 85. Relative humidity in the wall cavities of long term performance walls from November 2013 – mid June 2014.

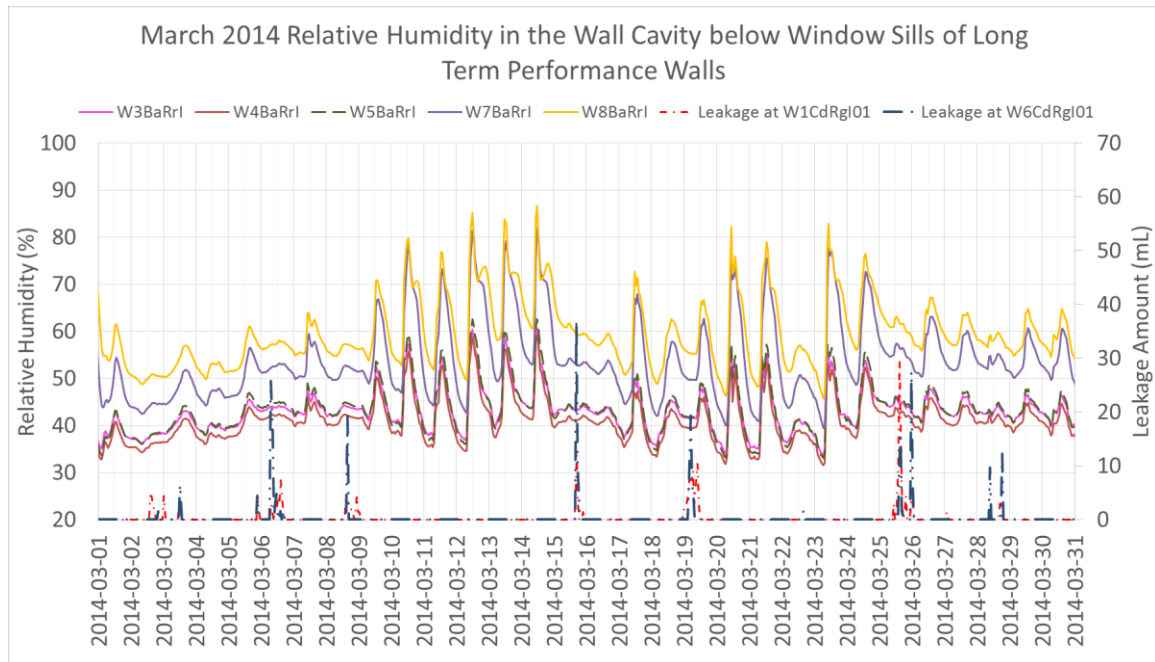
Figure 86. Close-up view of relative humidity in the wall cavities of long term performance walls in March 2014.

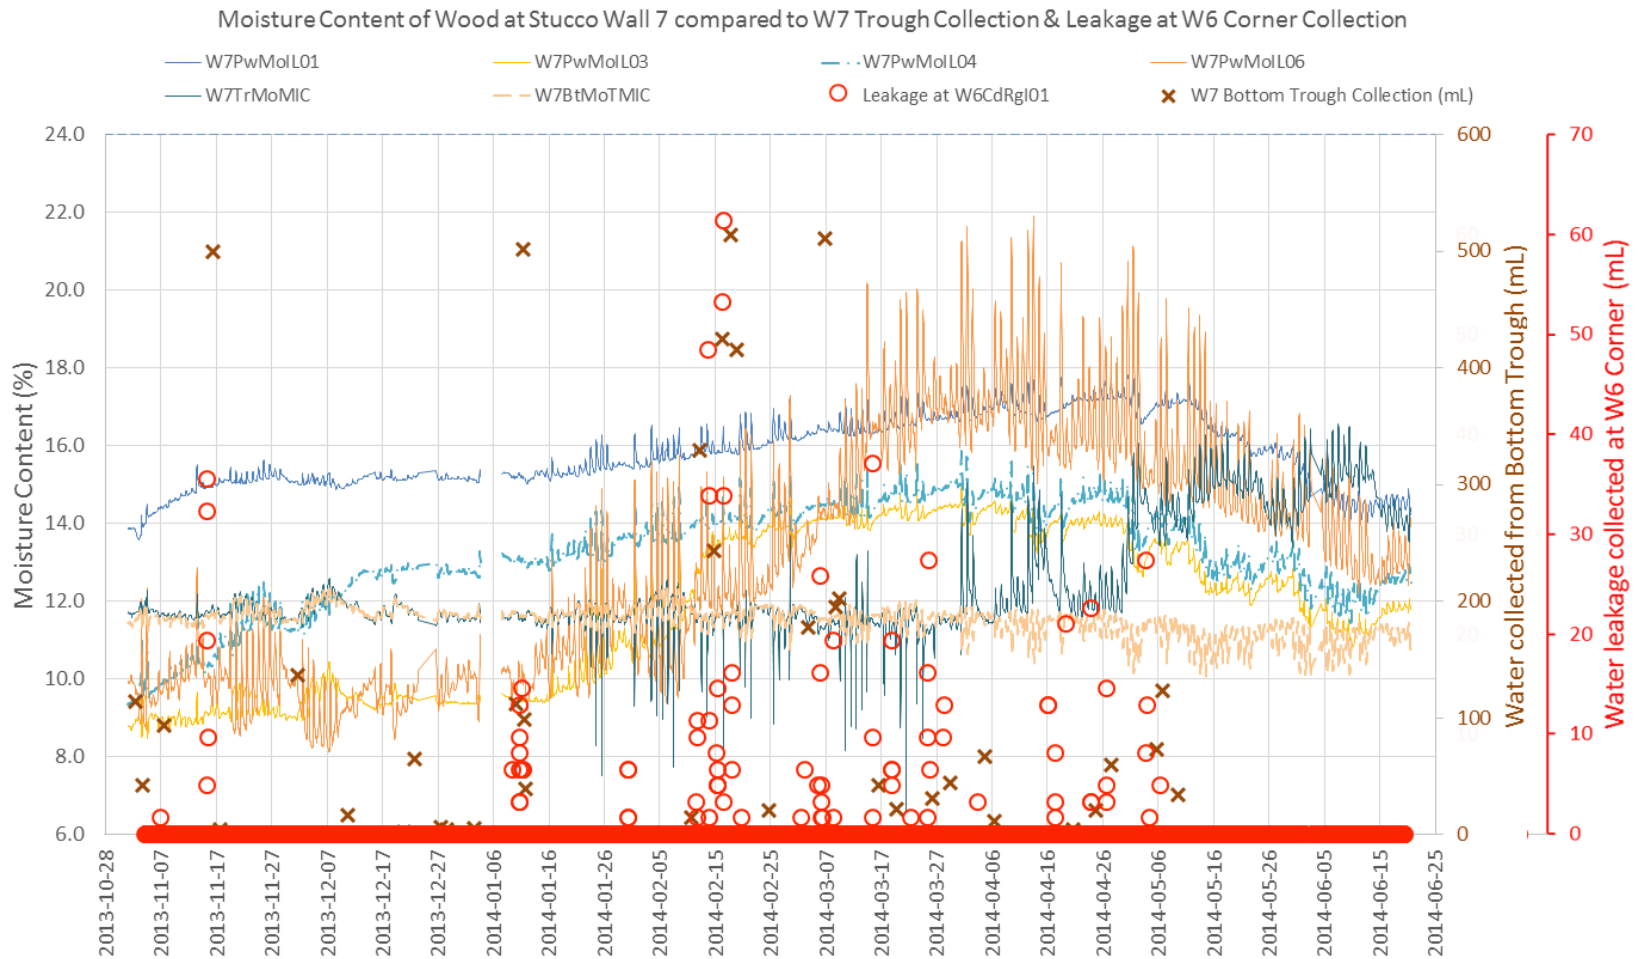
Figure 87. Comparison of the moisture content of wood framing around W7 wall cavity below corner window sill defect to the bottom trough water collection at W7, and to leakage amount at W6 Corner collection.
