Field Study of Wind Driven Rain Penetration into Vinyl Sidings and Stucco-Clad Wood-Frame
Wall Systems at Window Sill

A Thesis

Building, Civil and Environmental Engineering

September 2015

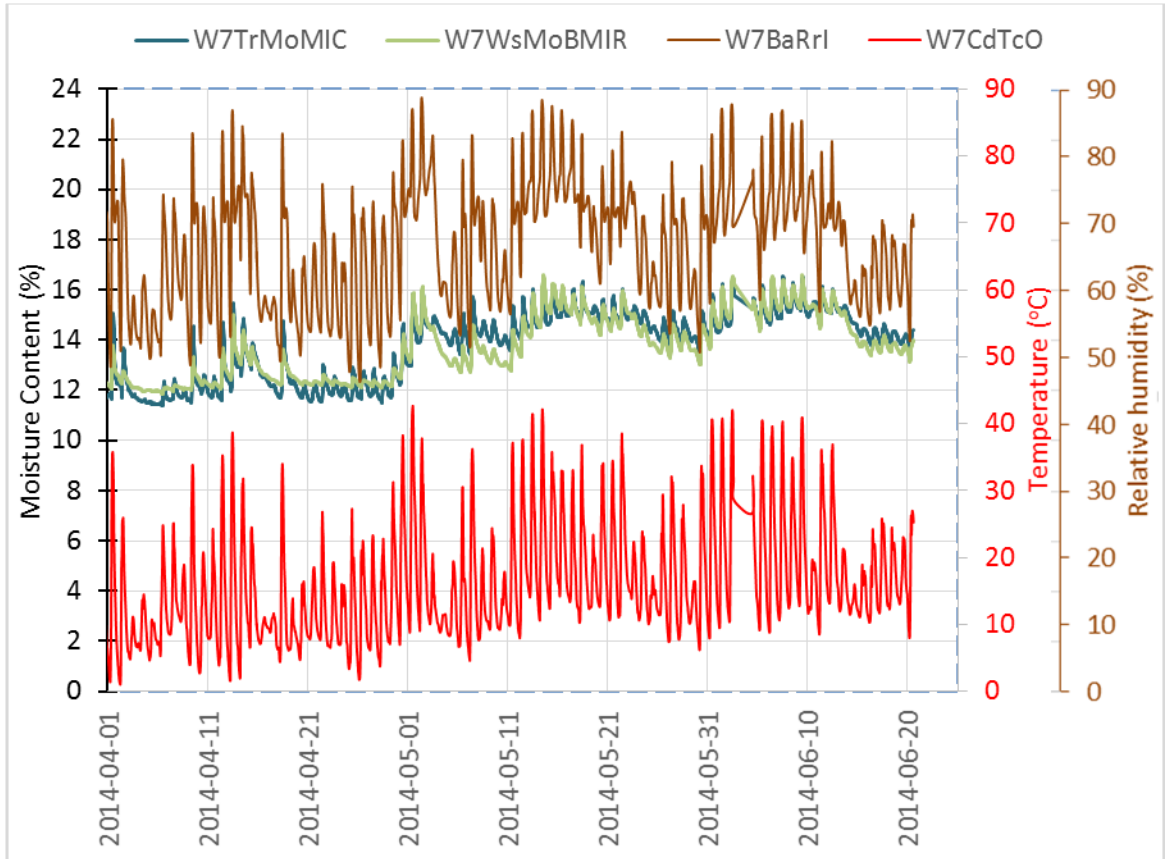
Figure 88. Moisture contents of trimmer studs at middle location MIC and window sill plate location BMIR, relative humidity in the stud cavity of stucco wall W7 by sensor W7BaRrI, and outside temperature measured at thermocouple W7CdTcO located on the exterior surface of stucco from April 1st, 2014 to June 21, 2014.

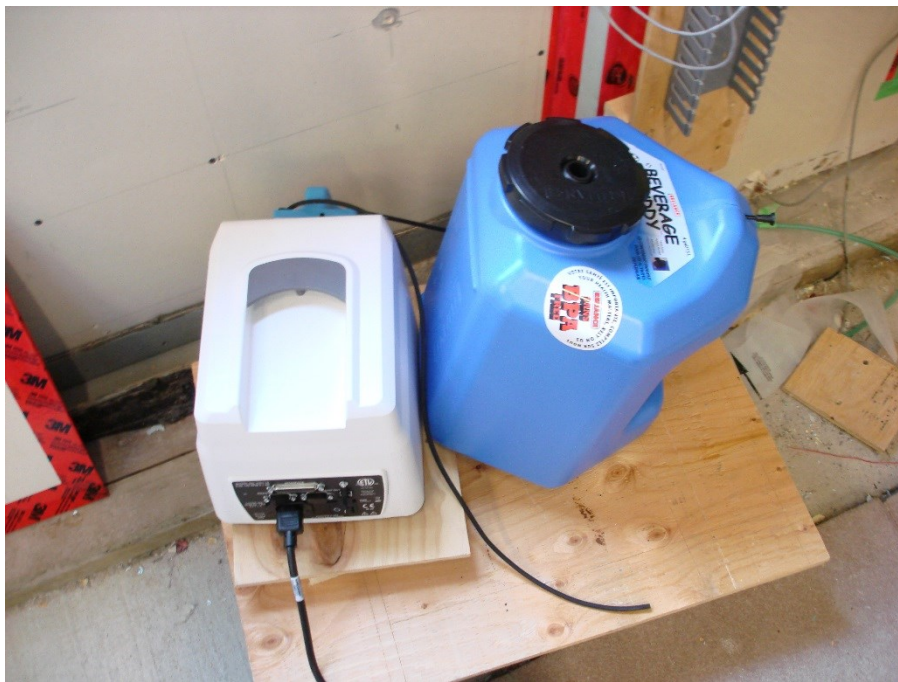
Figure A. 1. Cole-Parmer Masterflex® L/S® peristaltic pump and a water container used to calibrate the wall rain gauges and leakage gauges.

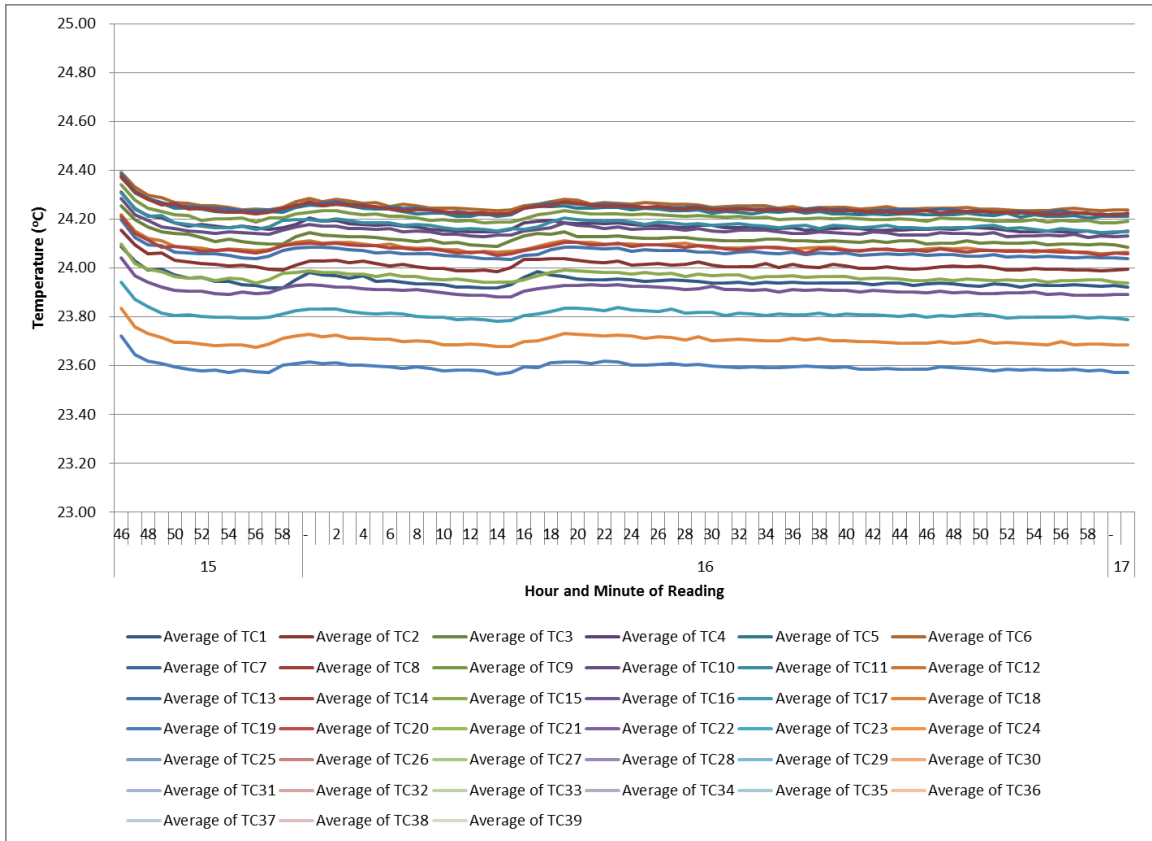
Figure A. 4. Calibration curve of thermocouples sensors at 24°C.

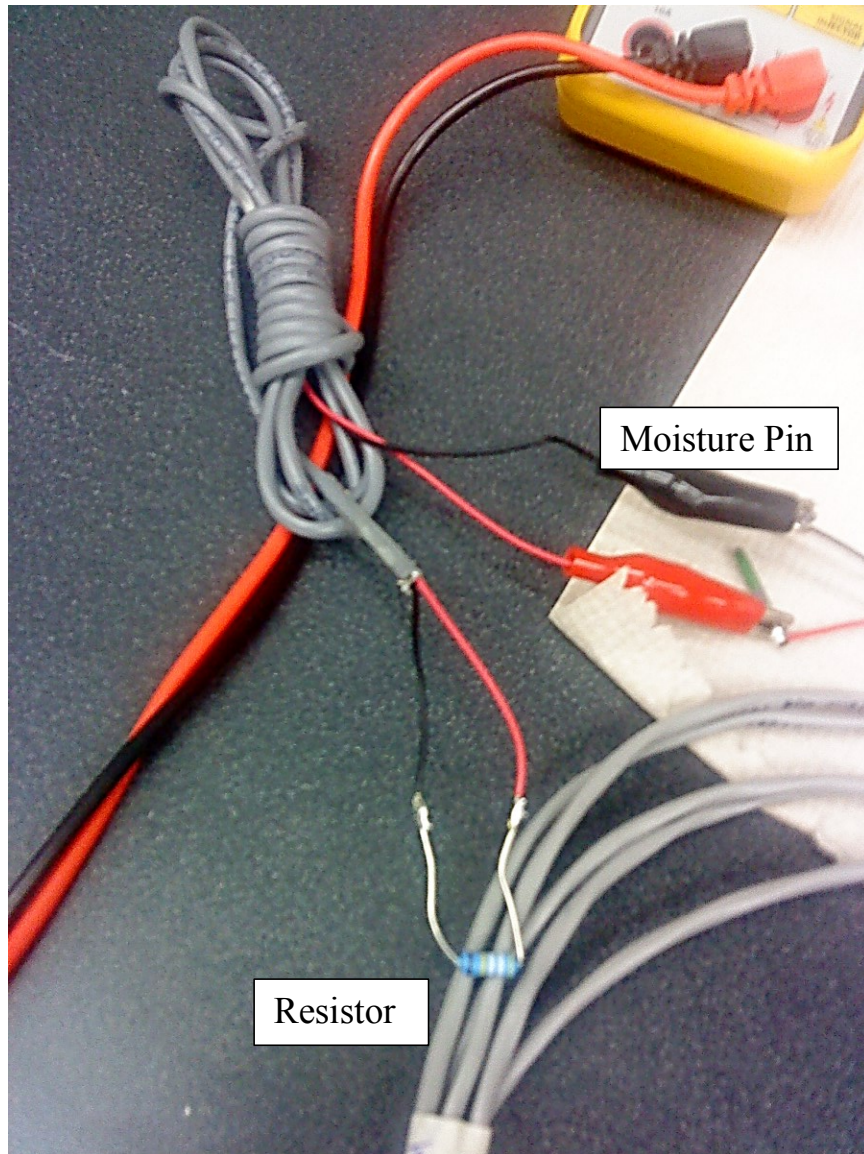
Figure A. 5. Testing of moisture pins using a resistor and digital circuit tester.

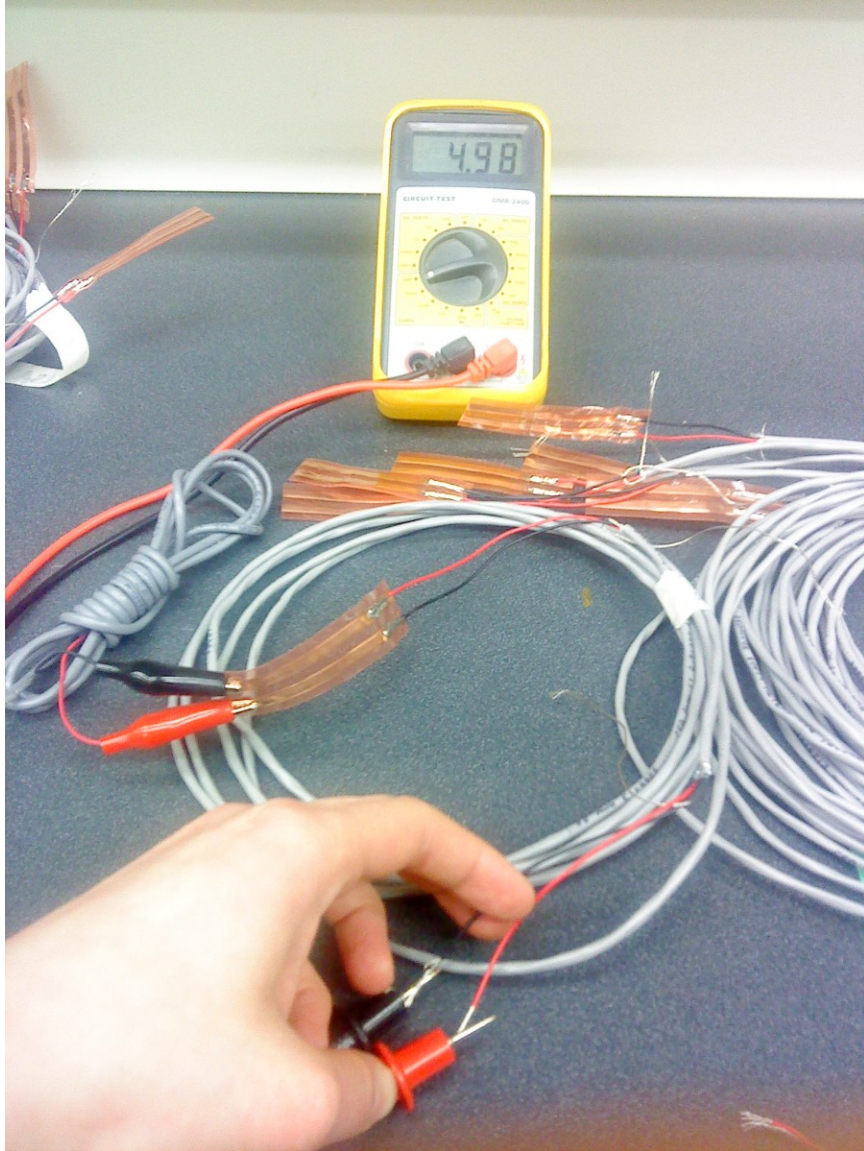
Figure A. 6. Testing setup for moisture detection tapes.

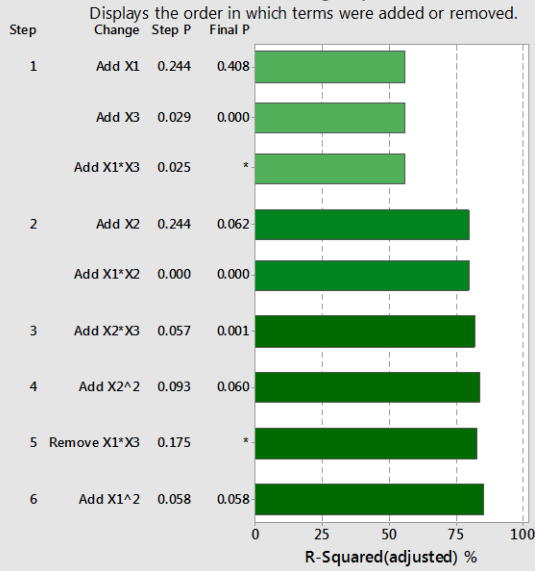
Model Building Sequence

Incremental Impact of X Variables

Long bars represent Xs that contribute the most new information to the model.

$$\text{Sum of W6Cd} = -14.0 + 45.1 X1 + 0.72 X2 + 0.94 X3 + 19.68 X1^2 + 0.0877 X2^2 - 5.48 X1 \cdot X2 + 0.931 X2 \cdot X3$$
