**Manufacturing and Fatigue Behavior of Thick Glass/Epoxy
Composite Beams**

Mechanical and Industrial Engineering

Concordia University

July 2016

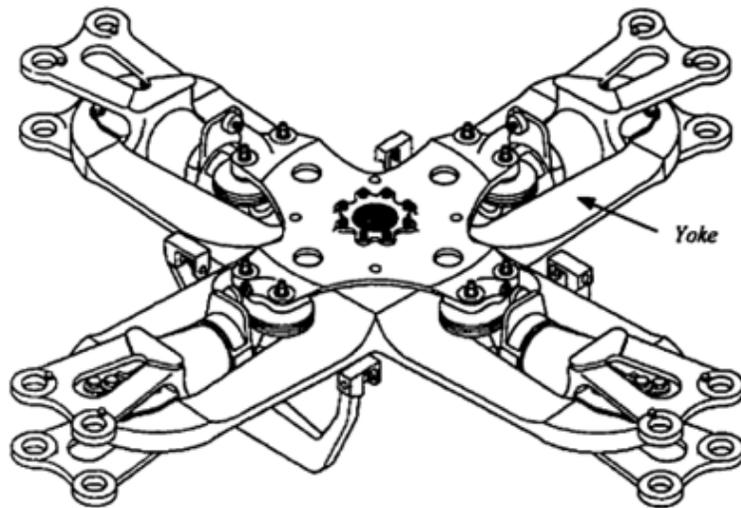
Figure 1.1. Bell M407 Main Rotor Hub [24]

connecting the blades to the mast as shown in Figure 1.1. Yokes support the rotating loads and the vibration bending loads of flapping blades. Therefore, they need to be rigid and sufficiently flexible. As such the yokes must have long fatigue lives to survive from many blade revolutions. A tapered configuration fabricated by glass fiber or other composite materials meet the requirements [23]. For the fatigue behavior of thicker composite parts, the research work has been mainly on the tapered composite structure, which consists of a thinner part, a ply-drop part and a thicker part.

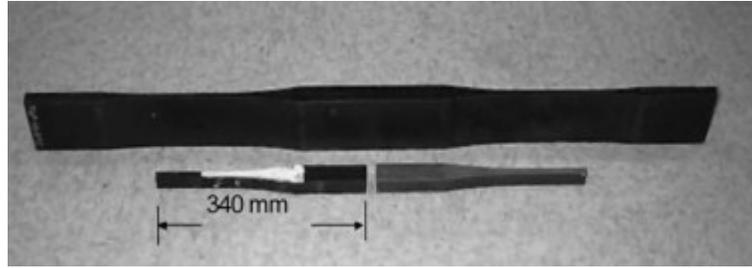
Figure 1.6 Flexbeam specimen cut from a full size rotor hub flexbeam[34]

To simulate the loading experience of a rotor hub flexbeam in flight, nonlinear tapered glass/epoxy specimens were cut from a full-size helicopter rotor hub (as shown in Figure 1.6) and were tested under combined constant axial tension and cyclic transverse bending conditions [34]. A 2D FE model was created to represent the flexbeam lay-up, geometry and loading conditions. Strain energy releasing rates associated with the delamination growth were calculated for various configurations. Different FE codes were used for the analysis. In nonlinear tapered laminates under combined tension-cyclic bending loading, the delamination started at the ply-drop nearest the surface of the flexbeam. It initially propagated toward the tapered region at the interfaces in a stable manner. As loading continued, some specimens failed catastrophically, delaminating along the entire length. Some specimens continued to delaminate at multiple interfaces without catastrophic failure. The dominating mode had similar behavior as that of linear tapered laminates. Double-cantilever beam tests data and strain energy release rates were combined to generate a curve predicting fatigue failure by unstable delamination.

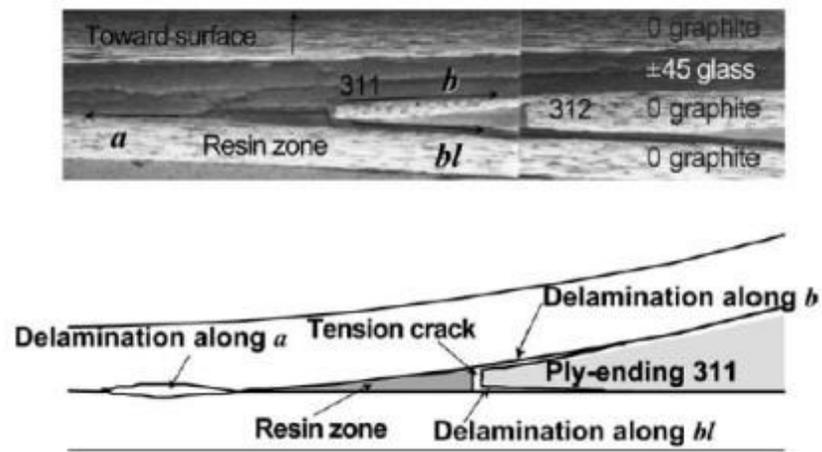
Figure 1.7 Initial delamination at ply-ending 311 and three possible paths of delamination growth [36]

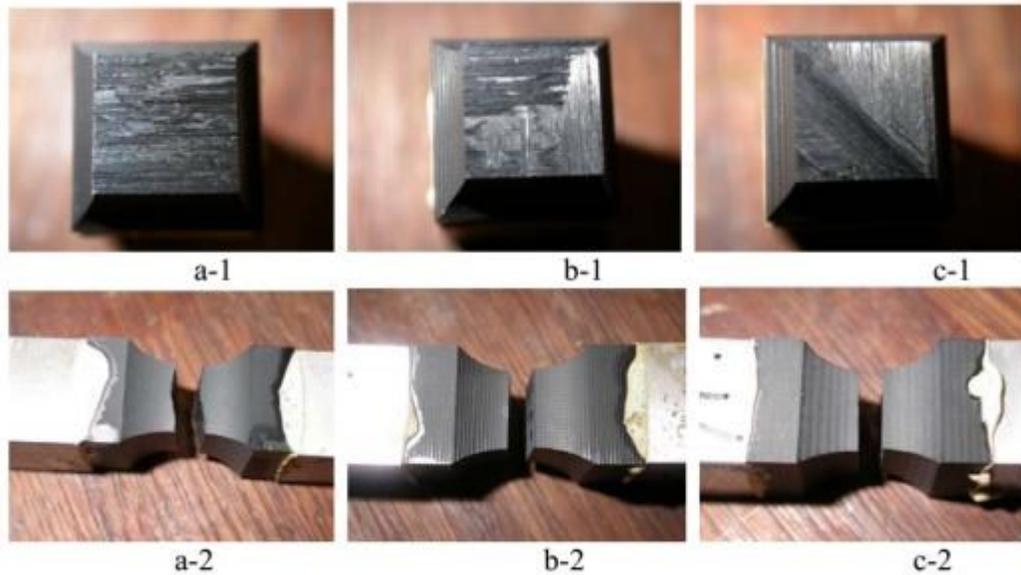
Figure 1.8. Fracture surface at the failed section: a) lay-up 0 b)lay-up 0/90 and c) Lay-up QI [38]

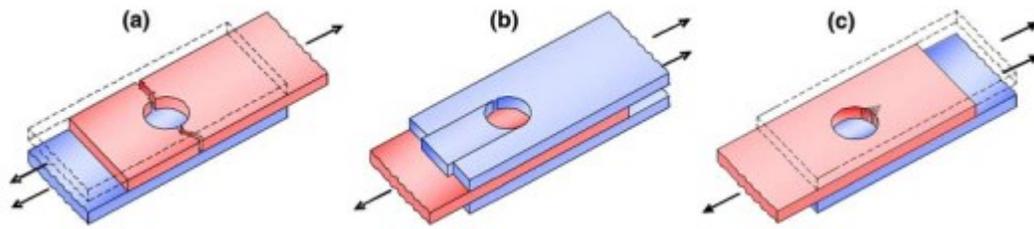
Figure 1.13. Failure modes of fibrous composite mechanical joints: (a) tension failure; (b) shear-out failure and (c) bearing failure [48]

There are three basic failure modes associated with composite bolted joint: net-tension, shear-out and bearing, depending on the laminate lay-up and joint geometry as shown in Figure 1.13. Net-tension is the tension failure of matrix and fiber due to the stress concentration. Shear-out failure always results from the shear failures of the matrix and fiber. Bearing mode failure is caused by the contact compressive stresses at the joint boundary. Fiber micro-buckling, matrix cracking, fiber-matrix shearing and delamination may occur due to the compressive stresses.

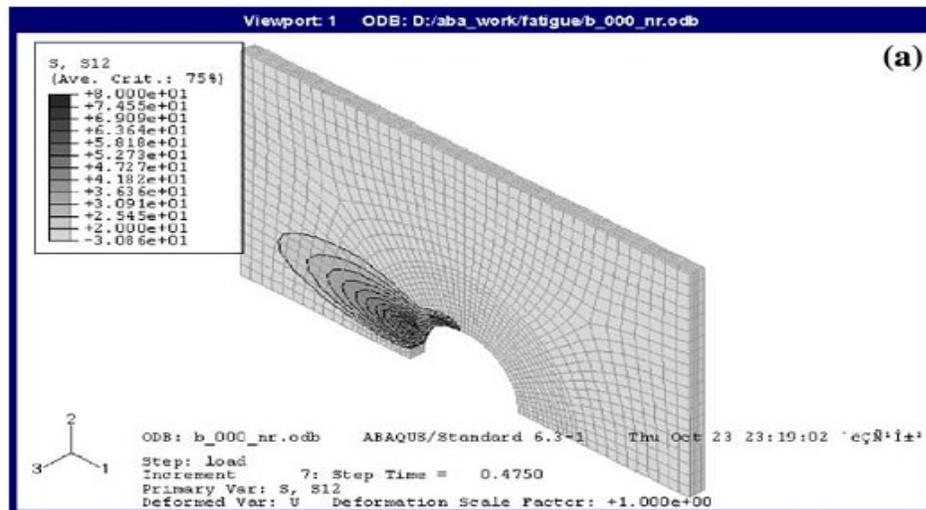
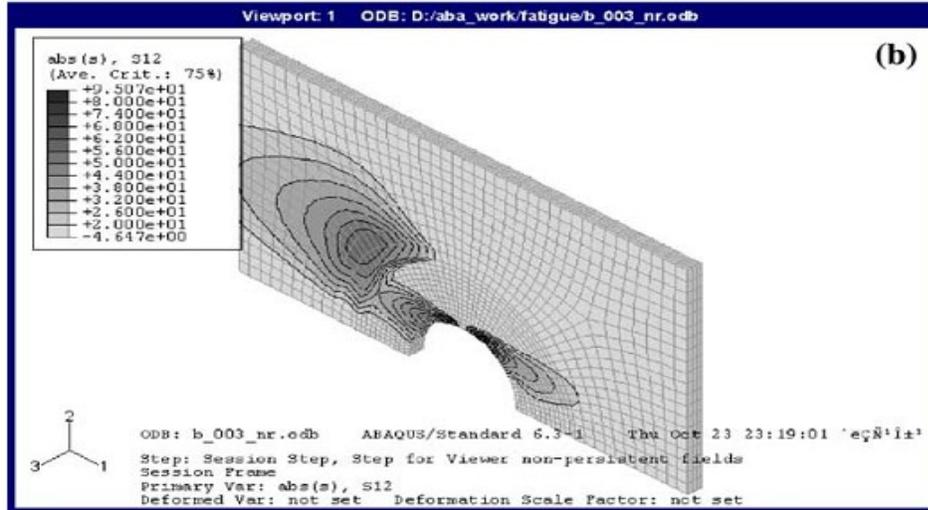
Figure 1.14. Shear stress distributions of the composite bolt joint of the $[90_2/0_8]_S$ laminate with initial clamping pressure of (a) 0 (b) 35MPa

specimens with bolted joints were subjected to zero clamping pressure and 35MPa clamping pressure, the specimen with higher clamping pressure had increasing fatigue life. From the shear stress distribution analysis of the $[90^{\circ}_2/0_8]_s$ laminate bolted joints as shown in Figure 1.14. The maximum shear stress occurred in the washer area where the through-thickness compression was applied. The fatigue failure was propagated through the shear crack. When the through-thickness compressive stress was applied in the maximum shear stress region, the washer area, the crack opening displacement was reduced by the Poisson's ratio effect. Therefore, the crack propagation was retarded by applying clamping force. For the fatigue tests of $[\pm\theta/0_8]_s$ laminates, it was found that the fatigue stress characteristics were not affected by the outer plies when the same bolt clamping pressure was applied, although their static strengths of were different. The stress versus fatigue life diagram of the bolted joint for the $[90^{\circ}/0_8]_s$ laminates is shown in Figure 1.15. The major factor of failure was shear crack.

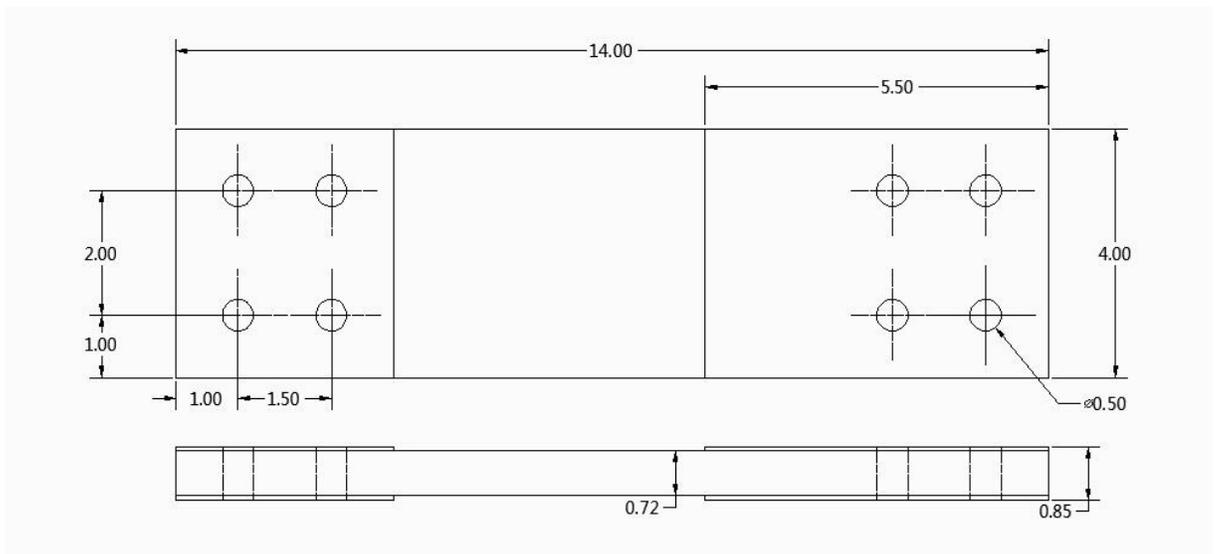
Figure 2.1. Proposed configuration of the thick flex beam (dimension in inches)

A particular configuration used in this study was proposed by the industrial partner, as shown in Figure 2.1. The manufacturing process included five steps: Hand lay-up, curing, edge trimming, bolted holes drilling and buffer pad bonding. Figure 2.2 presented the images of sample after each major step.

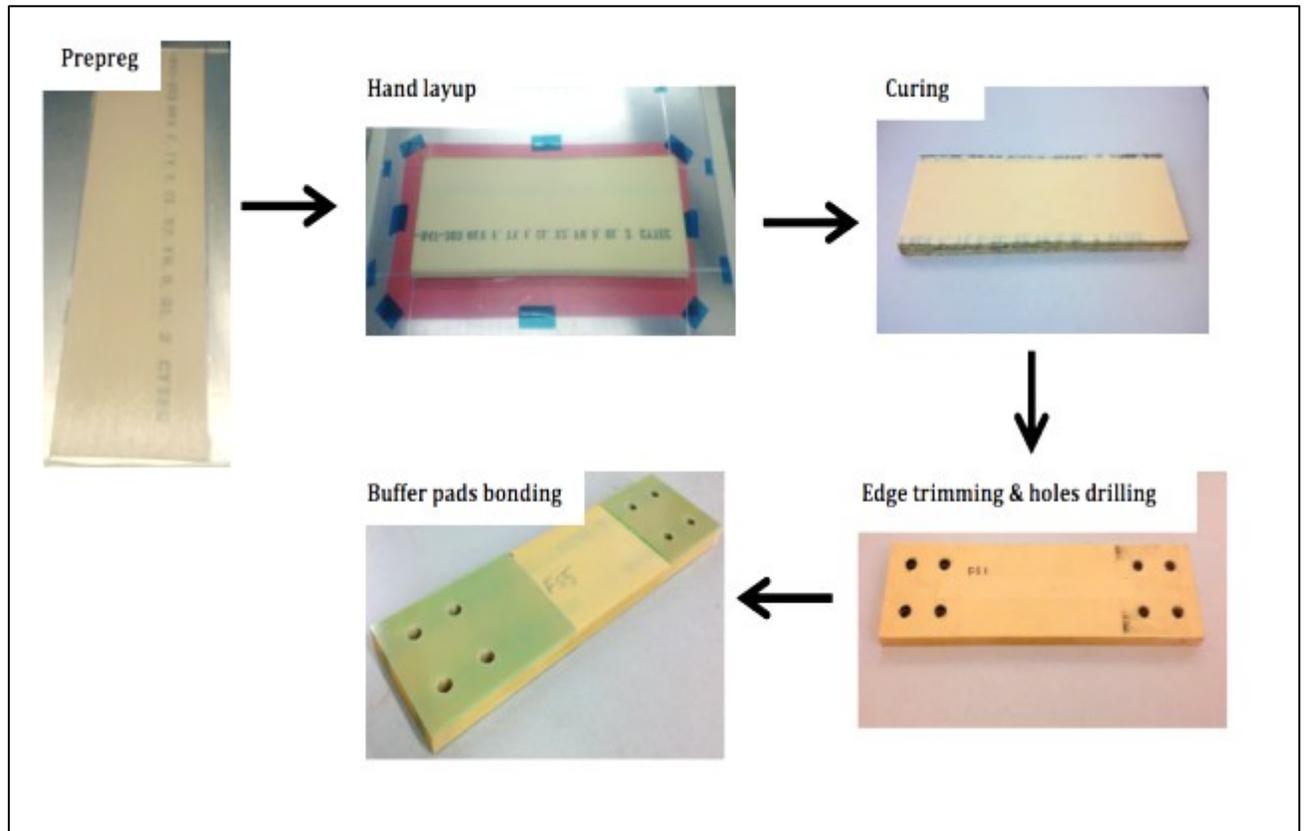
Figure 2.2. Photographs of specimen fabrication steps

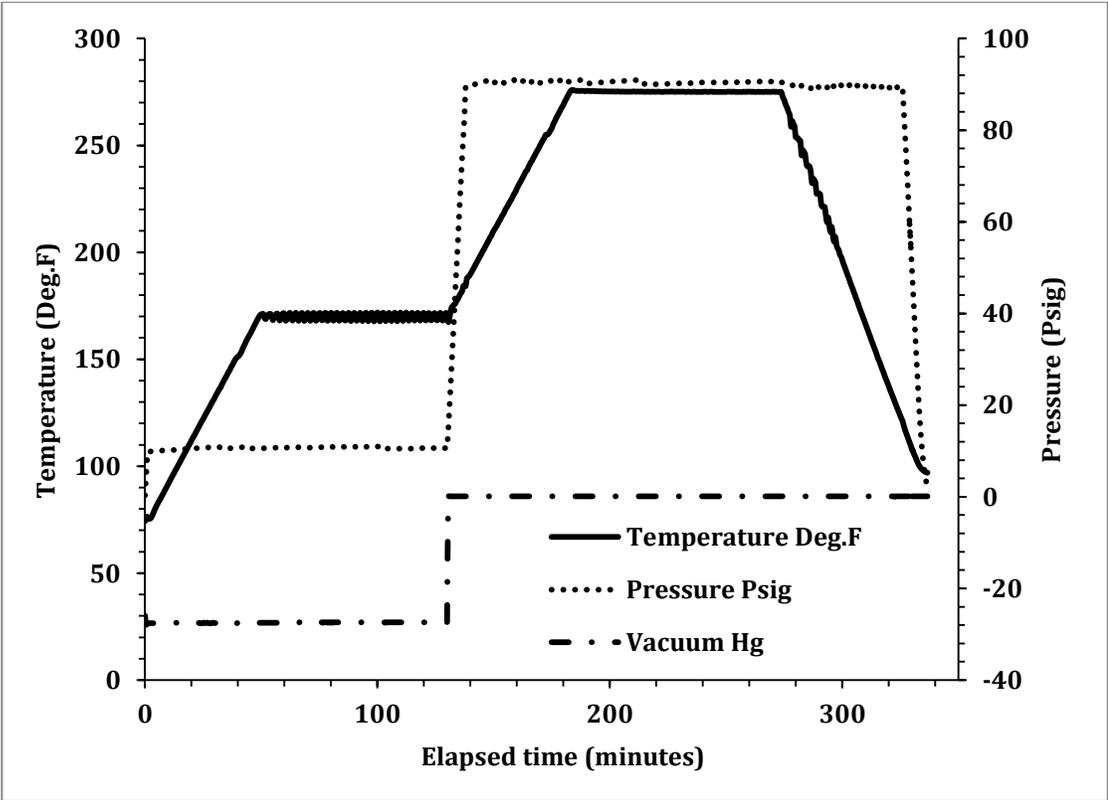
Figure 2.3. Cure cycle of thick E773-S2 glass fiber laminate

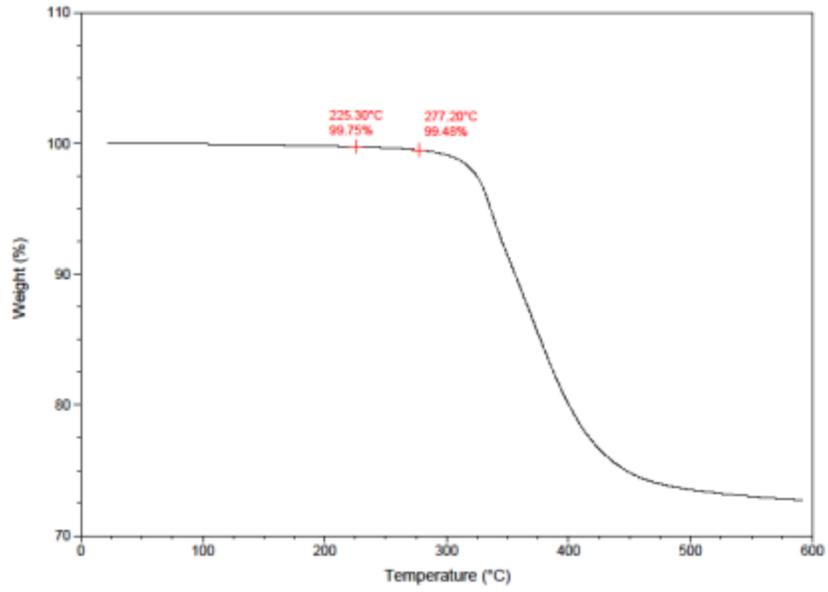
Figure 2.5. TGA test result of a cured specimen

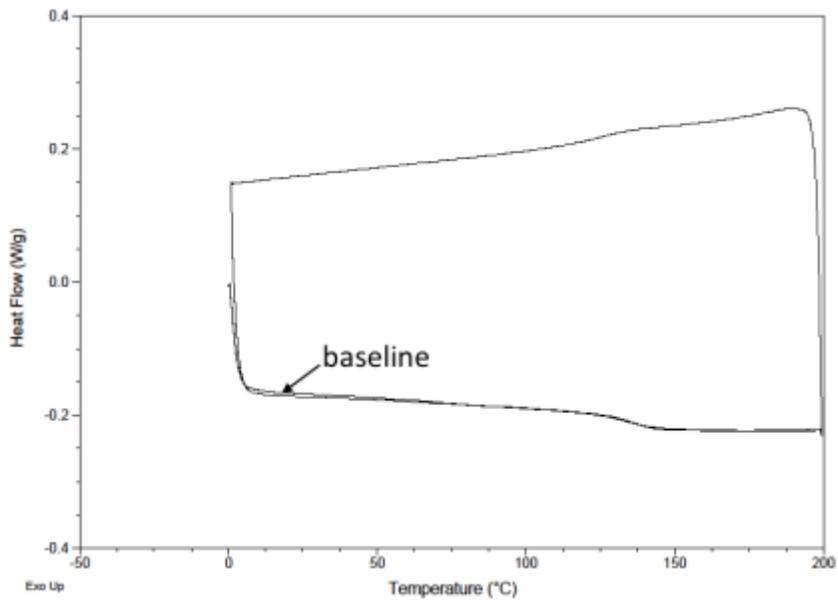
Figure 2.6 Typical DSC test result of a cured specimen

was performed to check the degree of cure of the finished part. The test coupon was placed into the aluminum hermetic pan and lid assembly. Heat-cool-heat cycle was chosen as the testing procedure. The second heat line as indicated in Figure 2.6 was used as a baseline. The heat flow profiles of every tested specimen followed the typical trend as shown in Figure 2.6. In the heat flow profile, the first heat line of cured specimen matched very well with the baseline. No exothermic reactions occurred in the first heating period. It means that the sample was fully cured.

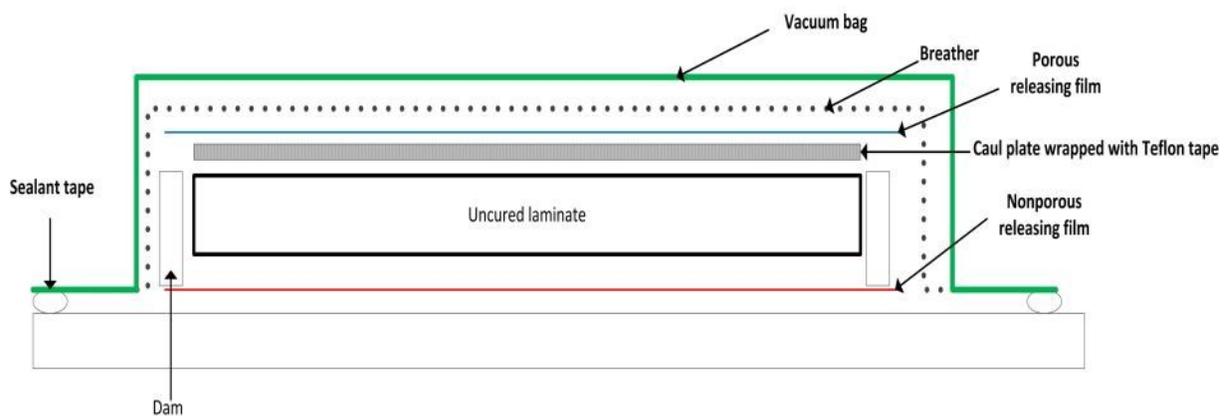
Figure 2.9. Schematic drawing of old bagging assembly

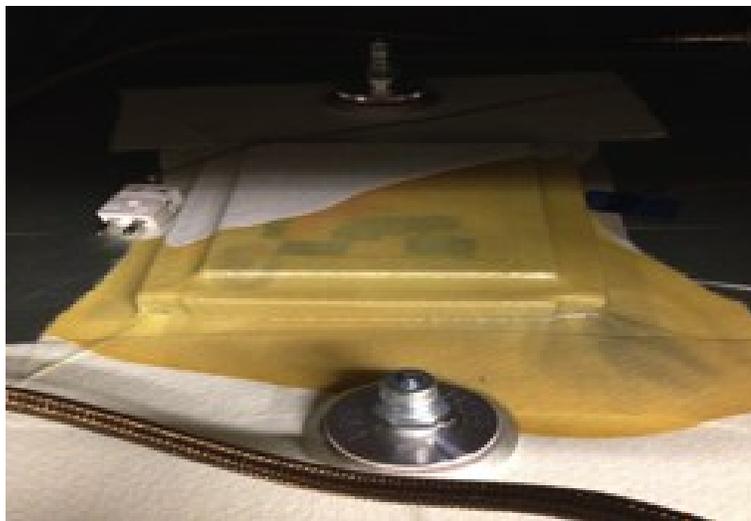
Figure 2.10. Resin bleeding condition by using initial bagging assembly

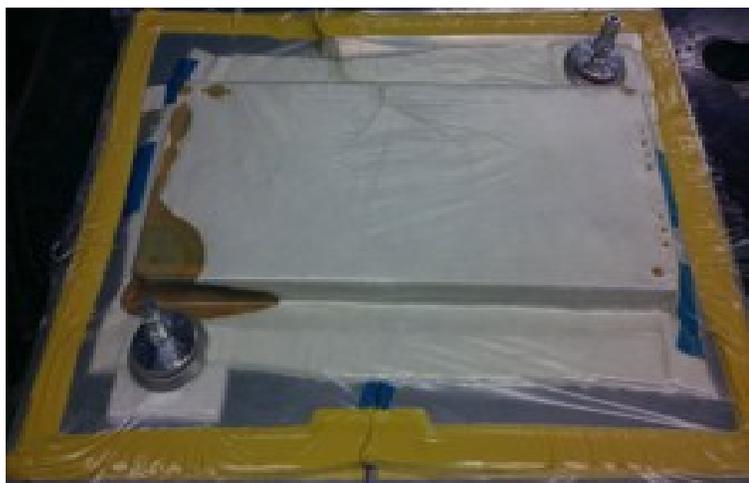
Figure 2.11. Resin bleeding condition by using modified bagging assembly

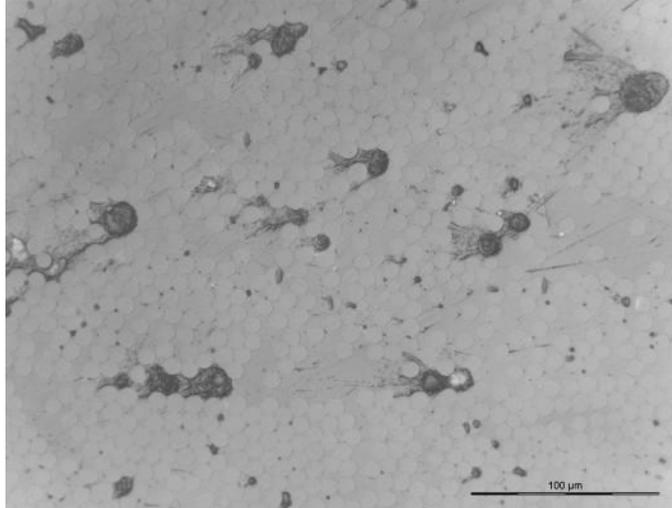
Figure 2.12. Microscopic image in $50\times$ magnification of the laminate debulking every 8 plies for 10 minutes

2.12 to Figure 2.14 were due to three debulking process: debulked every 8 plies for 10 minutes; debulked every 4 plies for 10 minutes and debulked every 3 plies for 5 minutes. When the debulking process was performed for every 8 plies, it could not achieve the aim of removing entrapped air. Large size of voids still existed. After reducing the member of layers to 3 and 4 for each debulking time, the irregular shape of voids could be effectively removed and also the size of voids decreased significantly. For the consideration of quality and efficiency, in the final procedure, the debulking was performed for every 3 plies for 5 minutes. It was investigated that the large size voids had a detrimental effect on the static flexural and flexural fatigue failure of unidirectional carbon fiber composite [58].

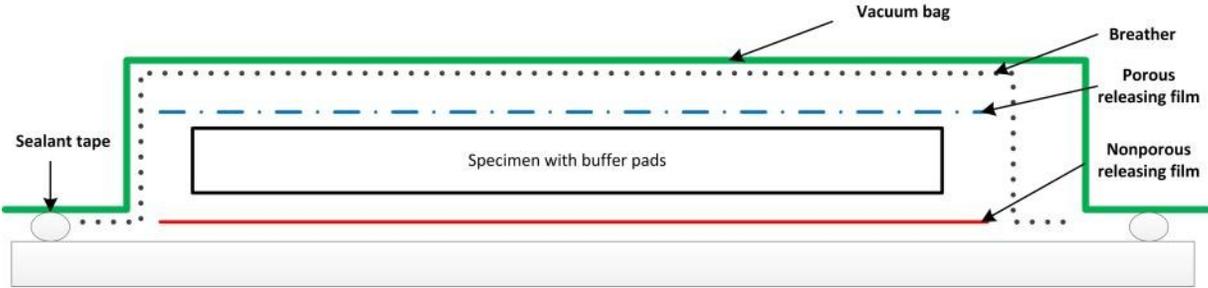
Figure 2.15. Bagging assembly of buffer pad bonding

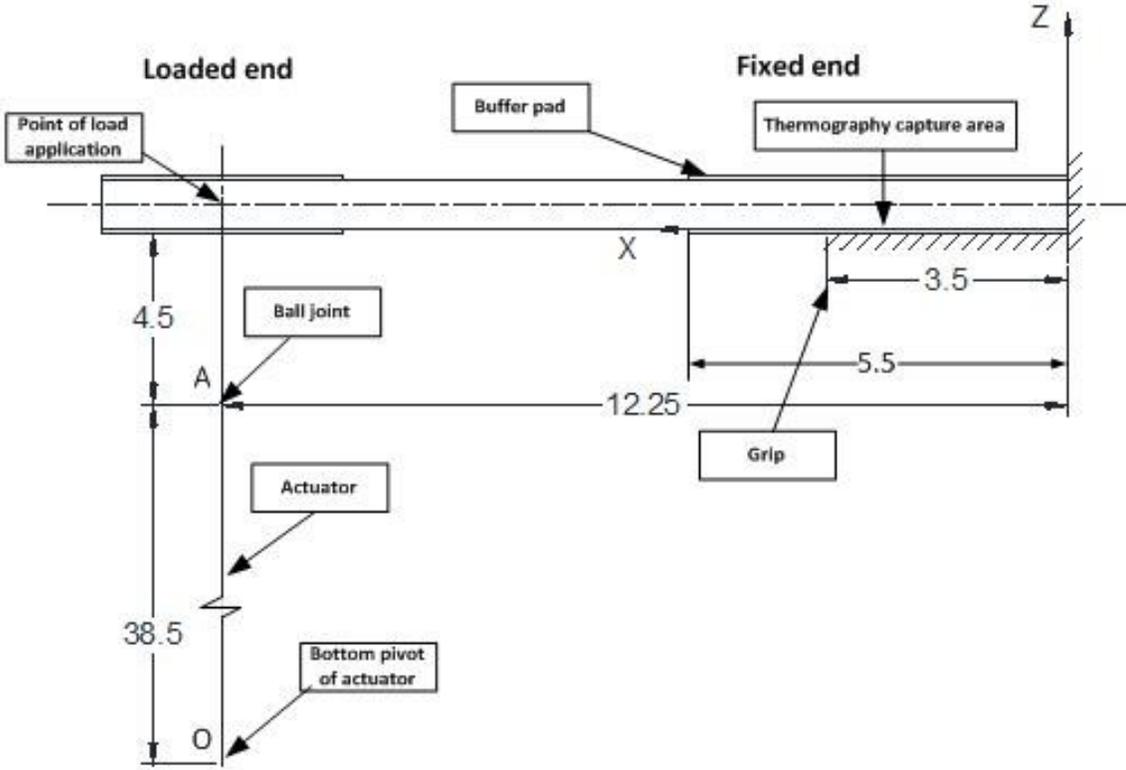
Figure 3.2. Schematic drawing of specimen at zero displacement (Dimensions in inches)

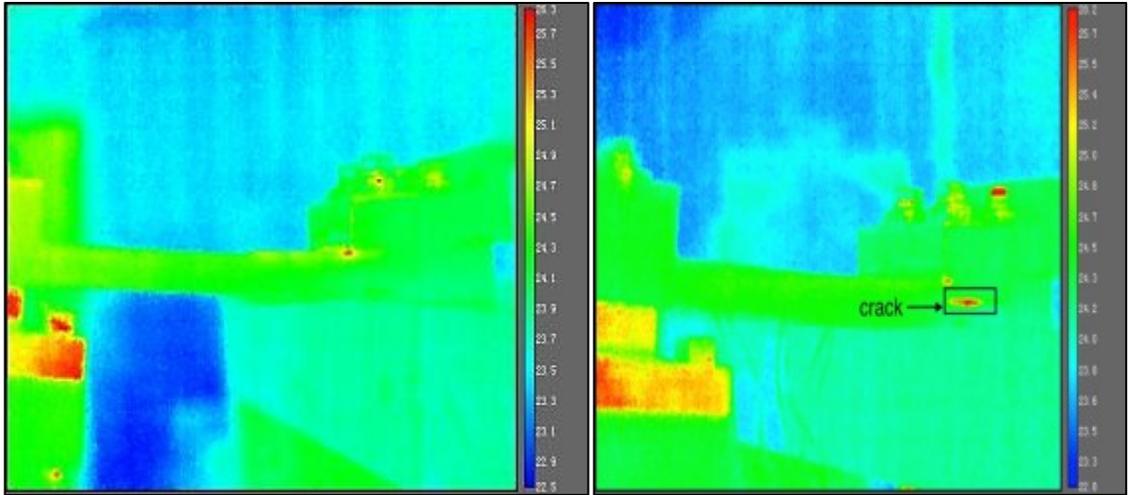
Figure 3.4. Typical thermal images of the test specimen at the periods without delamination (left) and with delamination (right)

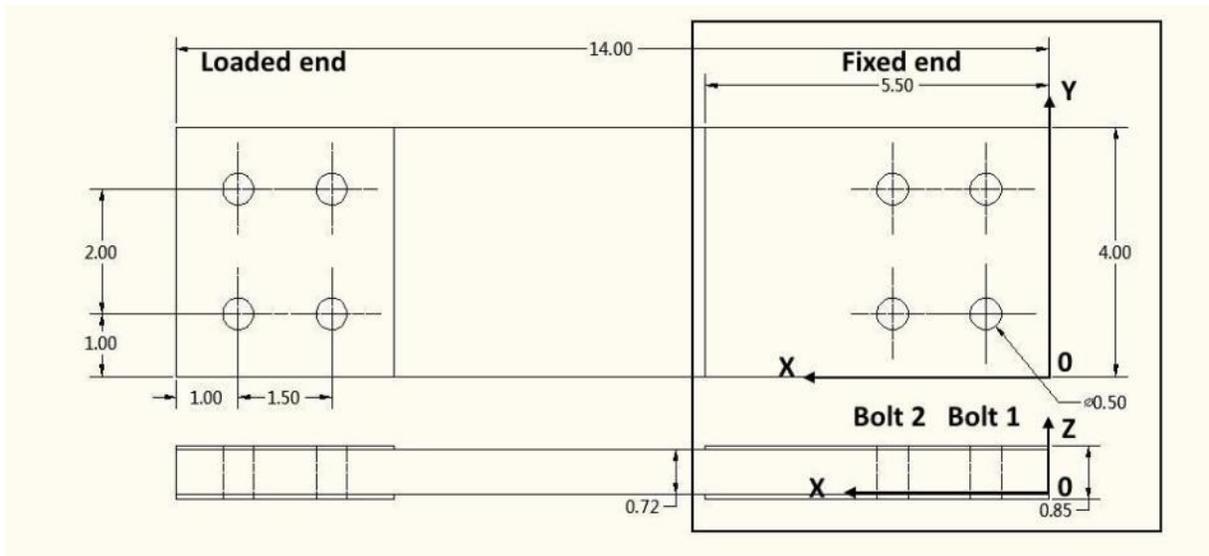
Figure 3.5. Investigated crack area

The side surfaces (XZ plane as shown in Figure 3.5) of the test specimens were painted in white color for the observation of crack initiation and propagation. When a crack initiated or propagated on the side surface, the number of cycles was recorded. After the tests, the lengths of the cracks were measured by caliper. For reference, the coordinates and the locations of bolted holes are indicated in Figure 3.5. To inspect the inside damage of the tested specimens, specimens were sectioned along X or Y directions after the fatigue test as shown in Figure 3.6. A crack may initiate within the specimen or at the edge. The occurrence of a crack on the side surface may or may not correspond to a crack initiation.

The region with the rectangle in Figure 3.5 is the area investigated in the following figures to discuss delaminations. They show the crack locations, propagation path and length on the two side surfaces (XZ plane) of specimens. The locations of the first bolt, second bolt and the grip (steel plate) are indicated in the figure. The two side surfaces of specimen are indicated with letter A and B in Figure 3.16. AL means the crack propagation toward the loaded end. The solid line shows the initiation length of the delamination, and the dotted line shows the propagation. The propagation of this surface crack toward the fixed end was not obvious. In Figure 3.16, the initial delamination on side A was at $Z = 0.43$ ". It is 61% of the total thickness (T), which belongs to the compressive part. As the crack propagated, another delamination occurred on side B. It was at $Z=0.20$ " ($Z/T=29\%$). The delamination on side B occurred during the period without supervision at night. Therefore the propagation was not recorded. The shear-out crack failure did not occur at this deflection level.

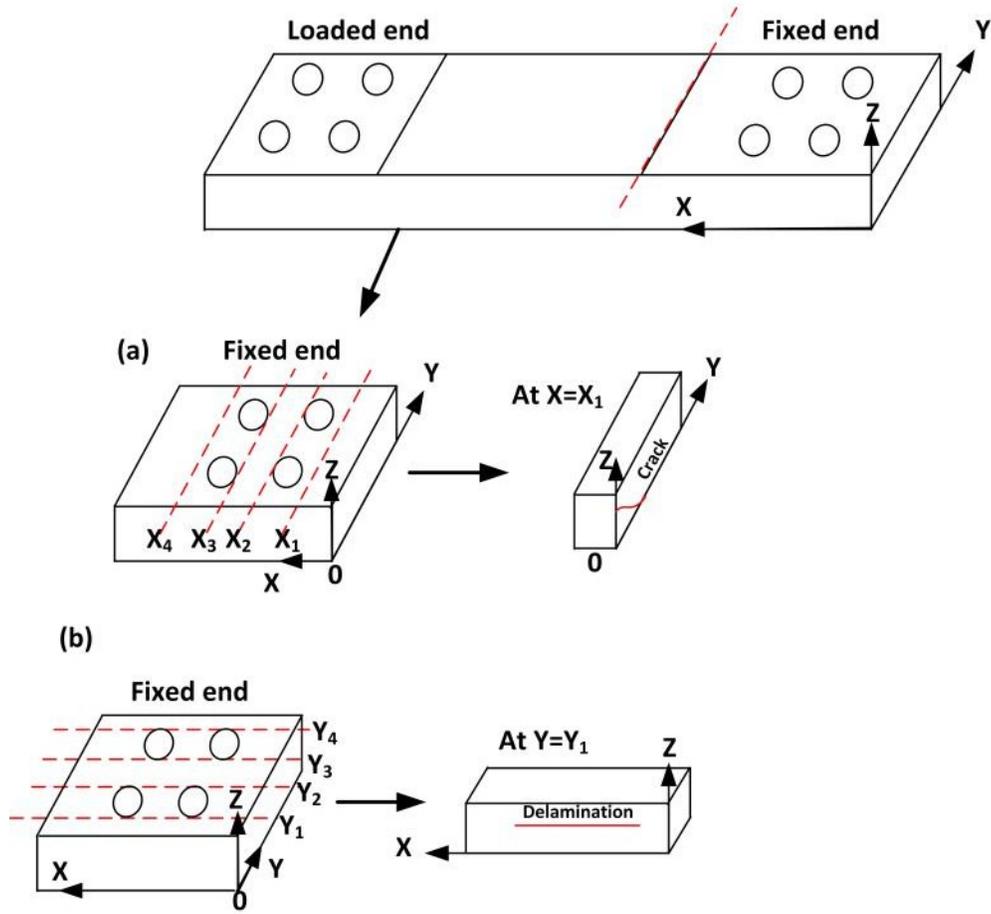
Figure 3.6. Sectioning of failed specimen at (a) different X positions and (b) different Y positions

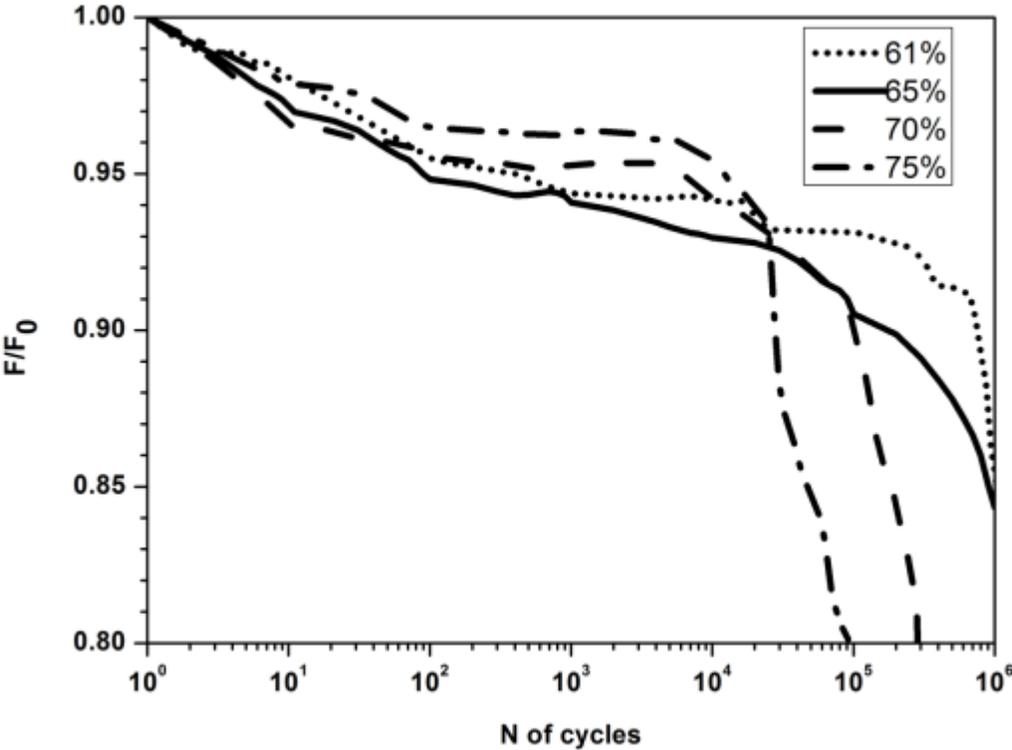
Figure 3.7. Load reduction ratio (F/F_0) versus the number of cycles for $[0]_{80}$ specimens

All curves in Figure 3.7 show two stages for the load reduction ratio. In the first stage, there is a gradual reduction of the load ratio. In the second stage, the rate of load drop increases. The number of cycles for the transition from step 1 to step 2 depends on the level of the maximum displacement.

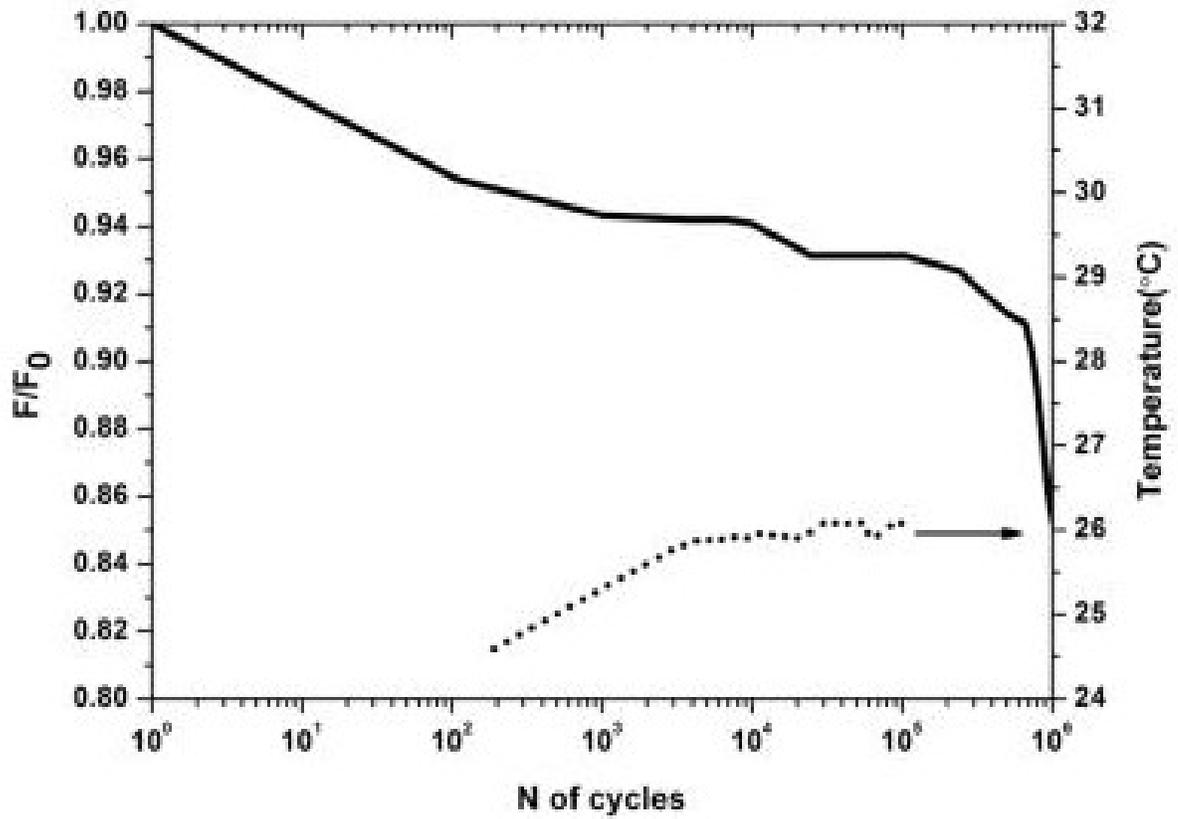
Figure 3.8. Load reduction ratio (F/F_0) and temperature increase at 61% deflection level

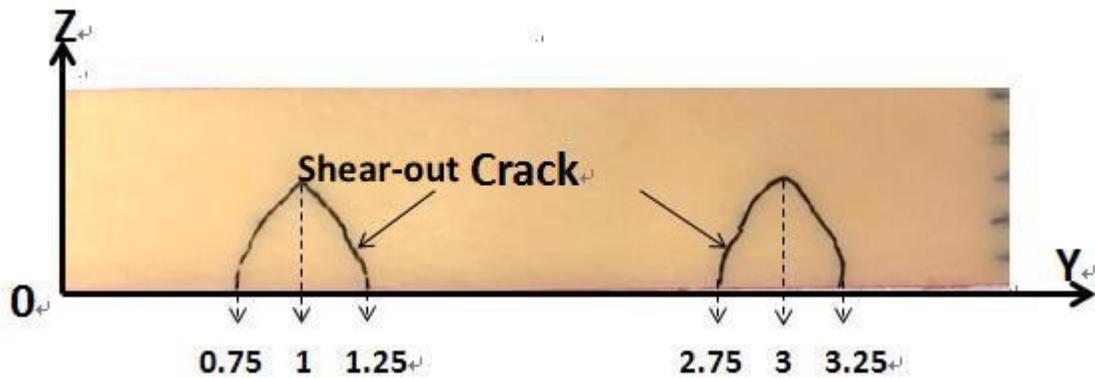
Figure 3.9. Typical crack caused by the shear-out failure of bolted joint at cross-section of $X_3 = 4.05''$

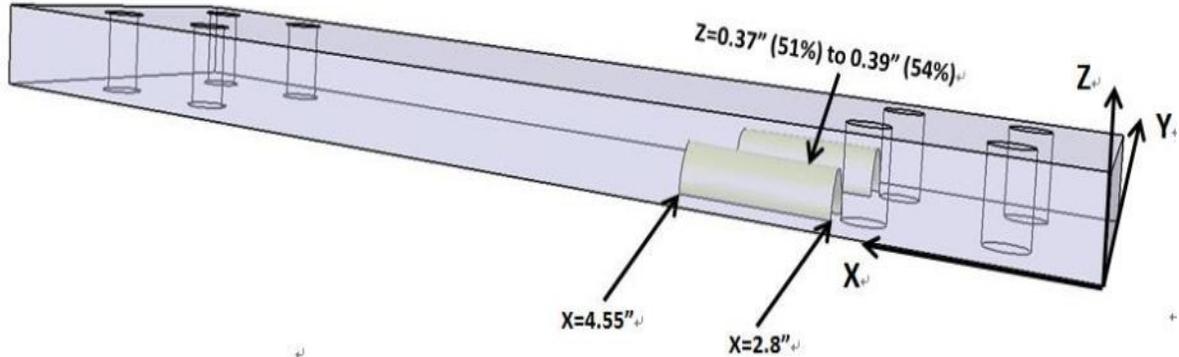
Figure 3.10. Schematic drawing of shear-out cracks of unidirectional specimen at 61% deflection level

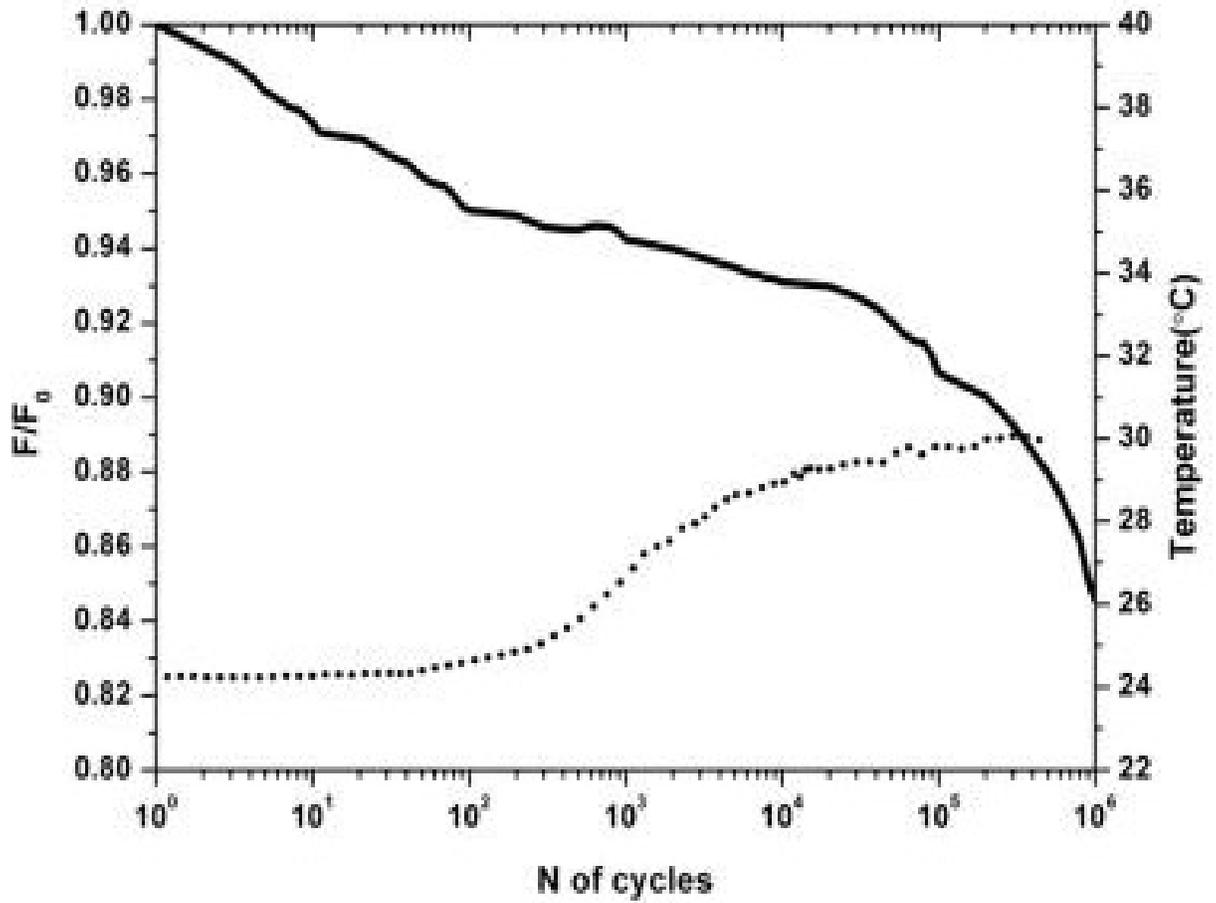
Figure 3.11. Load reduction ratio (F/F_0) and temperature increase at 65% deflection level

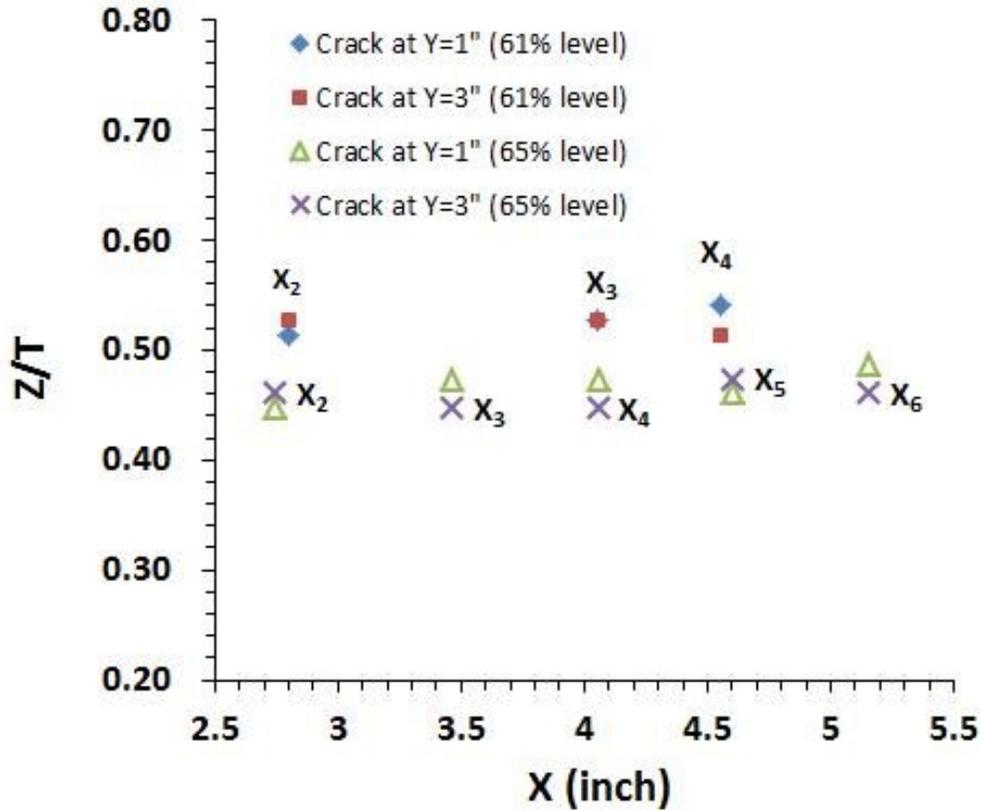
Figure 3.13. The through-thickness distribution of shear-out cracks on each sectioned piece of specimens at 61% and 65% deflection levels

From the shear crack distribution at 61% and 65% deflection levels, it was found this failure mainly appeared at the lower part of the specimen, which was under tension. The highest through-thickness locations (Z/T) of each shear-out crack on every sectioned piece are summarized in Figure 3.13. At 61% deflection level, shear-out cracks were observed on pieces X_2 , X_3 , X_4 . At 65% deflection level, shear-out cracks were observed on pieces X_2 , X_3 , X_4 , X_5 , X_6 . On each piece, there were two crack tips located at $Y = 1"$ and $Y = 3"$. They are distributed in the range of 45% to 54% (Z/T), mainly around the mid-thickness. The shear-out cracks are continuous along X direction within the observation range. The interlaminar shear has the potential to initiate the crack. When subjected to the low stress level but long fatigue cycles, shear-out failure in 0° layers is a common failure mode of the bolted joint.

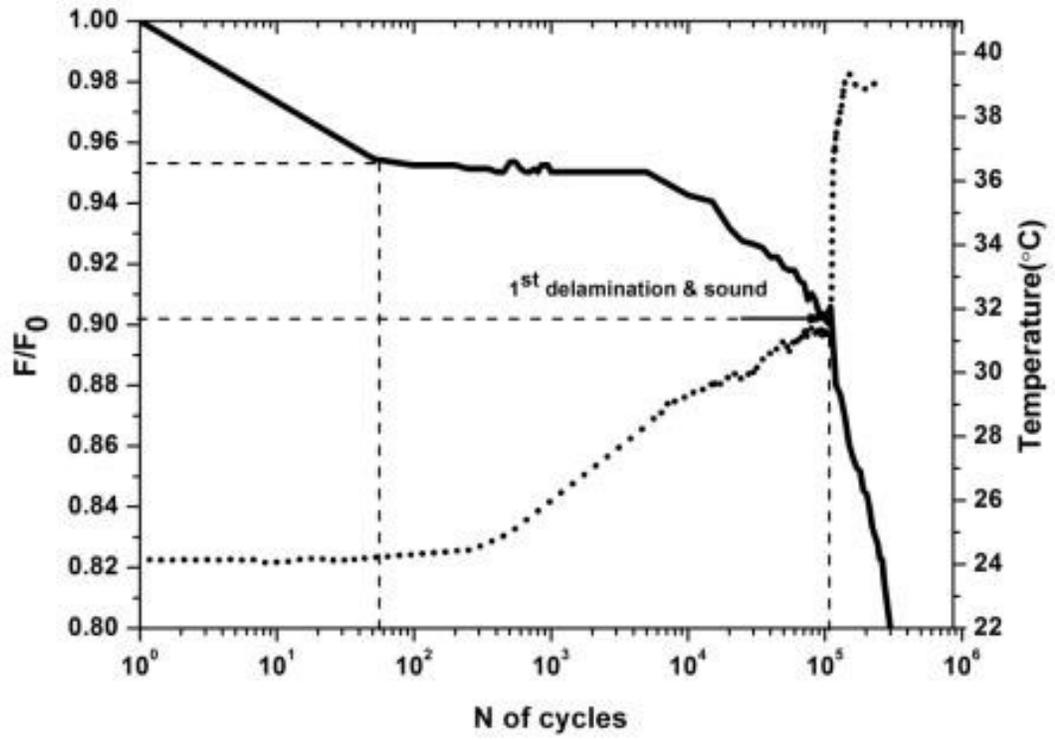
Figure 3.14. Load reduction ratio (F/F_0) and temperature increase at 70% deflection level

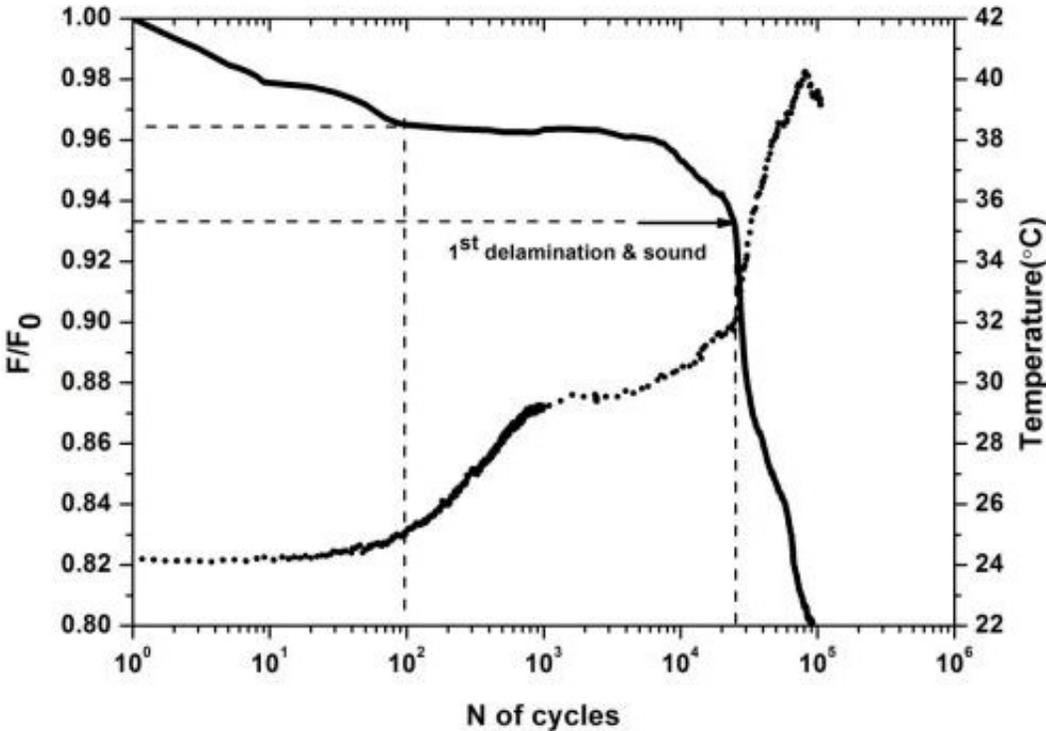
Figure 3.17. Load reduction ratio (F/F_0) and temperature increase at 75% deflection level

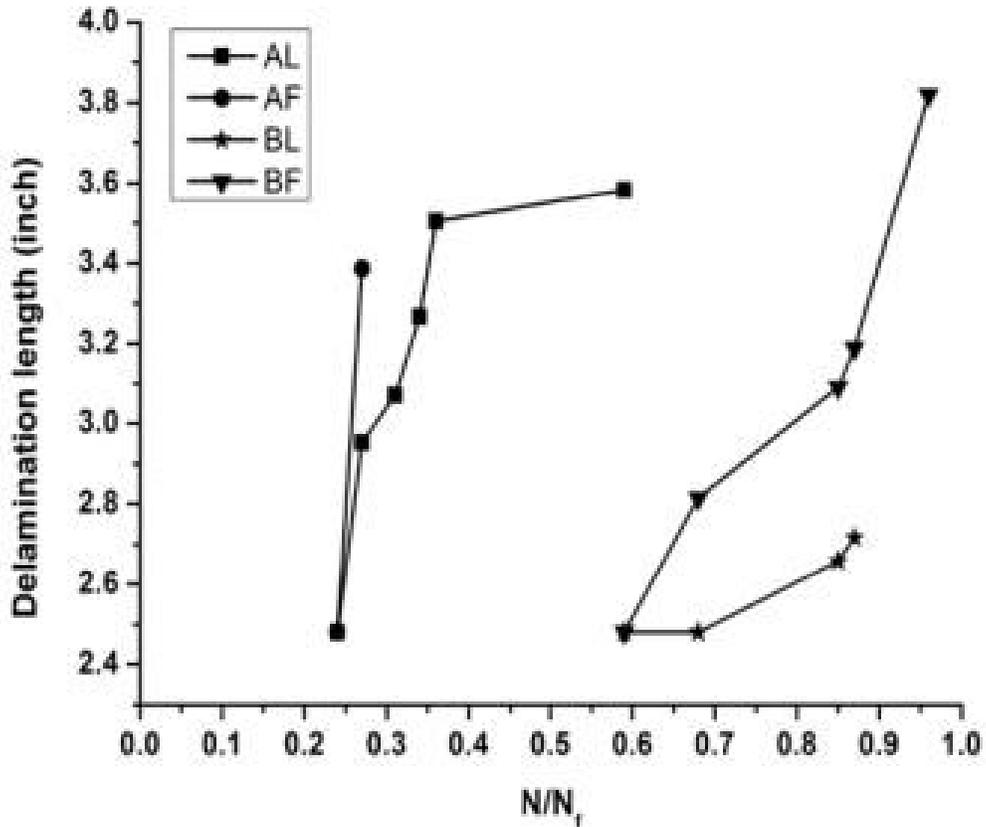
Figure 3.20. Crack propagations at 75% deflection level

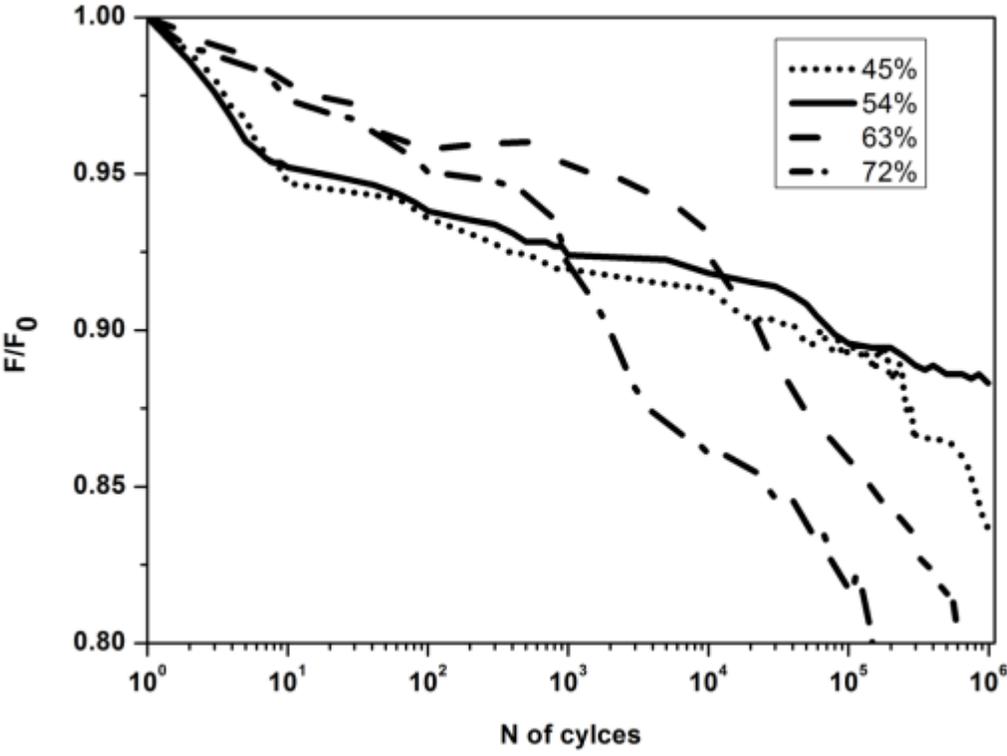
Figure 3.21. Load reduction ratio (F/F_0) versus the number of cycles for $[0/90]_{20s}$ specimens

deflection levels. Before 100 cycles, the first load drop was caused by the buffer pad debonding. For the two lower deflection levels namely, 45% and 54%, the first drop occurred earlier than the other two higher levels. This might be due to the poor bonding of the buffer pads, which was discussed in the manufacturing part. After that, the loads at those two levels decreased gradually until the delamination occurred. The specimens were run up to 10^6 cycles. For the specimens at two higher deflection levels namely, 63% and 72%, after the initial load drops, the bending loads decreased more quickly because of the early delaminations.
