**Manufacturing and Fatigue Behavior of Thick Glass/Epoxy
Composite Beams**

Mechanical and Industrial Engineering

Concordia University

July 2016

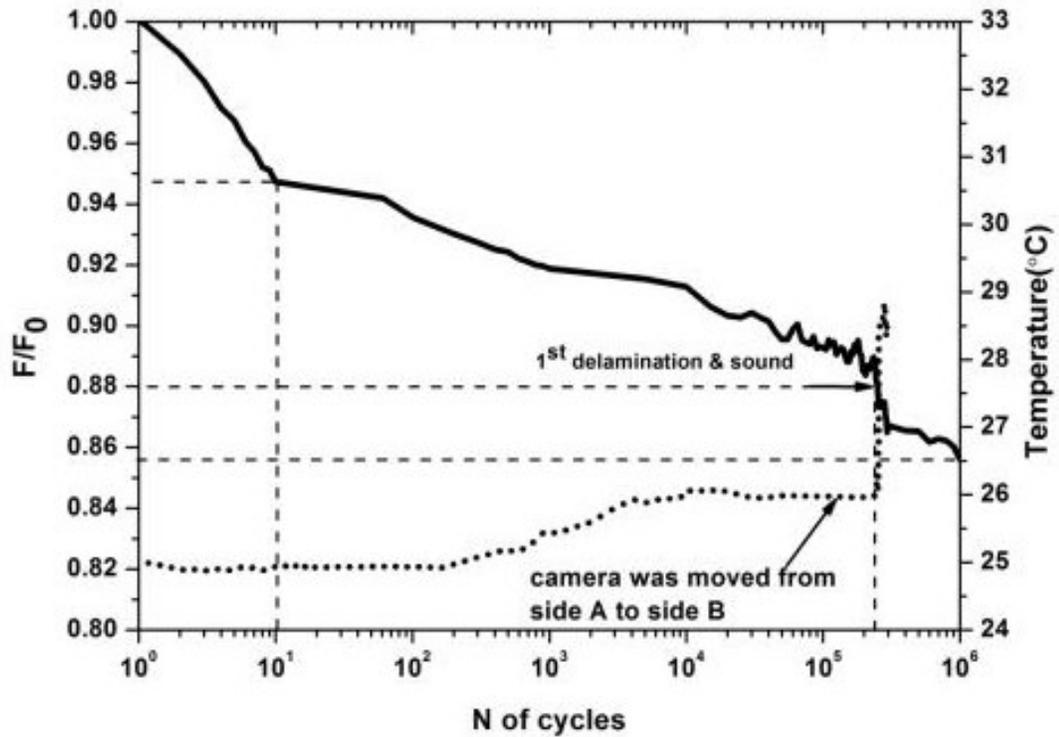
Figure 3.22. Load reduction ratio (F/F_0) and temperature increase at 45% deflection level

As presented in Figure 3.22, the buffer pad broke at 10 cycles with a 5% load drop. After that it experienced a gradual decrease until the crack occurred. The first crack occurred at about 230,000 cycles on side B along with a temperature increase and the sound. The second crack on side A occurred between 250,000 and 280,000 cycles. As shown in Figure 3.25, the initial lengths of those two cracks were about 1.7" and 1.6" respectively. The cracks on both surfaces propagated to two directions. The growth to the fixed end was more than the loaded end. The existence of bolted holes made the area around them become weaker, which provided an easier way for the propagation of crack. The mode of cracks on cross-ply specimens is different from that of the unidirectional specimens. The crack on the surface appears in a zig-zag shape as indicated by the solid lines in Figure 3.23. The enlarged schematic drawing of this failure is shown in Figure 3.24. The positions of the zig-zag points on side A and side B are the same, namely 3.2" away from the fixed end. Along Z direction, the initiated cracks are located around the mid-thickness. Those two cracks on side A and side B occurred within 50,000 cycles and grew quickly, which resulted in a rapid load drop. The load drop at 10^6 cycles was 15% of the initial state. The temperature recording at this level was not performed continuously on the same side surface, because there was only one thermal camera available in the lab. The recording always focused on side A. However, the first crack of this test specimen occurred on side B. The camera was moved to side B for the following recording. The temperature profile in Figure 3.22 shows a sudden increase from 26°C to 29°C at the point of damage initiation.

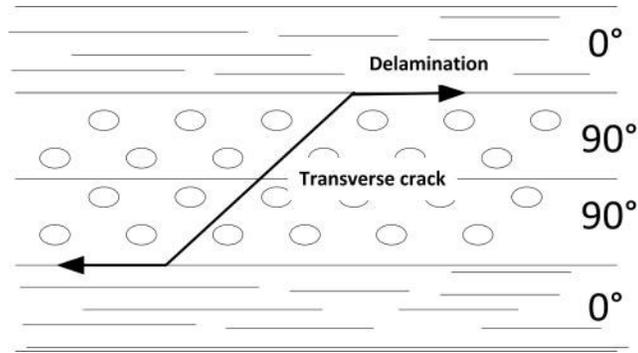
Figure 3.24. Schematic drawing of the zig-zag shaped failure at the mid-plane of the cross-ply specimen

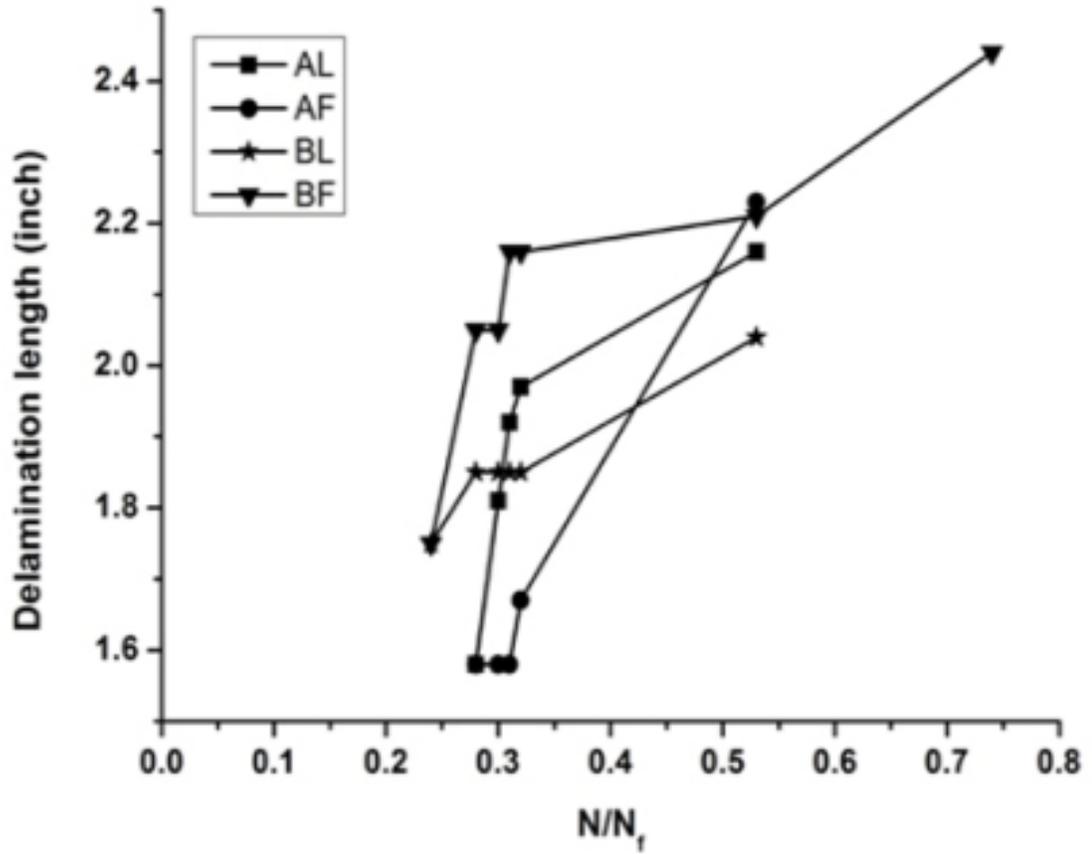
Figure 3.25. Surface crack propagations at 45% deflection level

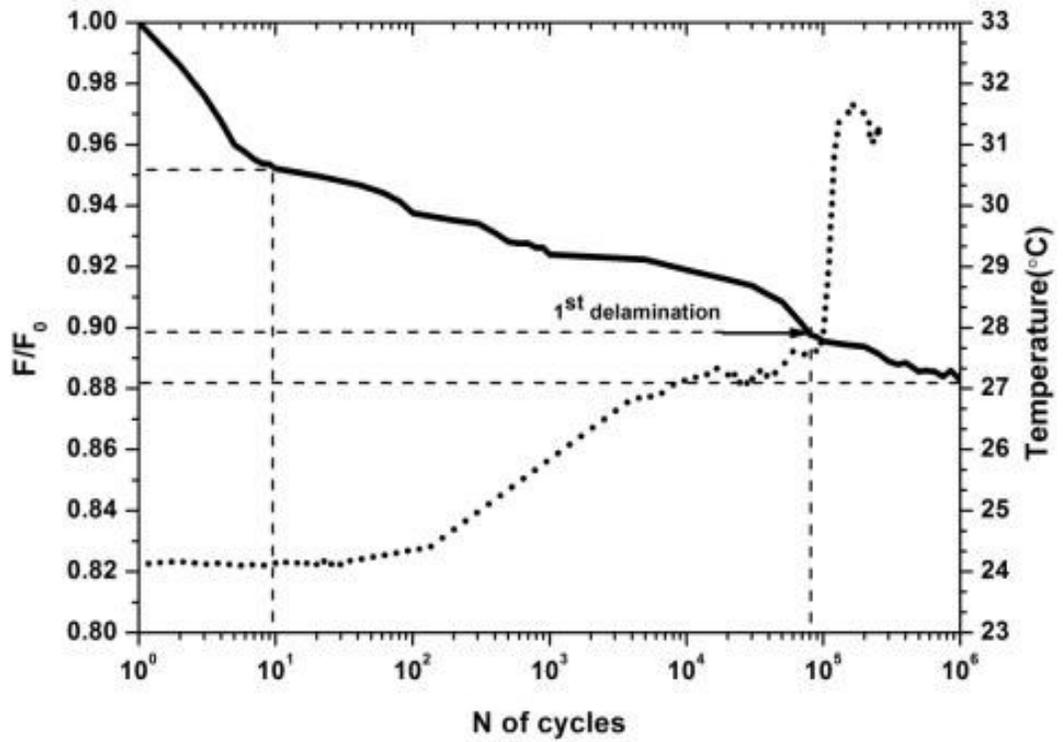
Figure 3.26. Load reduction ratio (F/F_0) and temperature increase at 54% deflection level

At the deflection level of 54%, the buffer pad was debonded at 10 cycles and induced a 5% load drop. The first delamination was observed on the side A at around 90,000 cycles along with a temperature increase from 27.5°C to 31.5°C as shown in Figure 3.26. As shown in Figure 3.27 and Figure 3.28, the initiated length of this delamination was 0.47". The initial zig-zag point was 3" away from the fixed end. The occurrence of this crack did not come with an audible sound because of the small crack size. However, the initiation of the crack was clearly captured by the thermography. After the crack was initiated on the surface, the temperature remained around 31.5°C. The delamination size was smaller and the propagation of this delamination was less than that of 45% level. This was probably because the crack surrounding region was not as weak as that at 45% level. The surrounded 90° fibers gave better resistance to the crack propagation. When the specimen was run up to 10⁶ cycles, the total load reduction was 12%.

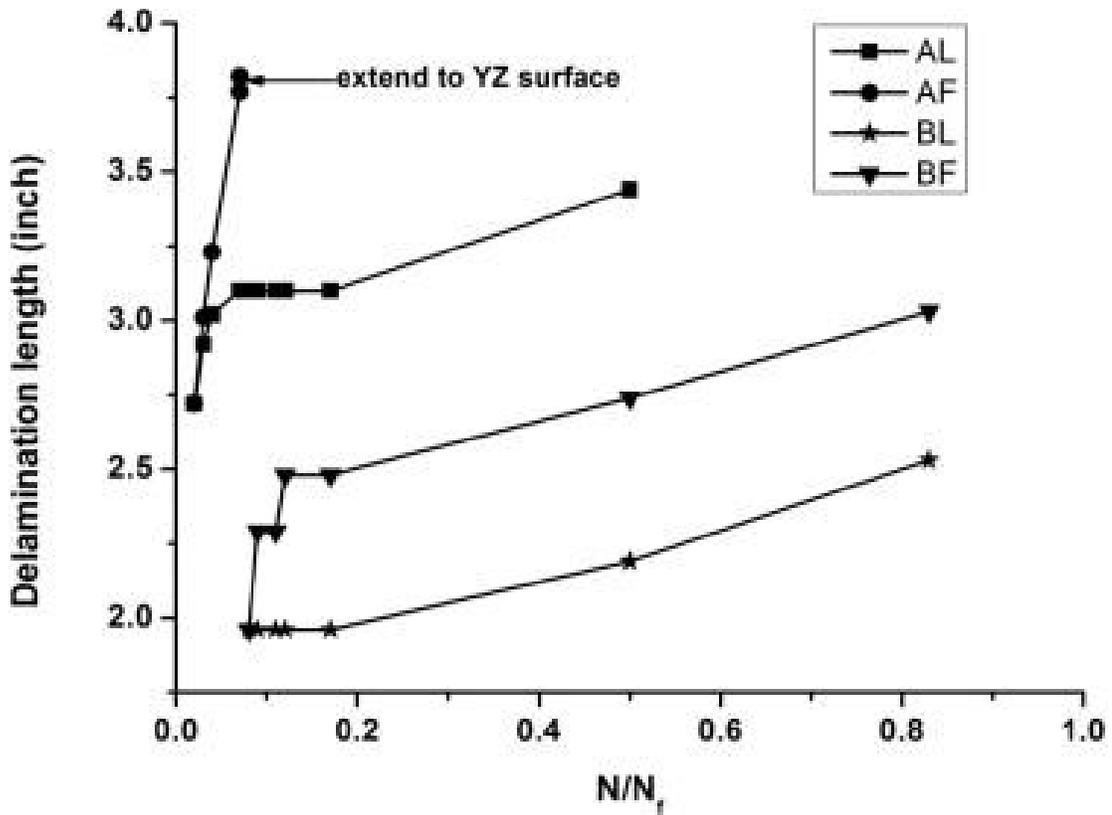
Figure 3.32. Surface crack propagations at 63% deflection level

on side A and side B are 3" and 2.5" away from the fixed end respectively. Figure 3.32 shows that the cracks propagated with a slow rate during the fatigue life. The crack on side A also extended on the YZ surface.

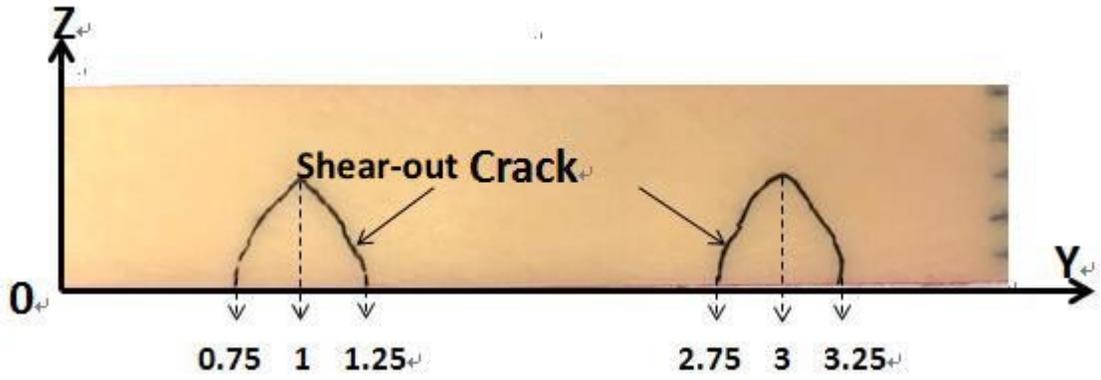
Figure 3.36. Shear-out failure mode of unidirectional specimens at 61% and 65% deflection levels

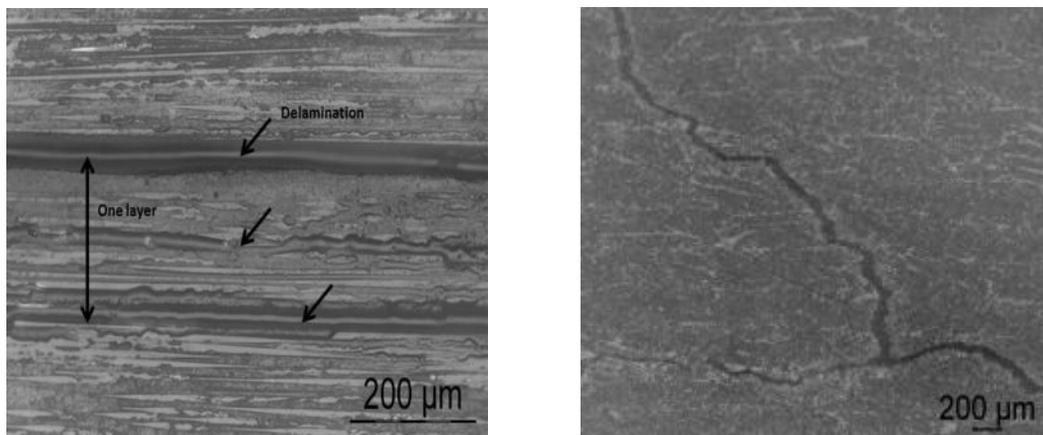
Figure 3.38. Microscopic images of the cracks of $[0]_{80}$ specimen on the XZ surface (left) and YZ surface (right)

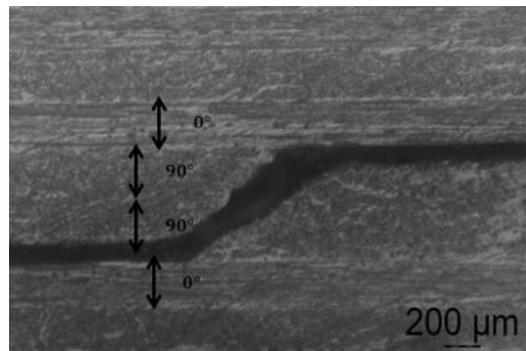
Figure 3.40. Microscopic image of the crack of $[0/90]_{20s}$ specimen

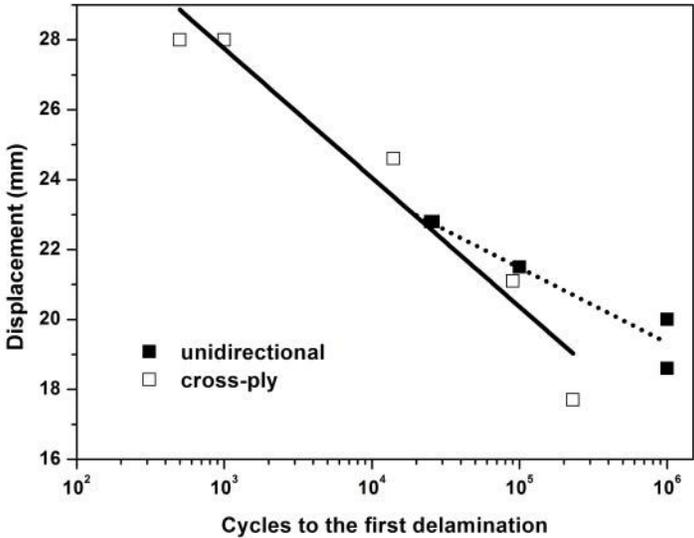
Figure 3.47. Cycles to first crack of $[0]_{80}$ and $[0/90]_{20s}$ test specimens at different displacements

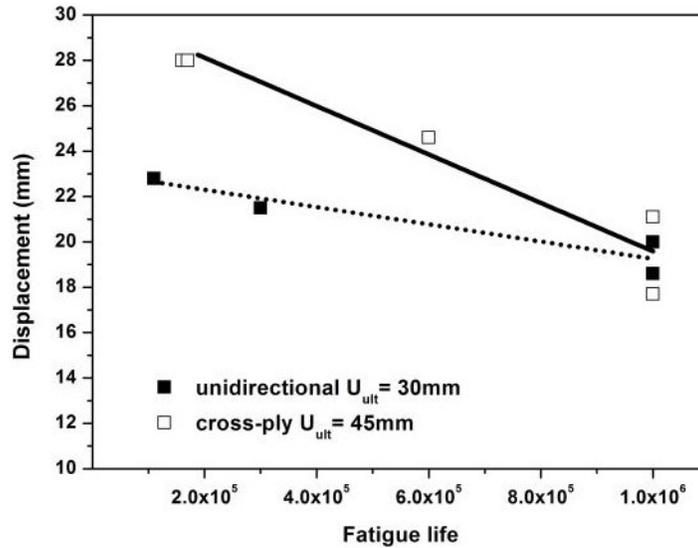
Figure 3.48. Fatigue life diagram of $[0]_{80}$ and $[0/90]_{20s}$ test specimens at different displacements
