# **Mechanical Performance Prediction and Retrofitting Technique of Heritage Timber Beams**

A Thesis

In the Department of  
Building, Civil, and Environmental Engineering

October 2025

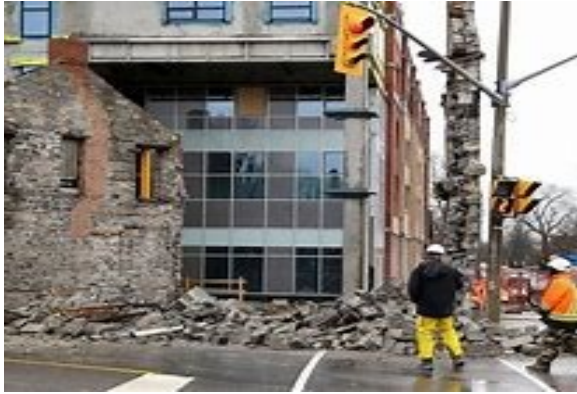
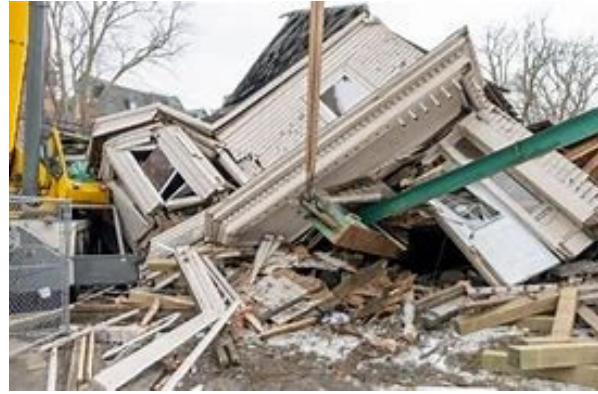
**Fig. 1.3.** Collapsed Heritage buildings

Unfortunately, some Heritage timber buildings have deteriorated and been damaged over the years due to excessive deflections, load modifications, and inadequate maintenance, leading to diminished functionality. The recent collapse of the Heritage building depicted in Fig. 1.3a, built in the 1840s in Ontario, Canada, highlights the serious consequences of inadequate inspection, maintenance, and reinforcement [6]. Similarly, another collapse in Halifax, Canada, depicted in Fig. 1.3b, happened when a Heritage building from 1861 was moved without the necessary reinforcement [7].

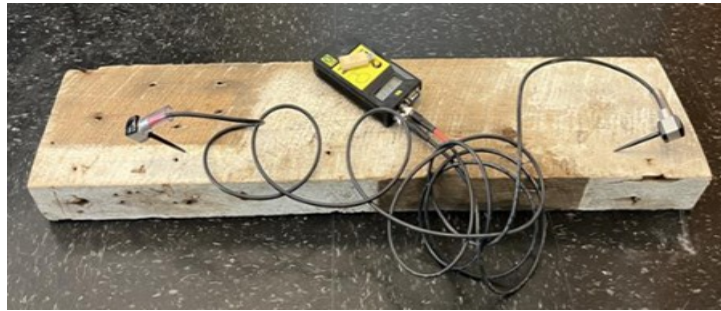
Fig. 3.1 portrays the NDT prior to the destructive tests. Moisture content was measured by a moisture meter, showing 7% to 12%, addressing bending test considerations [104]; however, the exact amount was calculated by the oven dry method, followed by density measurements [105].

**Fig. 3.1.** Non-destructive tests (Ultrasonic measurements)

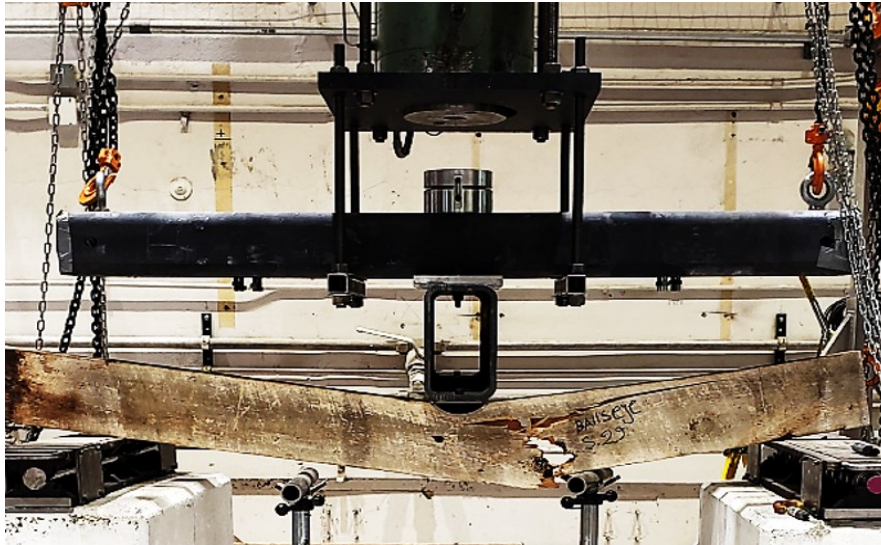
**Fig. 3.2.** Destructive tests on Heritage beams

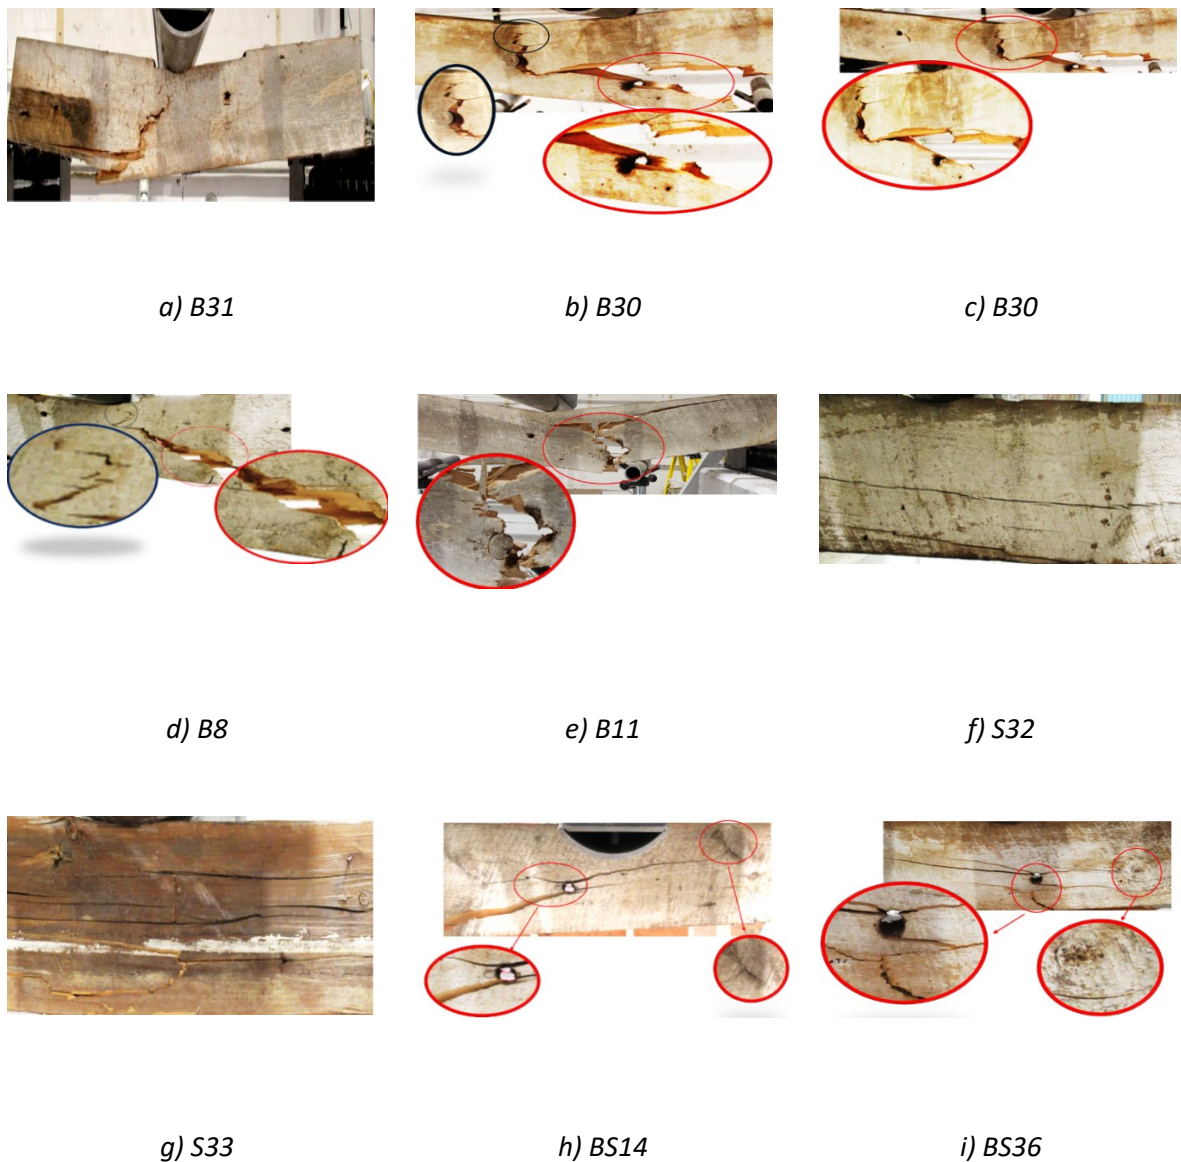
**Fig. 3.7.** Visual shear, flexural, and coupled failures

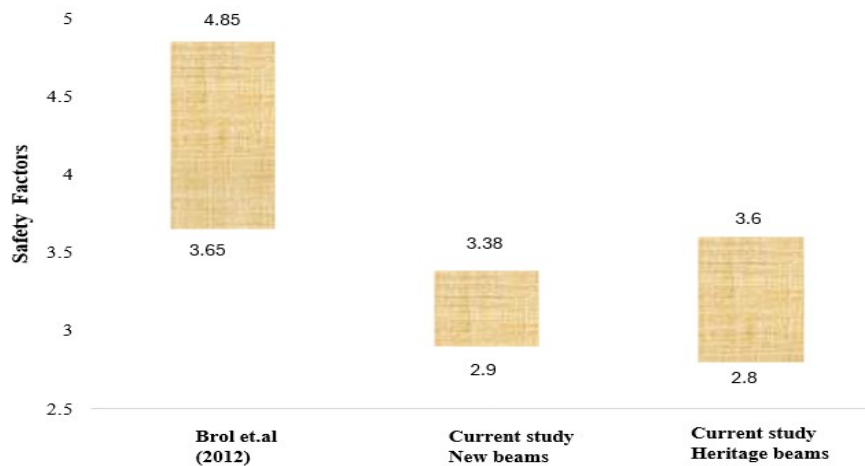
**Fig. 4.6.** Safety factor for Heritage and New beams, as well as from literature [19]

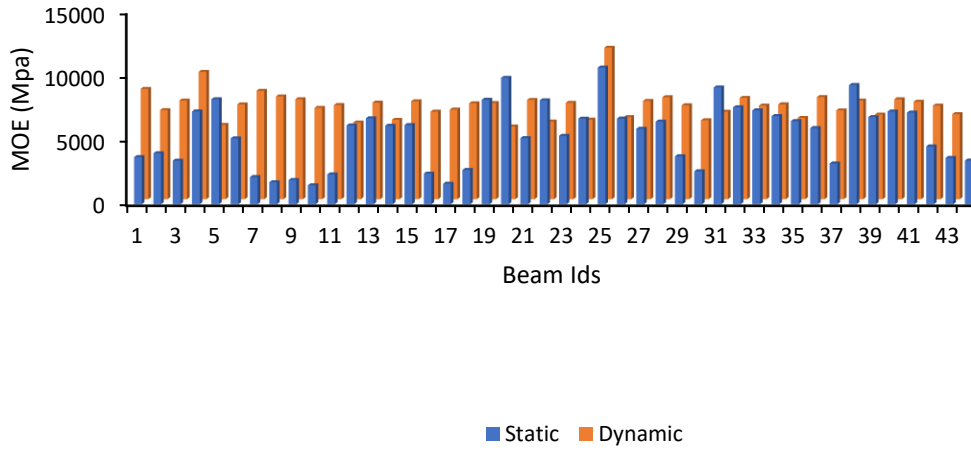
Fig. 4.8 a shows the comparison of  $MOE_{dyn}$  obtained from NDT and MOE from destructive tests, while Fig. 4.8-b demonstrates the ratio of the maximum load-carrying capacity of Heritage to New beams. Discrepancies are observed in the two MOEs of several beams, such that the MOE obtained from the destructive test is a true reflection of material behaviour, while the  $MOE_{dyn}$  does not consider age-related effects. Remarkably, for at least 10/44 beams, it can be observed that when there is a significant difference between two MOEs (Fig. 4.8a), the ratio of maximum load ( $F_{max, Heritage}/F_{max, SPF}$ ) is close to or under 1, indicating that the performance of the two entities is nearly identical. The experimental findings (shown in Figure 4.8) strongly support the scientific outcomes of the Null hypothesis. Clearly, 34/44 beams show ( $F_{max, Heritage}/F_{max, SPF}$ ) ratios of up to 2.5, suggesting that the Heritage beams, if not biologically deteriorated over time, exhibit considerably better structural and material performance compared to their SPF New counterpart beams.

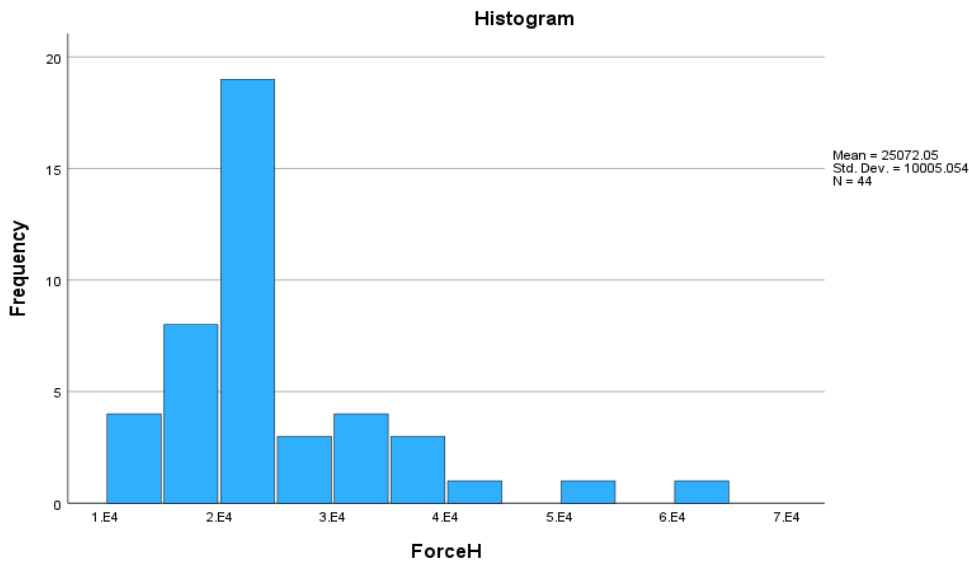
Frequency distribution describes the behaviour, overview, and distribution of the data, as presented in Fig. 4.9. As illustrated, most of the values for the maximum force in the Heritage beams are clustered around 20000 N, with the mean values of 25072 N. Table 4.3 provides the value of standard deviation as 10005 for the Heritage beams, whereas New beams show a value of 14329, indicating a stronger strength for the New beams, ultimately making the comparison between New and Heritage beams cumbersome, emphasizing the need to deploy a robust tool, such as the Null hypothesis.

**Fig. 4.9.** Maximum force (kN)- frequency distribution for Heritage beams (tested)

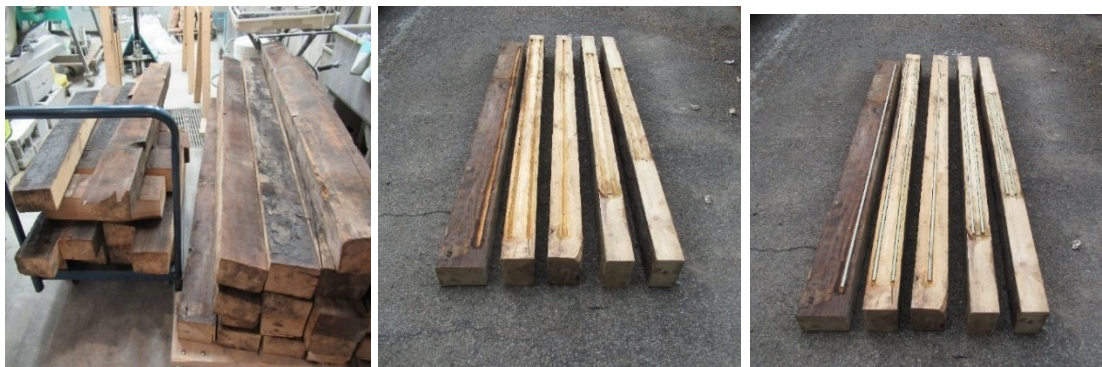
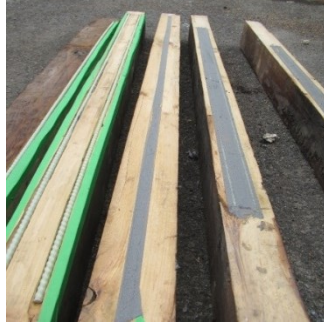
**Fig. 5.1.** a: Specimen groups, b: Grooving of the test specimens, c: placement of the reinforcements, d: application of the epoxy

The experimental testing campaign followed a structured procedure comprising specimen preparation, reinforcement embedding, and mechanical testing, as illustrated in Fig. 5.1 Heritage timber beams were carefully selected to reflect the actual structural conditions, with some exhibiting signs of fire-induced damage, such as surface charring and superficial cracks. Before reinforcement, the beams were thoroughly cleaned to remove debris, dust, and loose fibres, ensuring a clean surface for adequate bonding. Circular grooves matching the dimensions of the reinforcement bars were precisely milled along the beam lengths, with a minimum diameter of 3mm greater than the FRP bars. Reinforcement configurations varied across specimens, with GFRP bars placed on either the tension or compression side to evaluate performance differences. They were bonded using epoxy resin. Care was taken to ensure full resin coverage and impregnation, minimizing the risk of de-bonding. Three replications of each beam configuration were made. Previous studies have employed 3-5 replicates [10,29–31]. After inserting FRP bars, the beam was left for 14 days for curing before testing. Loading displacement control, quasi-static. Other studies applied monotonic loading at a constant rate of 3 mm/min up to failure [10,131].
