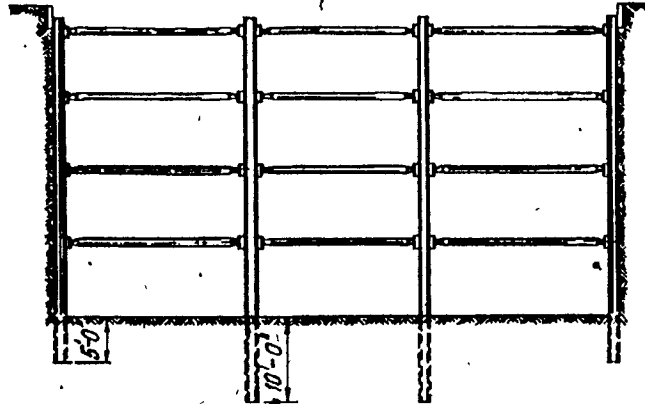
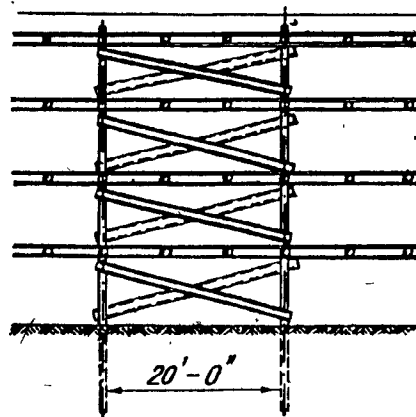
The case which follows is an example of the collapse of the lining of an excavation due to the ineffective bracing. The tunnels in Fig. 24

were constructed by a cut-and-cover method which had been standardized after many years of experience. As the enclosure was not watertight, and the excavation was to extend well below the level of the ground water, the soil was dewatered by the well point method. At one part of the work, some changes were made, which caused the absence of both three-dimensional bracing between the vertical struts and the absence of any connection between the upper struts and bracing with the bottom of the excavation. The joists in the inner wall of the eastern part tilted some 20 ft at the top along a length of 200 ft and the wall collapsed. This accident emphasises the need for horizontal stiffening of bracings and struts across large distances.

Bracing for the support of the side of an excavation for part of the underground railway in Berlin, Germany.
