A database tool to support building envelope failure diagnosis

A Thesis

Building, Civil & Environmental Engineering

Presented in Partial Fulfillment of the Requirements
For the Degree of Master of Applied Science (Building Engineering)
Concordia University
Montreal, Quebec, Canada

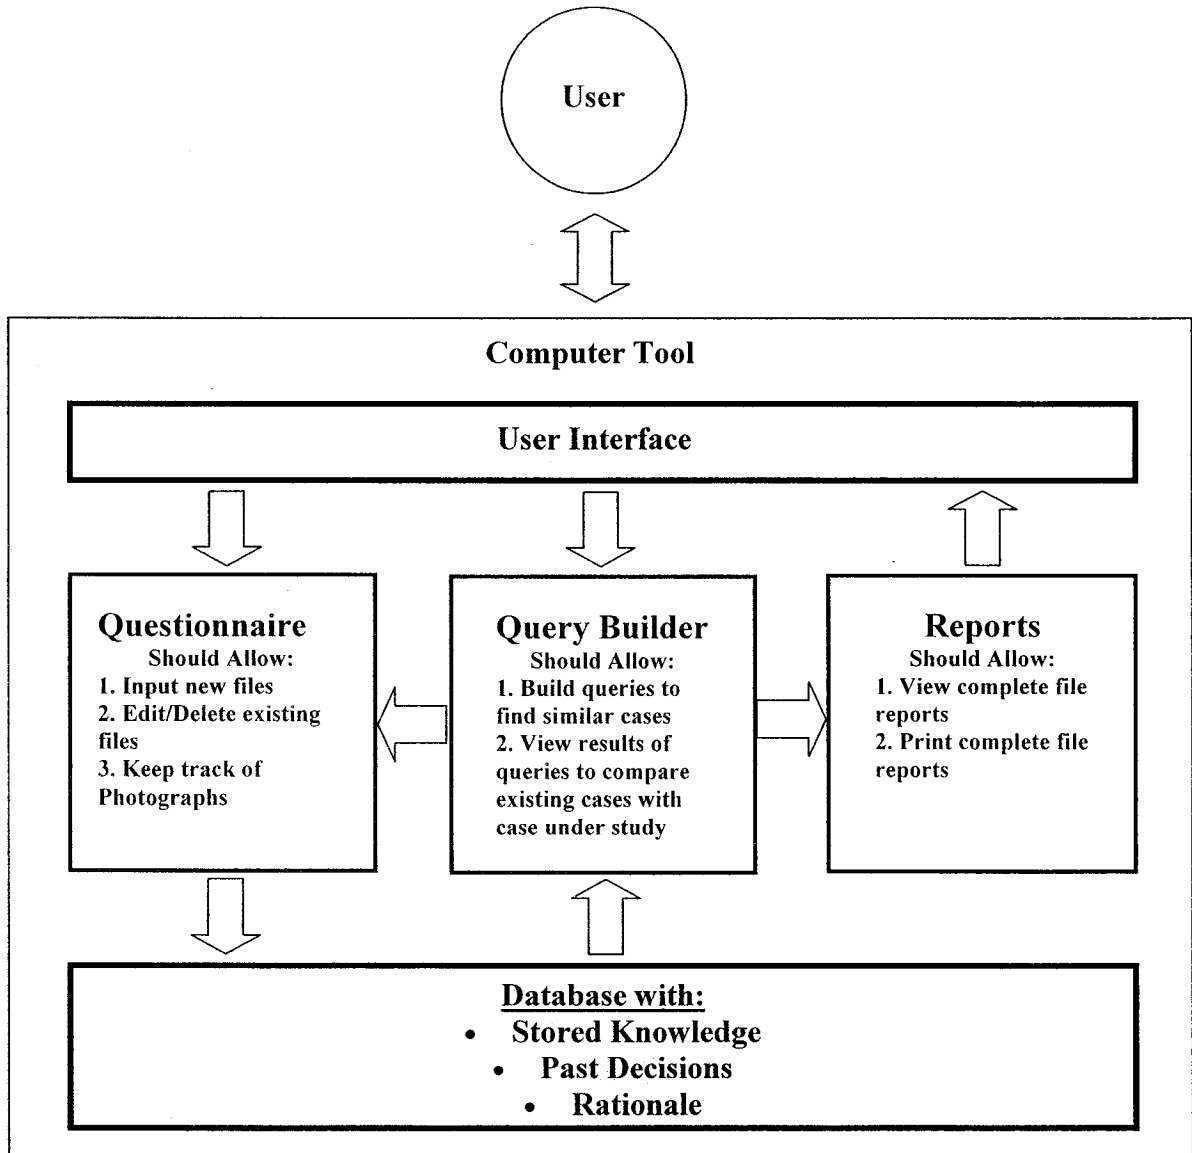
After analyzing the requirements, a model was designed to guide the construction of the new tool. The outcome was the following architecture:

Figure 2.1 Architecture of the proposed tool

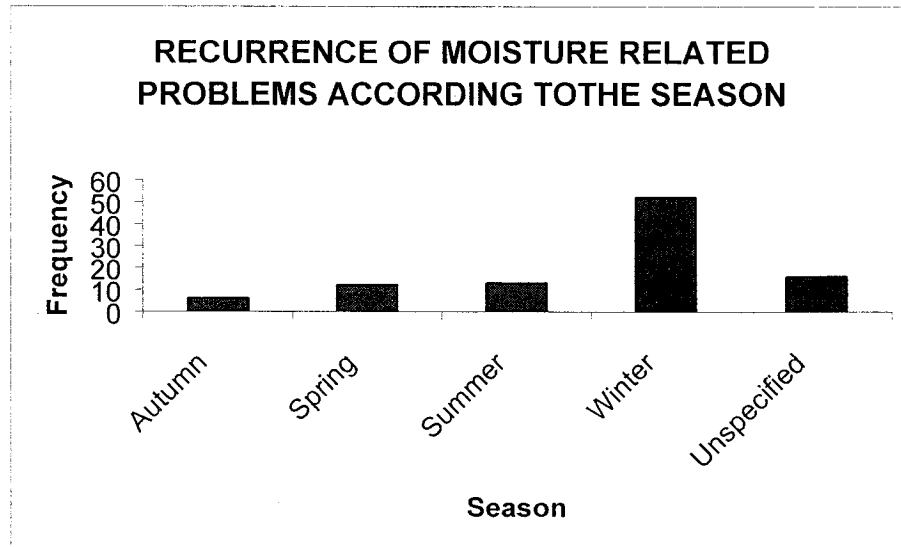
Figure 3.1 shows the recurrence of moisture related problems according to the season of the year. Most of the problems occur in winter, when the differences between interior and exterior environments are greater. The harsh climate in this season makes evident many of the building envelope problems that under milder weather conditions would pass undetected. One frequent case happens in those periods of winter in which the temperature rises enough to melt snow that accumulates in roofs and due to the presence of ice dams leads to water infiltrations in the envelope.

Figure 3.1: Recurrence of moisture related failures according to the season of the year

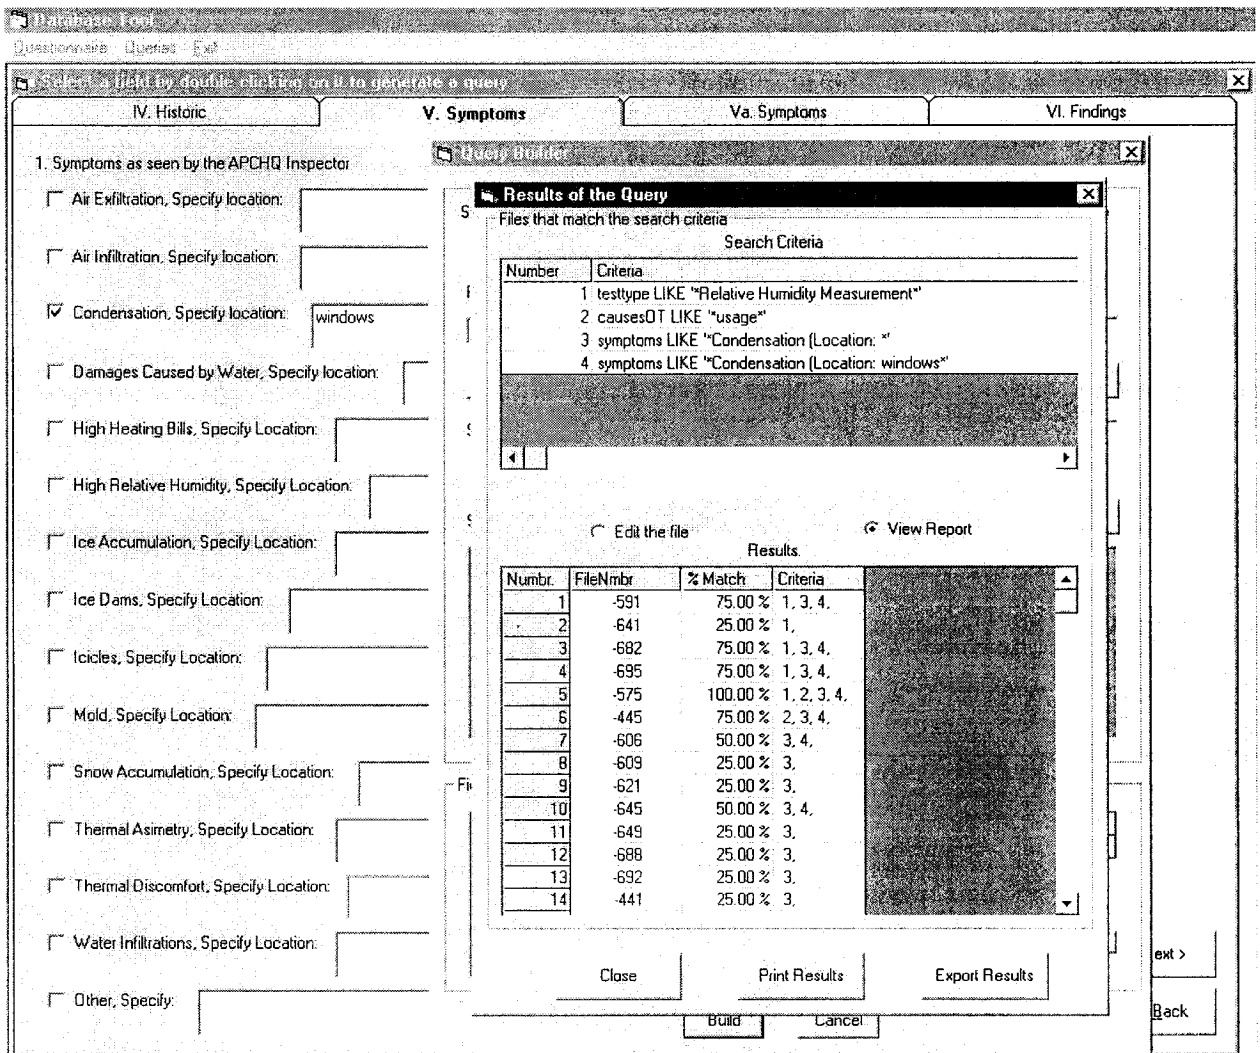
(Test type LIKE *Relative Humidity*) OR (Causes LIKE *usage*) OR (Symptoms LIKE *Condensation*) OR (Symptom Location LIKE *Windows*)

Figure 4.7 Results of query for case 3

The case that matches all the search criterion is 575 (because this is the sample case) and there are 4 cases that matched in 75% of the criterion. Such cases are 571, 682, 695 and 445.
